# AIRCRAFT ACCIDENT INVESTIGATION REPORT

AIR CENTRAL CO., LTD.  
BOMBARDIER DHC-8-402, JA849A  
KOCHI AIRPORT, JAPAN  
MARCH 13, 2007

May 28, 2008

Aircraft and Railway Accidents Investigation Commission  
Ministry of Land, Infrastructure and Transport

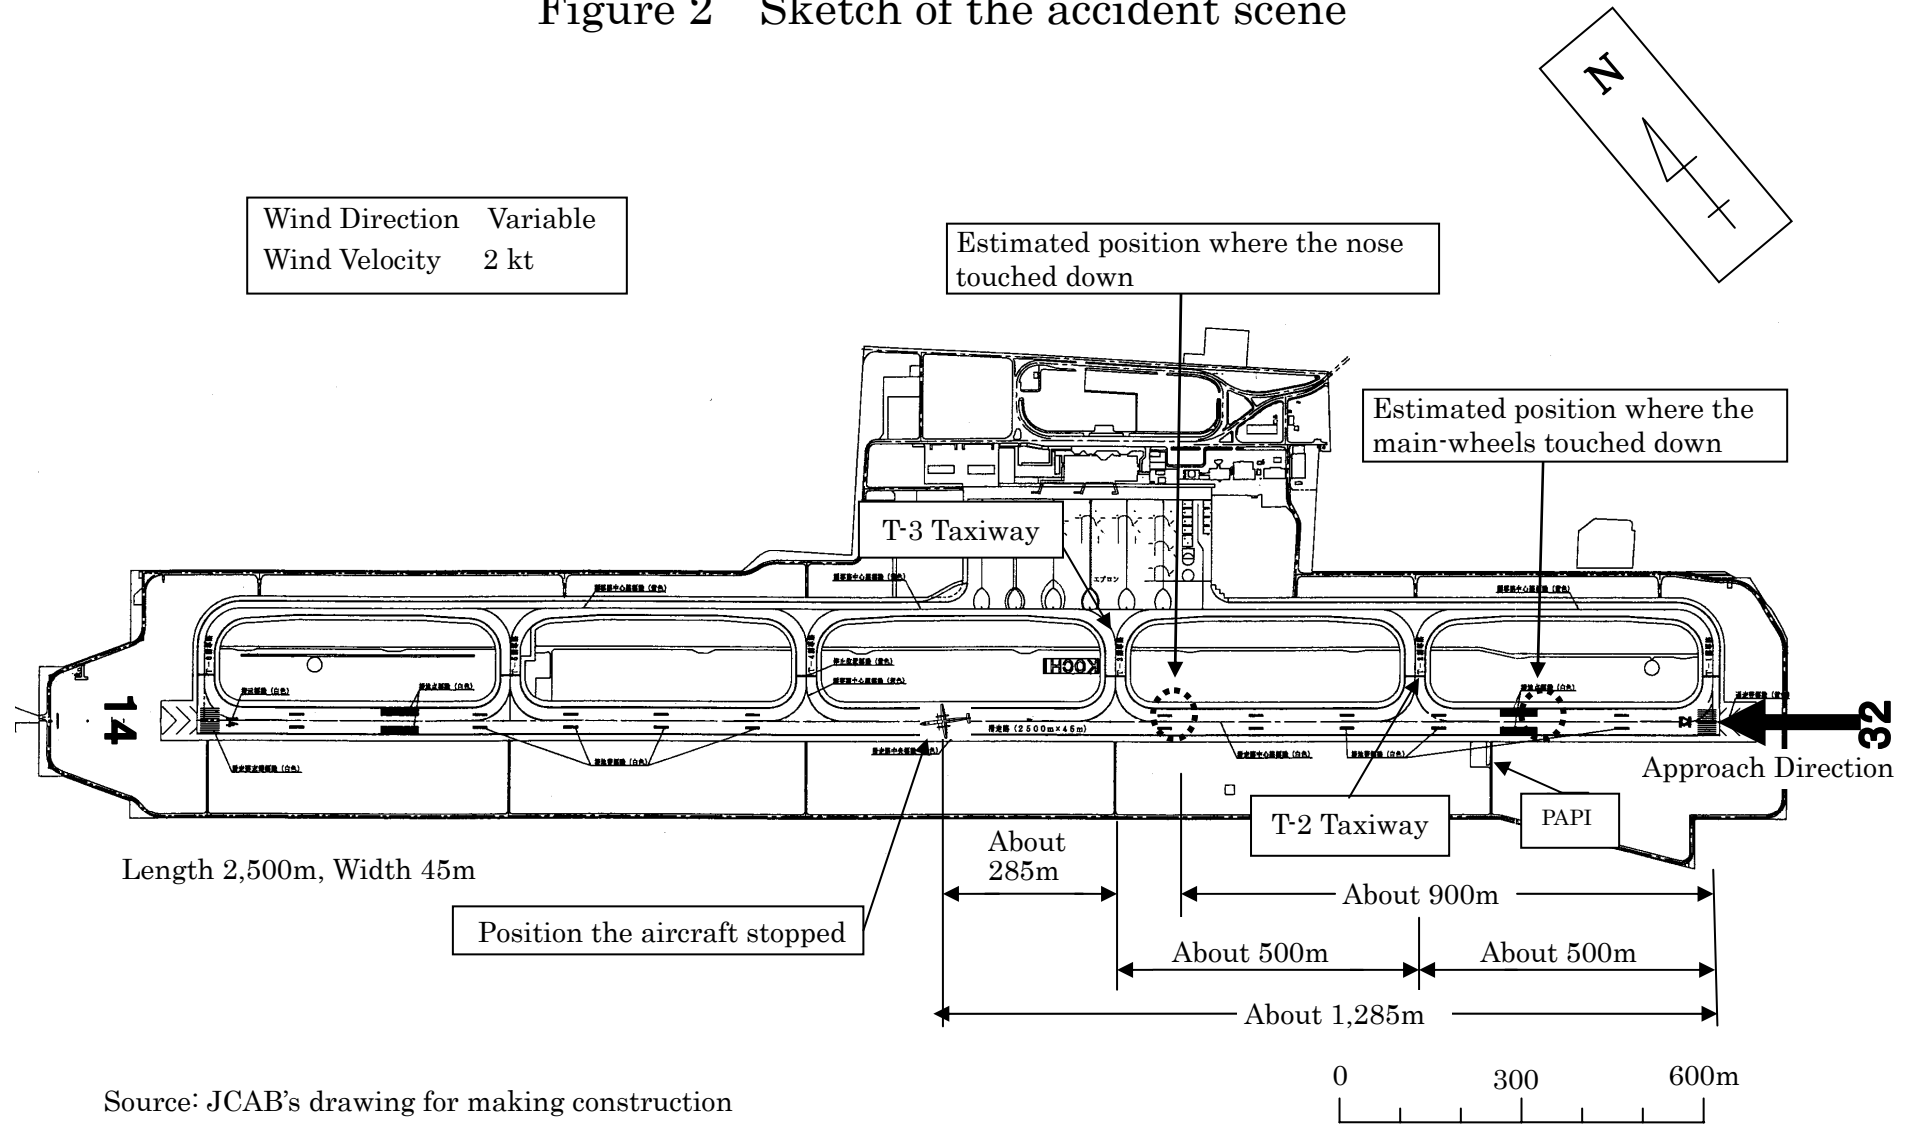
Figure 2 Sketch of the accident scene

The contact marks made by the aircraft nose were found on the runway from about 900 m beyond the threshold up to 1,285 m, the point at which the Aircraft came to a rest.

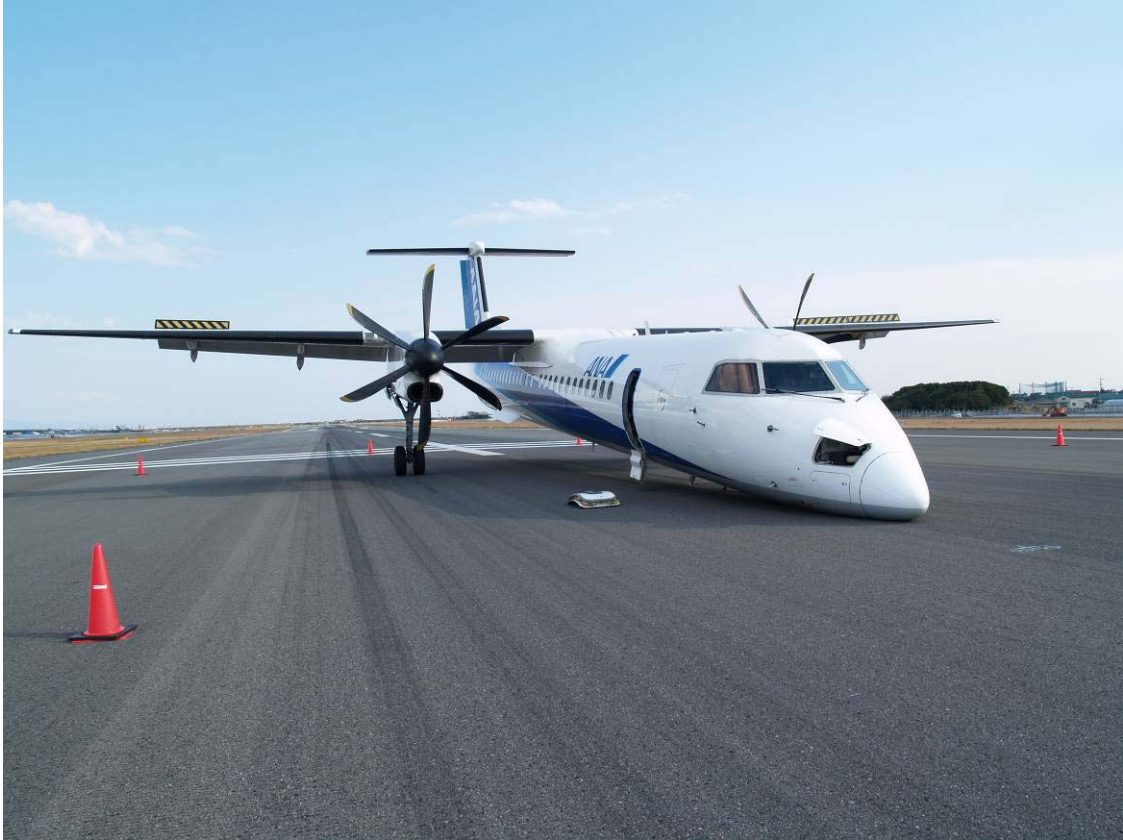
Photo 1 Accident Aircraft (1)

With the nose wheels retracted, the main structural members of the lower part of the forward fuselage were damaged by the contact against the runway during landing.

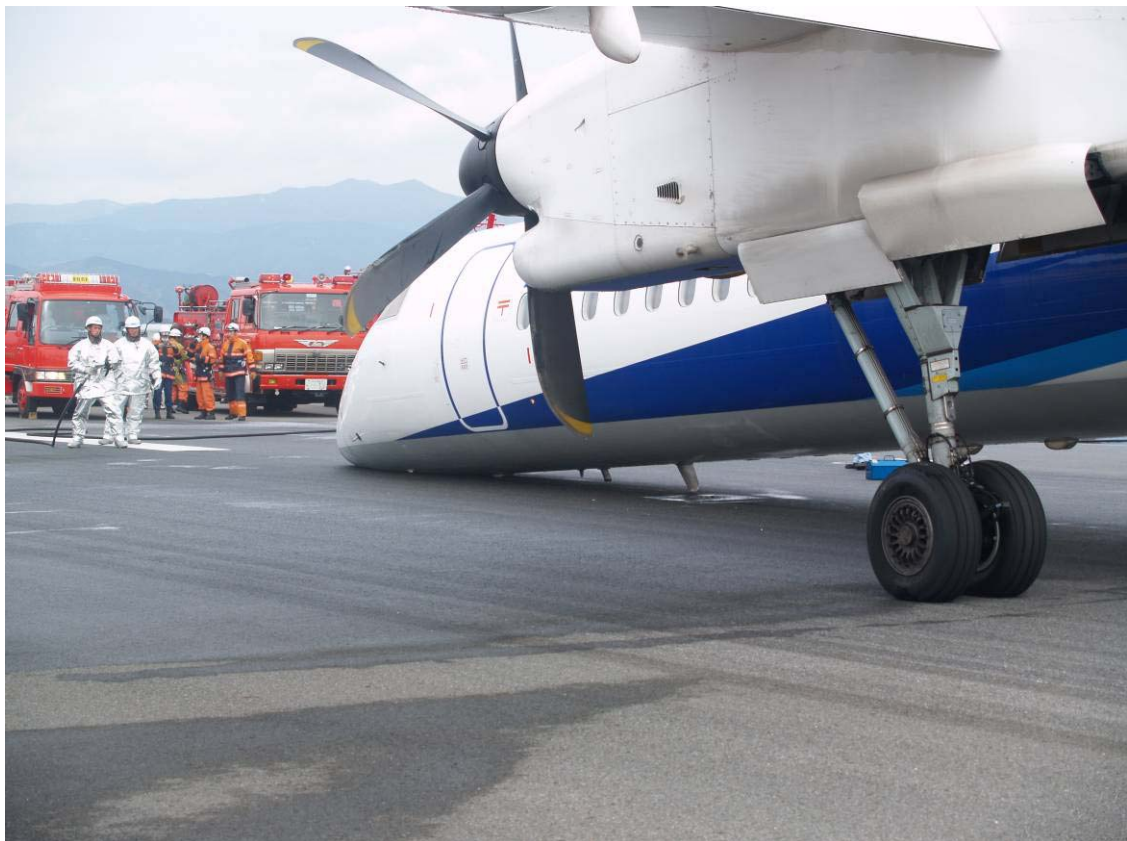
Photo 2 Accident Aircraft (2)

The main structural members (such as frames, stringers, skins) of the lower part of the forward fuselage of the Aircraft were damaged. The VHF antenna (No. 2) installed in that position was also damaged.

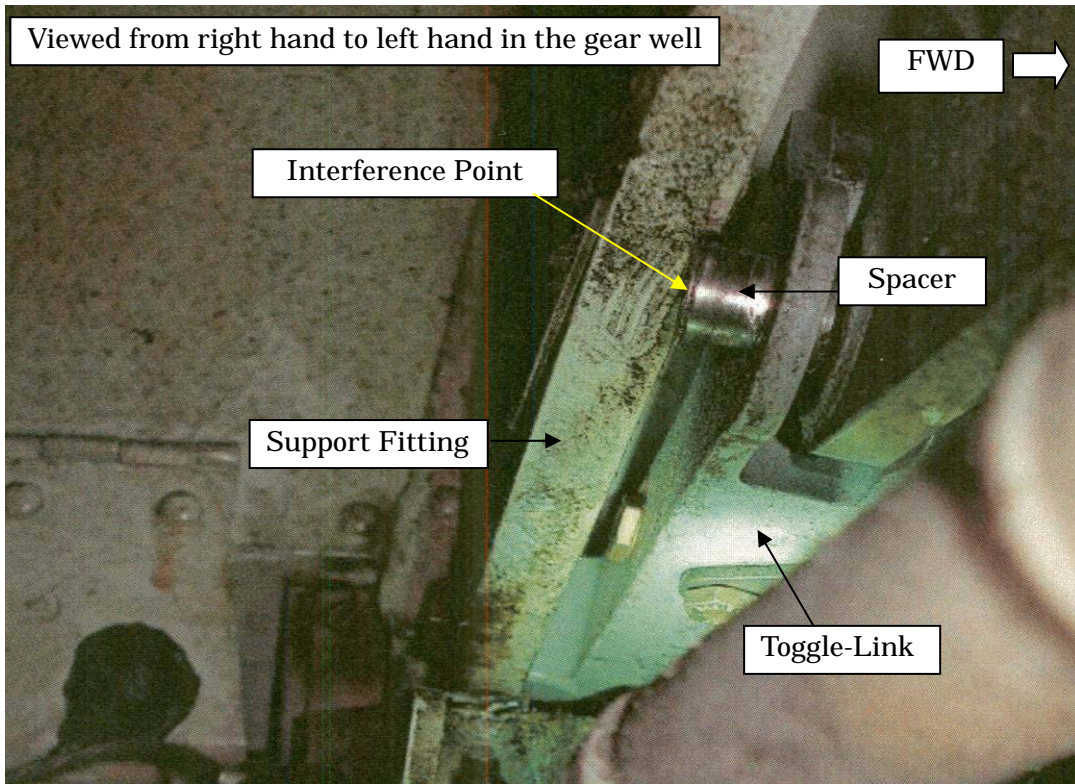
Photo 4 Spacer Interfered Point

**3.5** Based on the results of the investigation outlined in 2.10, it is recognized that the event in which the doors of the nose landing gear did not open, was caused by that, during flight with the gear retracted, the spacer migrated out aftward in excess of the limit from the hinge part of the toggle link assy, which comprises part of the door linkage mechanism of the nose landing gear, and when the gear down operation was made later, in the course of opening the doors of the nose landing gear, the toggle link assy was folding upward, the spacer interfered with the support fitting, which prevented the movement of the toggle link assy.

It is estimated that the spacer interfered with the support fitting because, as described in 2.12.1 (4), the spacer and the support fitting are in relative location susceptible to interference if the spacer migrates out aftward in case that the bolt is missing.

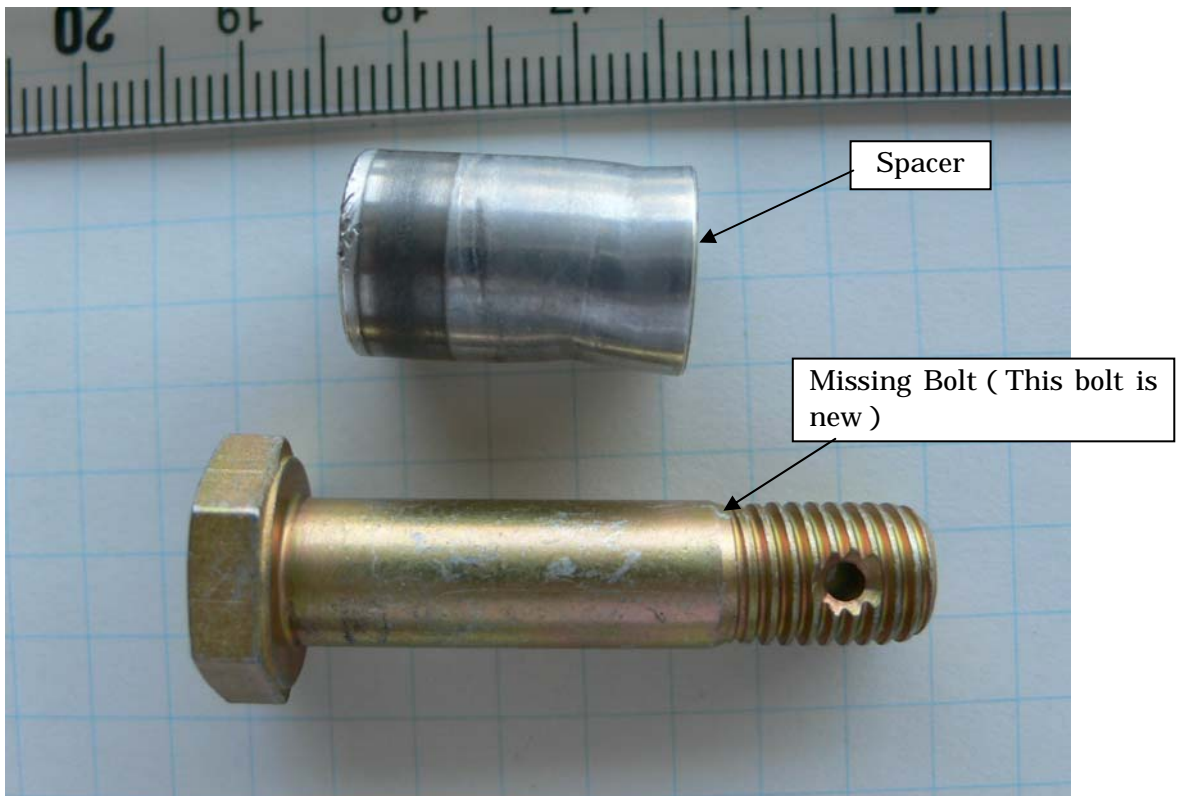
Photo 5 Spacer removed from the accident aircraft and new bolt for reference

**3.6** It is estimated that the event in which the spacer migrated out of the toggle link assy of the Aircraft was caused by that the bolt to be installed through the spacer, had been missing, and during operations of the Aircraft (4,197 landing cycles, during which NLG door made 16,788 movements), the spacer was gradually pulled aft out of the toggle link assy under the influence of the nose landing gear retract/extend operation, airframe vibration, aircraft acceleration, and so on.

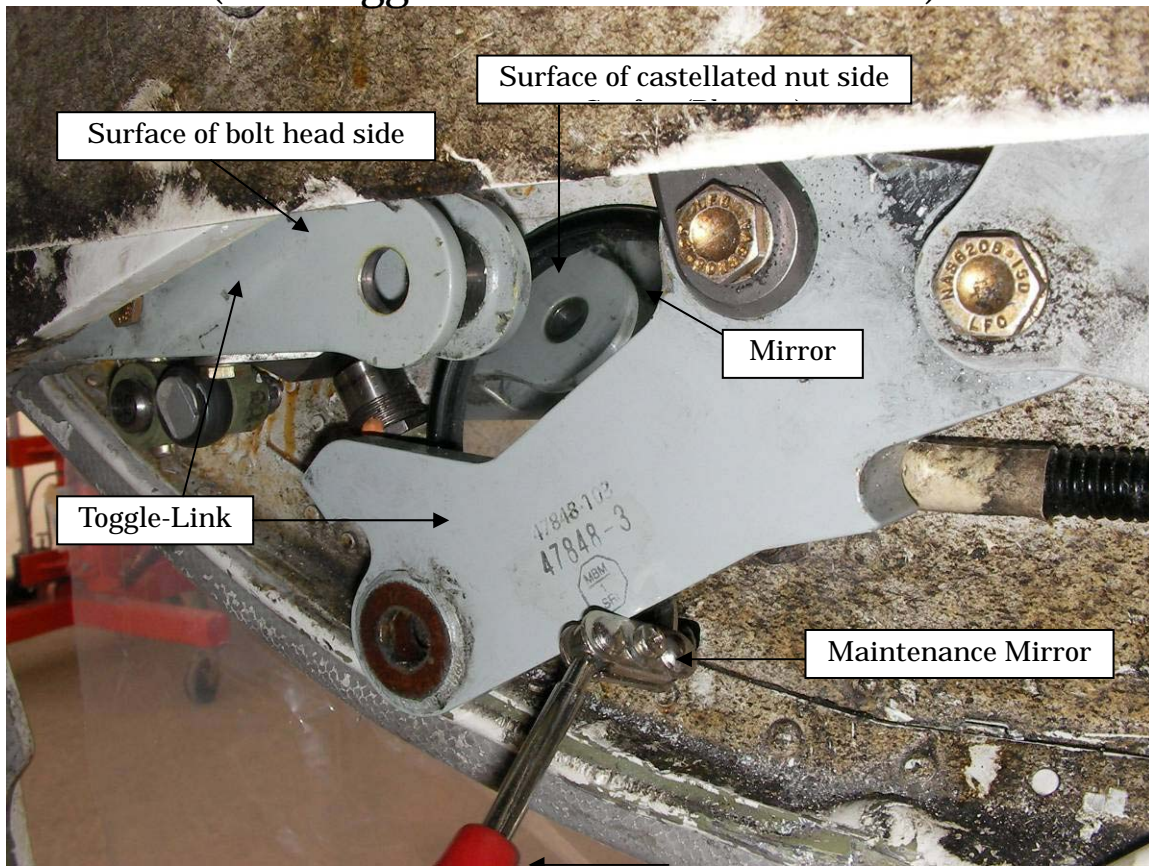
Photo 6 Toggle-Link of the accident aircraft (1)  
(Two toggle links are disconnected)

- (5) Neither on the toggle link surface to be under the bolt head nor on the toggle link surface to be in contact with the castellated nut and washer, there exhibited any marks such as stains or peeling of paint that would have indicated the existence of the bolt.

As described in 2.10 (4) and (5), the bolt and nut were not found in the toggle link assy of the Aircraft. Moreover, there were no traces that could indicate the existence of the bolt head and

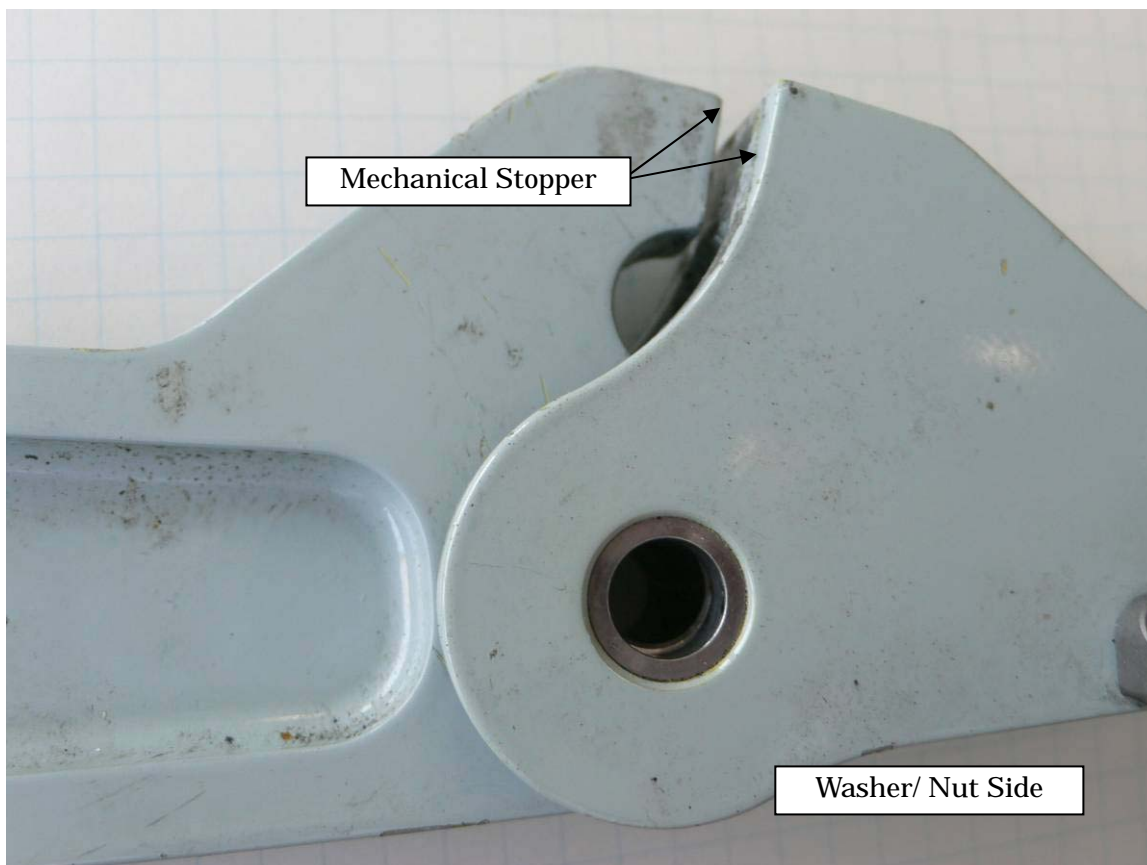
Photo 8 Toggle-Link removed from the accident aircraft (3)

nut/washer had not been present since shortly after the manufacture of the Aircraft up until the occurrence of this accident, because there are no stains, peeled paint and the like on a surface of the toggle link which is located underside of the bolt head if the bolt is installed, and on the other surface of the toggle link, to which the castellated nut/washer would have made contact, and those conditions are different from other aircraft on which those parts are installed.

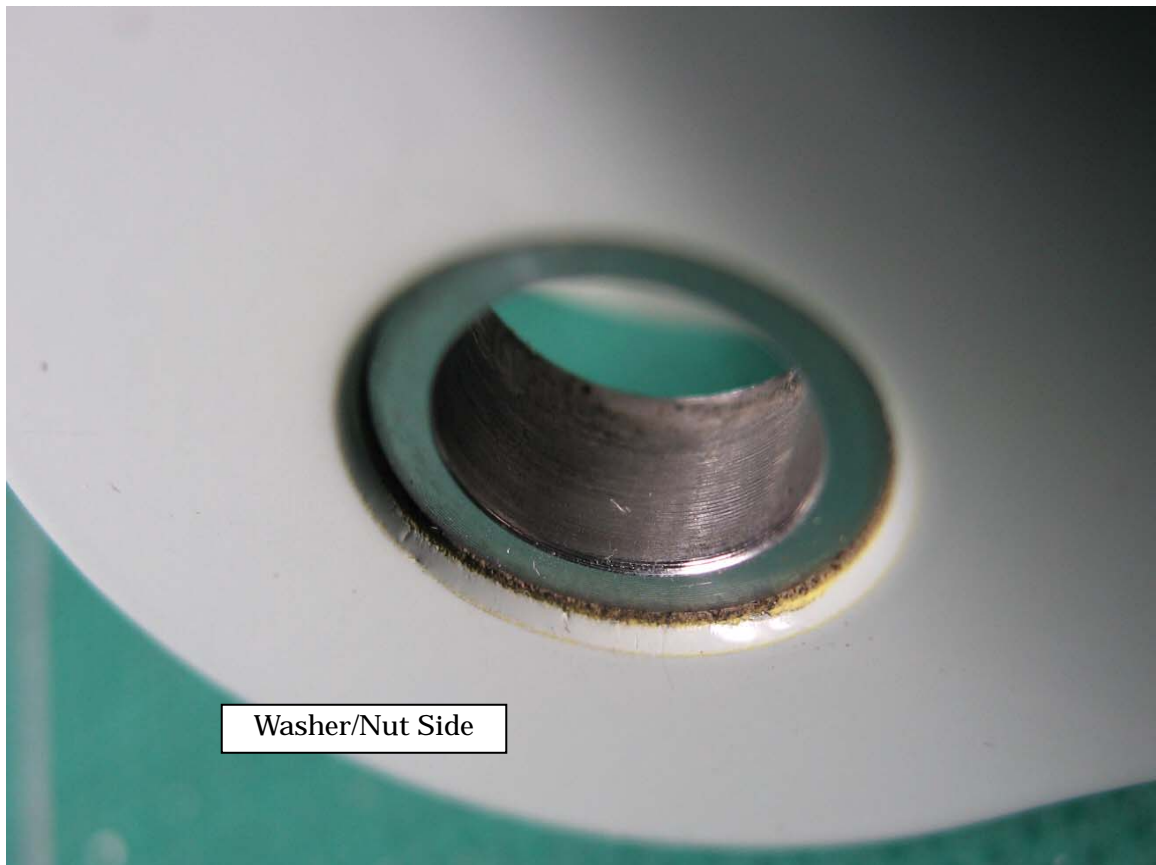
Photo 12 Inner Surface of Flanged Bushing removed from the accident aircraft

- (2) The wear condition on the inner surface of the flange bushing of the toggle link assy was compared with a new flange bushing, and it is considered that at least a bolt specified on the drawing has not been installed through the toggle link assy.
- (3) The impact marks on the bottom surface of the support fitting was caused by the pressure yield<sup>\*19</sup> by the contact load from the spacer, and it is estimated that the load was 862N~2,451N.
- (4) As for the paint peeled off the side surface of the support fitting, it is probable that the paint

It is estimated that the bolt had been missing since early time based on the investigation of the inner surface of the flange bushing as described in 2.12.4 (2), as well. Furthermore, as described in 2.12.3, it is estimated that the impact marks on the mechanical stopper were widened because the mechanical play of the toggle link grew larger as the bolt had not been installed.
