# AIRCRAFT ACCIDENT INVESTIGATION REPORT

<b>Company</b>	Oriental Air Bridge Co., Ltd.
<b>Type, Registration Mark</b>	Bombardier DHC-8-402, JA858A
<b>Accident Class</b>	Aircraft damage caused by a bird strike
<b>Date and Time of the Occurrence</b>	At about 08:11 Japan Standard Time (JST: UTC+9 hours), July 20, 2024
<b>Site of the Accident</b>	Tsushima Airport, Tsushima City, Nagasaki Prefecture (34° 17' 05" N, 129° 19' 50" E)

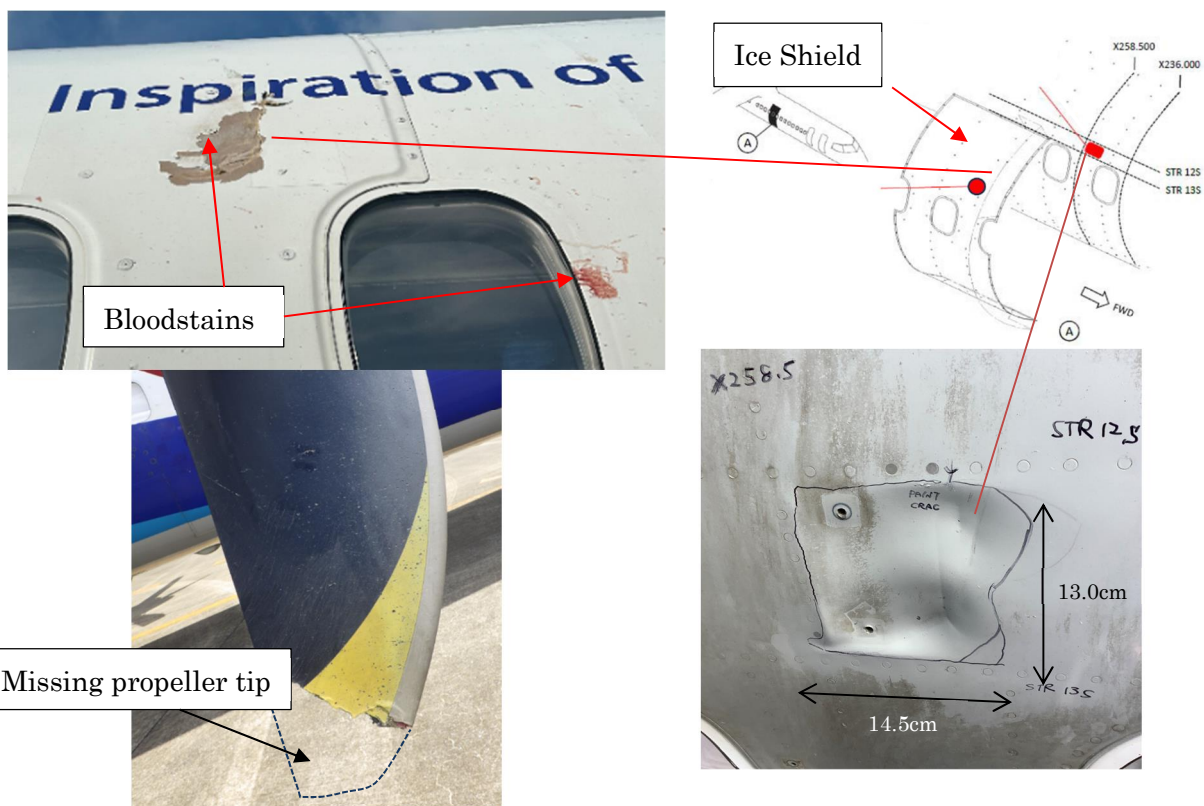
Figure 1: Locations of the Damage to the Aircraft

- A dent on the right fuselage 14.5cm wide, 13.0cm long and 0.5cm depth between stringers 12S and 13S (inside the ice shield\*<sup>1</sup>) near X258.50 frame.
- Damage including cracks on the ice shield which covers the dent described above.
- About 8cm missing from the right propeller of Blade #2 tip.
- There were Bloodstains of the bird on the ice shield and its vicinity and the right propeller #2 Blade tip.

The JTSCB concludes that it is certain that the bird struck the right propeller during the landing roll and the bird was accelerated by the propeller rotation and struck the fuselage and caused damage to the aircraft.
