The investigation for this report was conducted by Aircraft and Railway Accidents Investigation Commission about the aircraft accident of Japan Airlines Boeing 747-400D (an approach to JA8546 of the same airline) in accordance with Aircraft and Railway Accident Investigation Commission Establishment Law and Annex 13 to the Convention of International Civil Aviation for the purpose of determining cause of the aircraft accident and contributing to the prevention of accidents and not for the purpose of blaming responsibility of the accident.

Junzo Sato,
Chairman,
Aircraft and Railway Accidents Investigation Commission

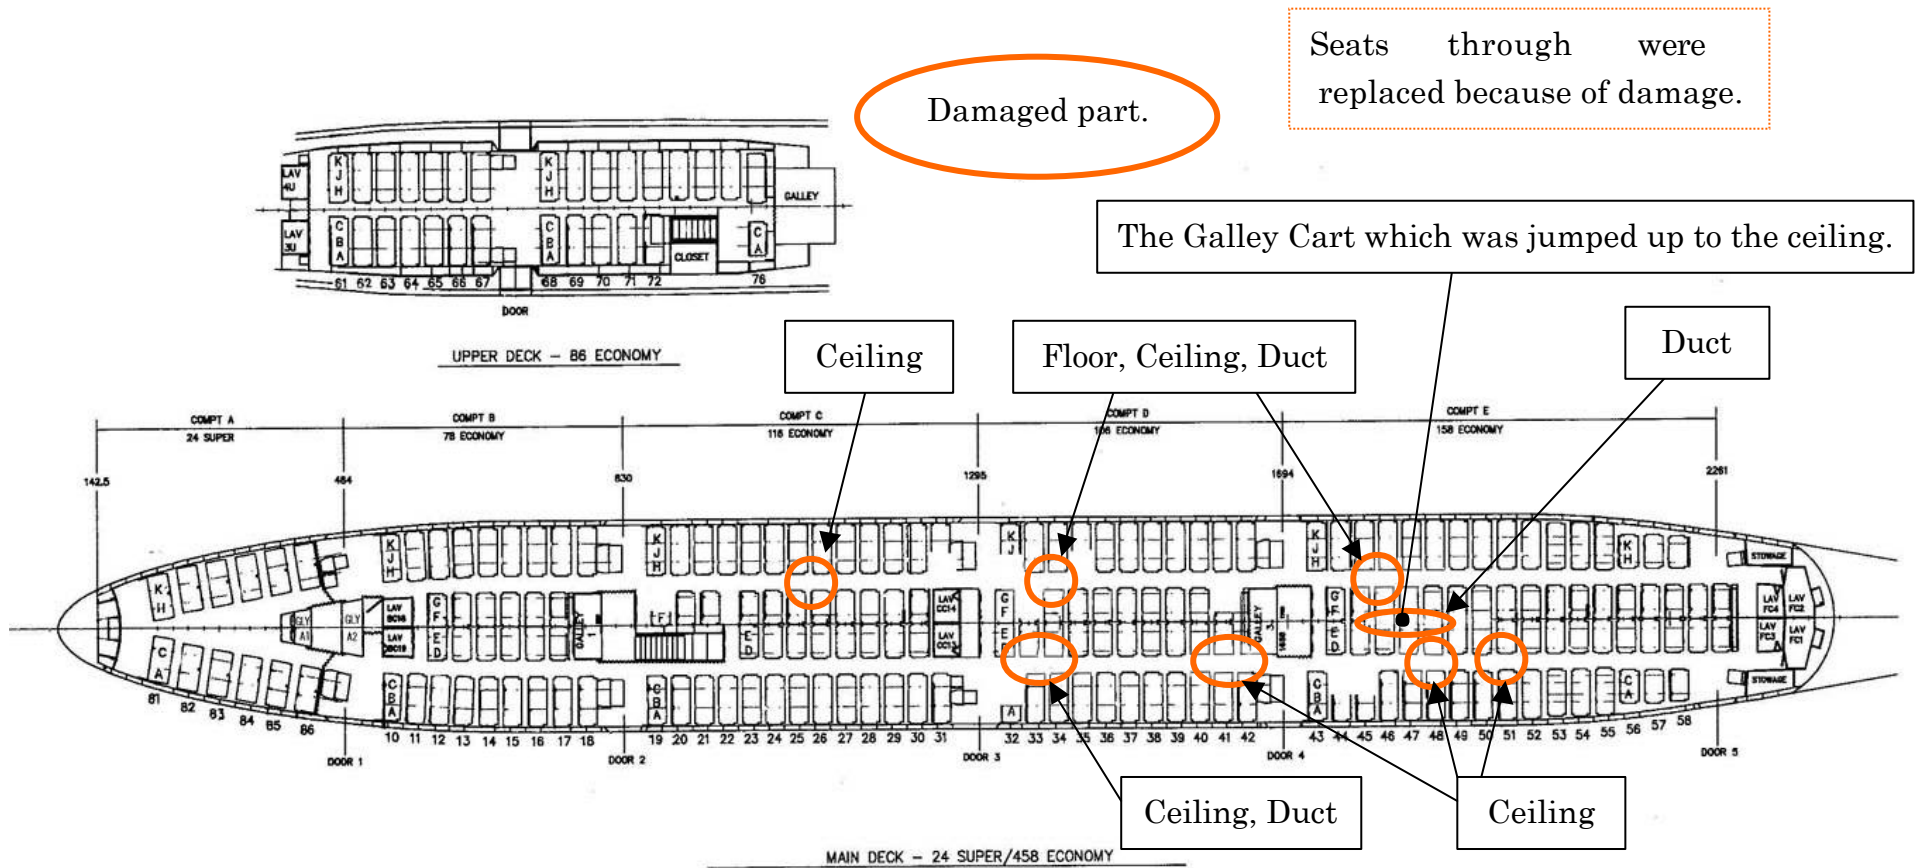
Figure 15 Damages to Aircraft A

The following is a list of seats that were replaced due to damage sustained. The numbers in parentheses indicate positions in the passenger cabin shown in Attached Figure 15.

- Seat 19G due to damage to its right armrest ()
- Seat 31H due to damage to its left armrest ()
- Seat 32H due to damage to its left armrest ()
- Seat 33G due to damage to its right armrest ()
- Seat 35H due to damage to its left armrest ()
- Seat 41G due to damage to its right armrest ()
- Seat 44C due to damage to its right armrest ()
- Seat 45C due to damage to its right armrest ()
- Seat 32B&C due to damage to their attached tables ()

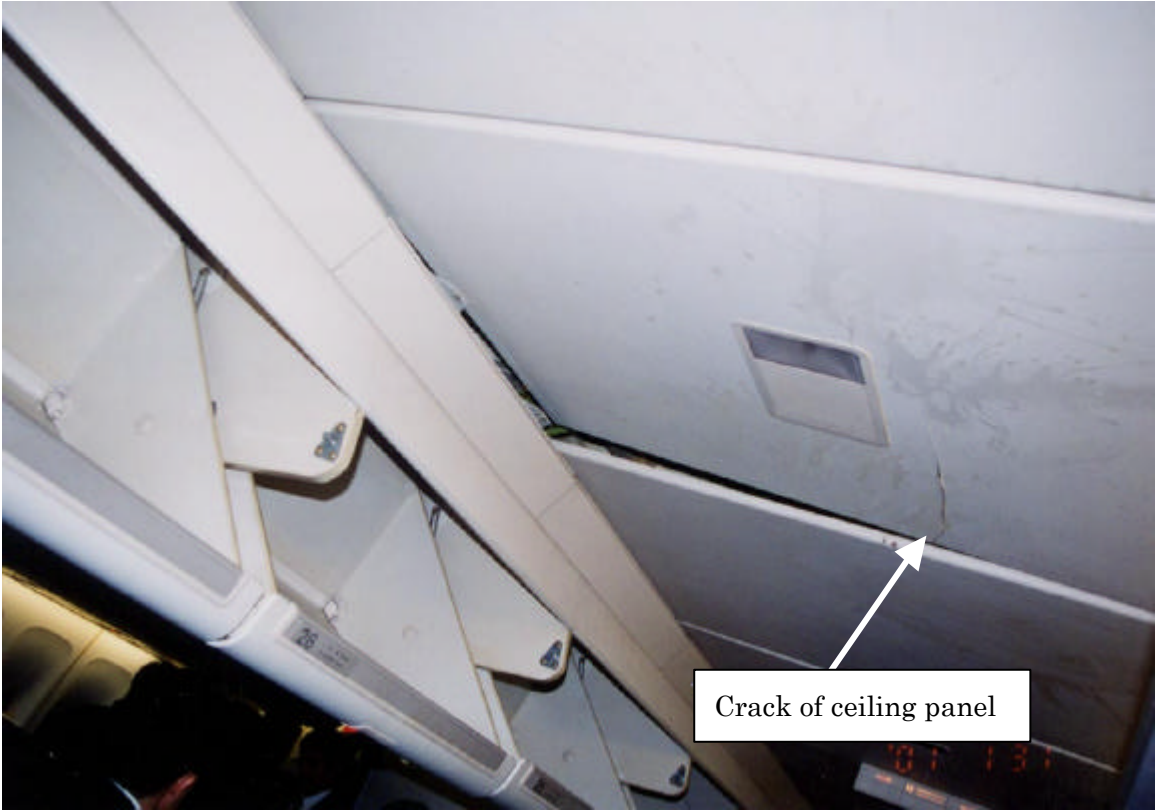
Photograph 1 Damage of the ceiling panel (Aircraft A) 1

Cracks were noted on part of the panel in the vicinity of seat 26

The damage of ceiling panel over right side pass way seat No. 26(view from backward)

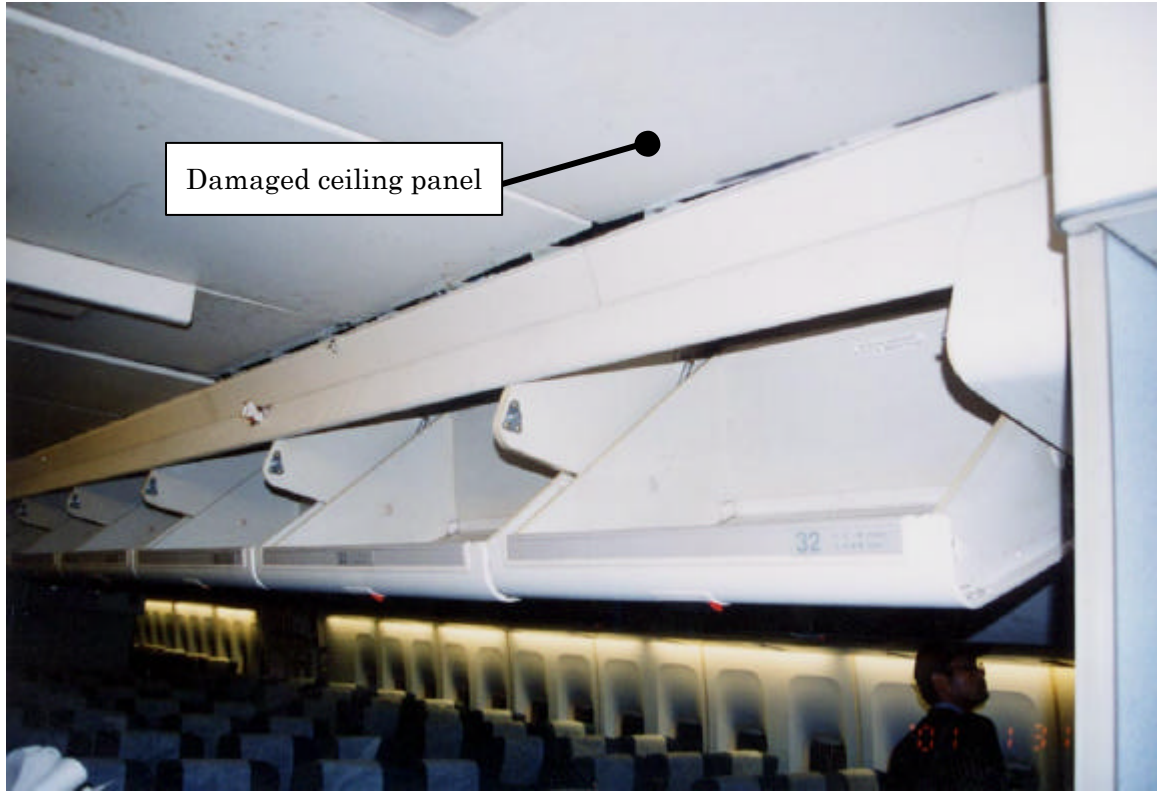
Photograph 2 Damage of the ceiling panel (Aircraft A) 2

Dents and bends were noted on part of the panel in the vicinity of seat 32

The damage of ceiling panel over right side pass way seat No. 32(view from front)

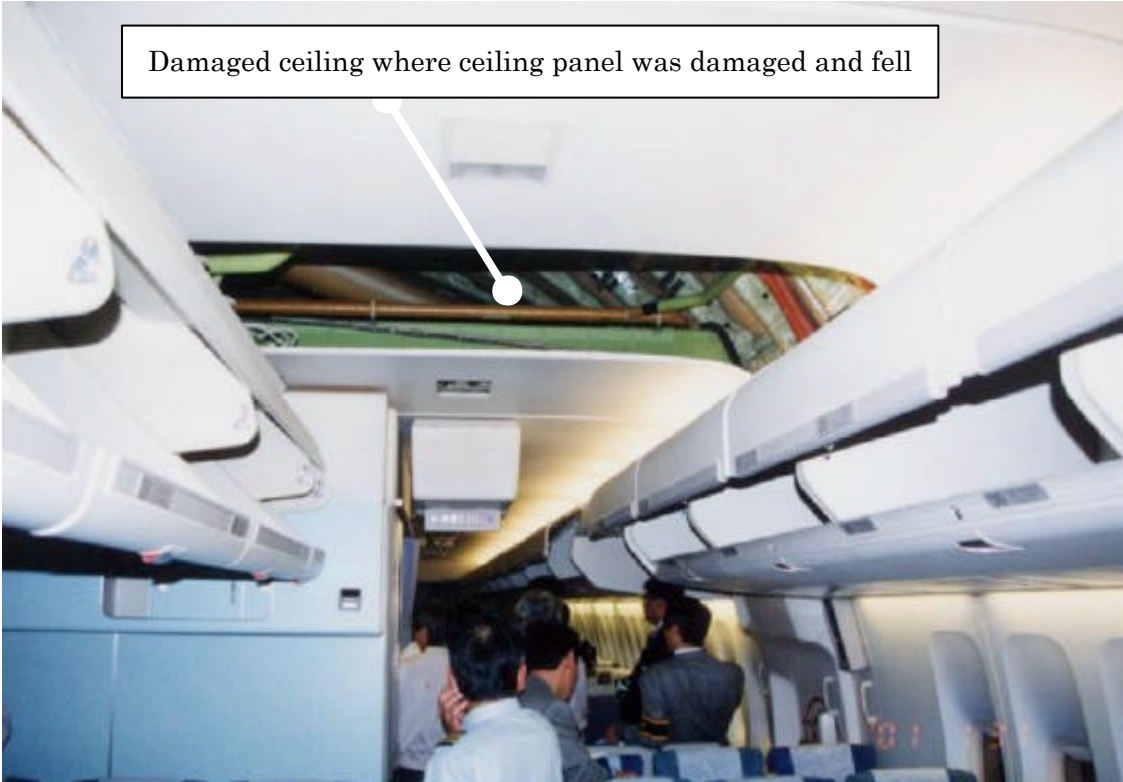
Photograph 3 Damage of the ceiling panel (Aircraft A) 3

The panel in the vicinity of seat 41 was fractured and had dropped onto the cabin floor.

The damage of ceiling panel over left side pass way seat No. 41(view from front)

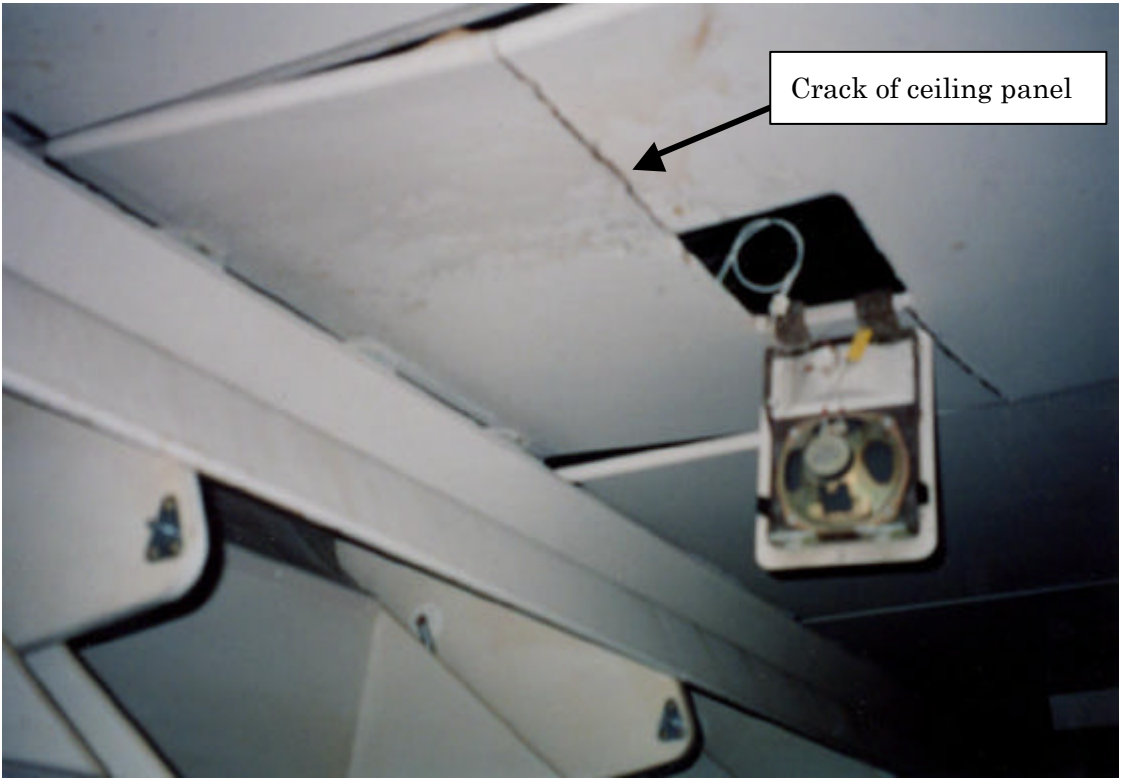
Photograph 4 Damage of the ceiling panel (Aircraft A) 4

Cracks were noted on part of the panel in the vicinity of seat 48

The damage of ceiling panel over left side pass way seat No. 48(view from front)

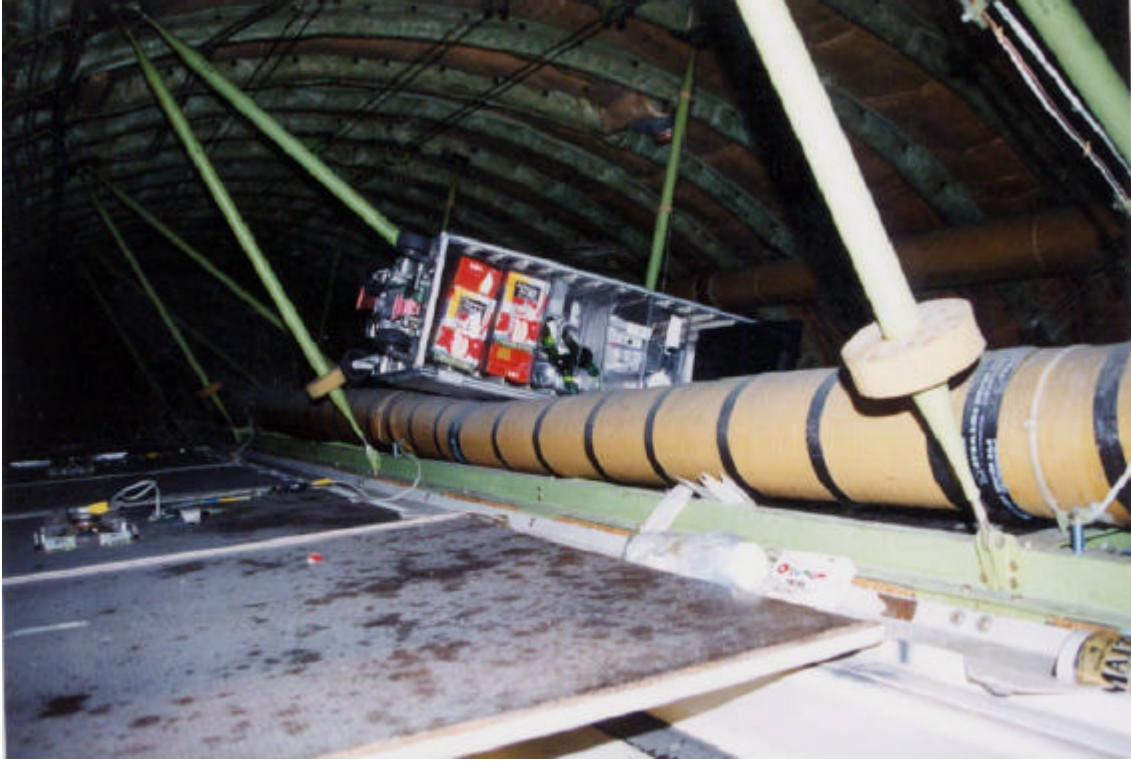
Photograph 5 Situation of the galley cart that was jumped up to the ceiling of Aircraft A 1

Five of the passenger service galley carts sustained damage. One of these was found resting on top of a ceiling panel in the vicinity of seats 47E and 47F.

The galley cart mentioned in the (4) above was found resting on an air-conditioning duct behind the ceiling in the vicinity of the seat 46–48EF, and the portion of the duct concerned was slightly crushed.

Rear view from the ceiling of right side pass way of seat No. 45

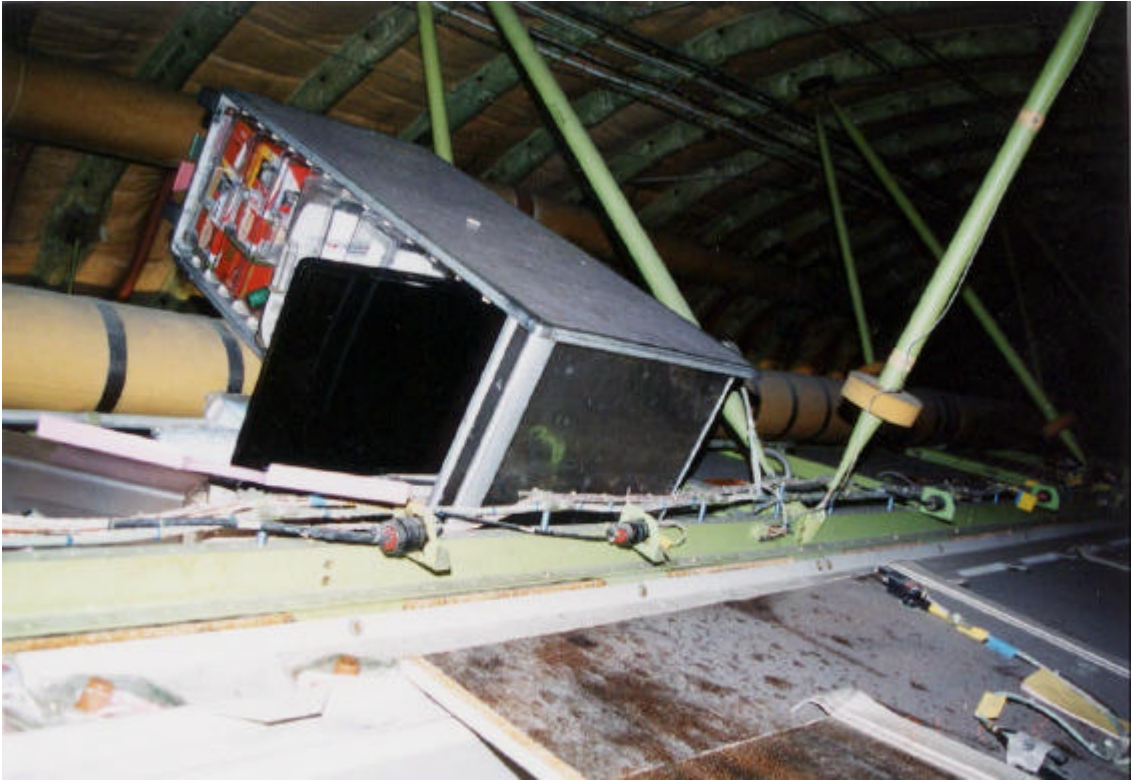
Photograph 6 Situation of the galley cart that was jumped up to the ceiling of Aircraft A 2

Rear view from the ceiling of left side pass way of seat No. 46

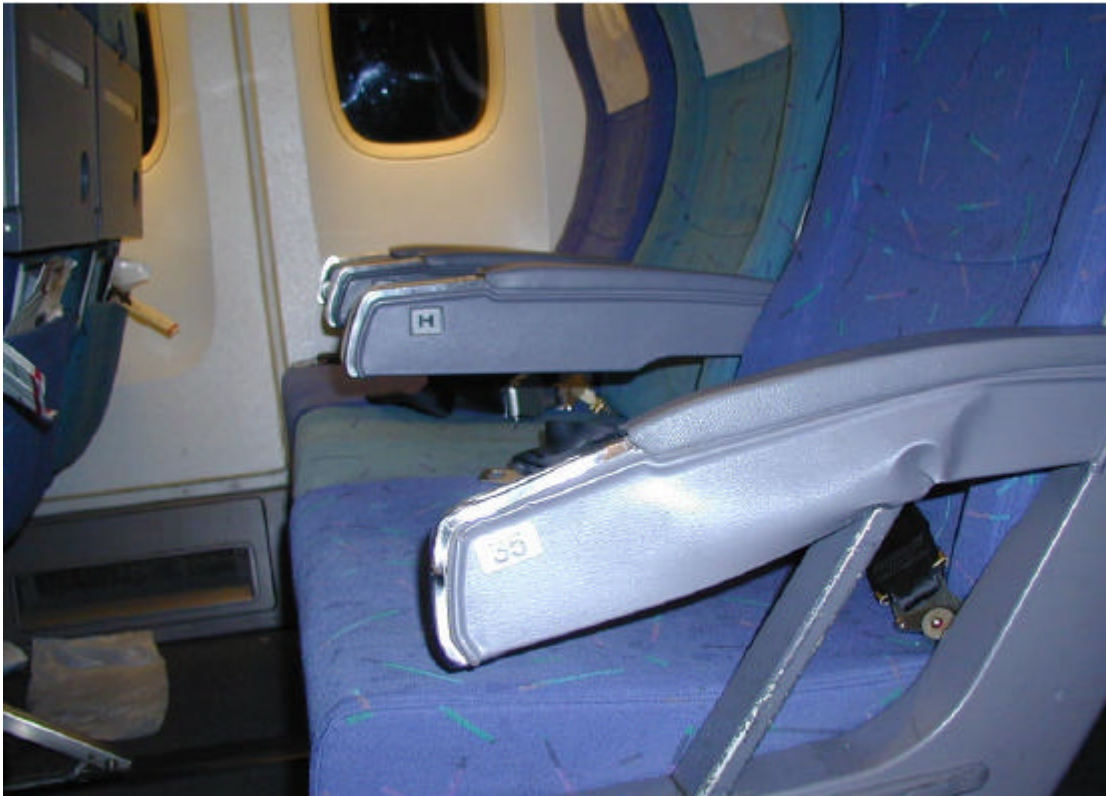
Photograph 8 Damage of seats (Aircraft A) 2

Damage of seat armrest of right side pass way seat No. 35
