**AIRCRAFT ACCIDENT INVESTIGATION REPORT**  
**AIRFRAME DAMAGE FROM LIGHTNING STRIKE IN FLIGHT**  
**ALL NIPPON AIRWAYS CO., LTD.**  
**BOEING 787-9, JA891A**  
**AT AN ALTITUDE OF APPROXIMATELY 1,500 M, ABOUT 77 KM**  
**EAST-SOUTHEAST OF NARITA INTERNATIONAL AIRPORT**  
**AT ABOUT 16:15 JST, MARCH 20, 2024**

Adopted by the Japan Transport Safety Board

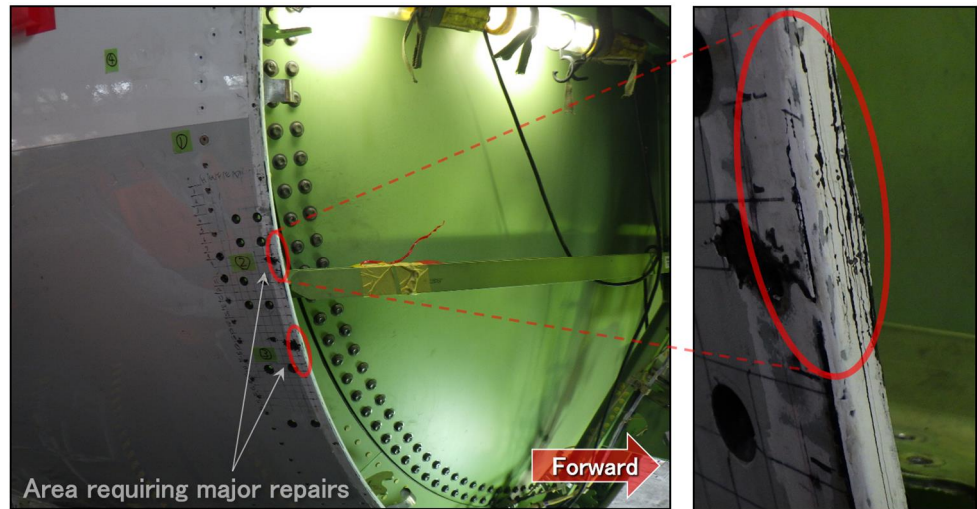
Figure 2: Damage to Forward Right Side Fuselage and Enlarged View

<b>2.2 Injuries to Persons</b>	None
<b>2.3 Damage to the Aircraft</b>	<p>Extent of Aircraft Damage: Substantial damage</p> <ul style="list-style-type: none"> <li>• Delamination on the outer skin of the forward right side fuselage</li> </ul> <p>(Area requiring major repairs): Two locations (Figure 2)</p>

In this accident, it was determined that the damage required major repairs because the delamination of the outer skin of the forward right side fuselage had propagated across all layers.

<p>The multi-layered delamination was repaired by the company according to the repair method obtained from the design and manufacturing company, as the 3D ultrasound image was available at the company. It is desirable that non-destructive testing shall be conducted periodically on the repaired parts to confirm that there is no propagation of the delamination (Figure 7).</p> <p>(2) The Company's Measures against Lightning Strikes</p> <p>The company has taken the following measures against lightning strikes:</p> <ul style="list-style-type: none"> <li>• Winter: Establishment of avoidance routes at airports on the Sea of Japan side (Toyama Airport, Akita Airport)</li> <li>• Spring and Summer: Provision of lightning information to flight crews via ACARS at Tokyo International Airport and Narita International Airport.</li> <li>• A 3D aviation weather application development in collaboration with the Japan Aerospace Exploration Agency (JAXA) and MTI Co. Ltd. and promotion of the information provision by ground operating staff through its introduction.</li> </ul> <p>(3) Temperature Zones with High Risk of Lightning Strike</p> <p>Aeronautical Information Manual Japan (AIM-J) No. 80 (Late 2024 Edition. Sections 851), (Published by Japan Aircraft Pilot Association) states as follows; (excerpts)</p> <p><i>f. Flight operation in a thunderstorm area</i></p> <p><i>a) Horizontal avoidance: When avoiding a cumulonimbus, detouring is the easiest and safest choice. A pilot should avoid any thunderstorm regarded as SEVERE or strong radar echoes at least by 20 nm. (Omitted)</i></p> <p><i>c) Flight proximity to a thunderstorm</i>  <i>(When required to operate within the area described in a))</i>  1) to 3) (Omitted)</p> <p><i>4) Avoid a 0 °C altitude with enough margin. Strong turbulence, strong icing and electric discharge are often encountered at that altitude. Statistically, -8°C ~ +8°C of this level, a thunderstorm may be experienced with 90% possibility. It is recommended to avoid the freezing level by 5,000 feet above or below. (Omitted)</i></p>

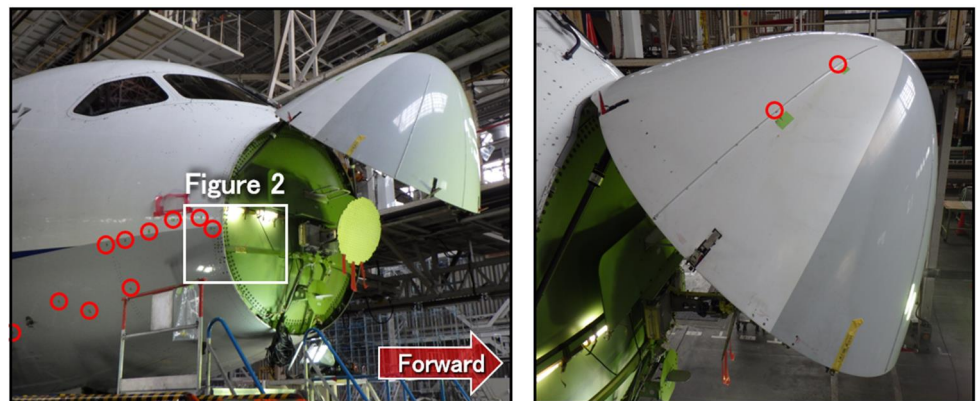
Figure 3: Damage to Parts other than those Requiring Major Repairs

- Burn marks on the upper and rear of the above:  
10 locations (Figure 3, left)
- Burn marks on the radome: Two locations (Figure 3, right)
