AIRCRAFT SERIOUS INCIDENT INVESTIGATION REPORT

DEVIATION FROM A RUNWAY (LIMITED TO WHEN AN

HONDA AIRWAYS CO., LTD.

HONDA AIRCRAFT HA-420, JA924H

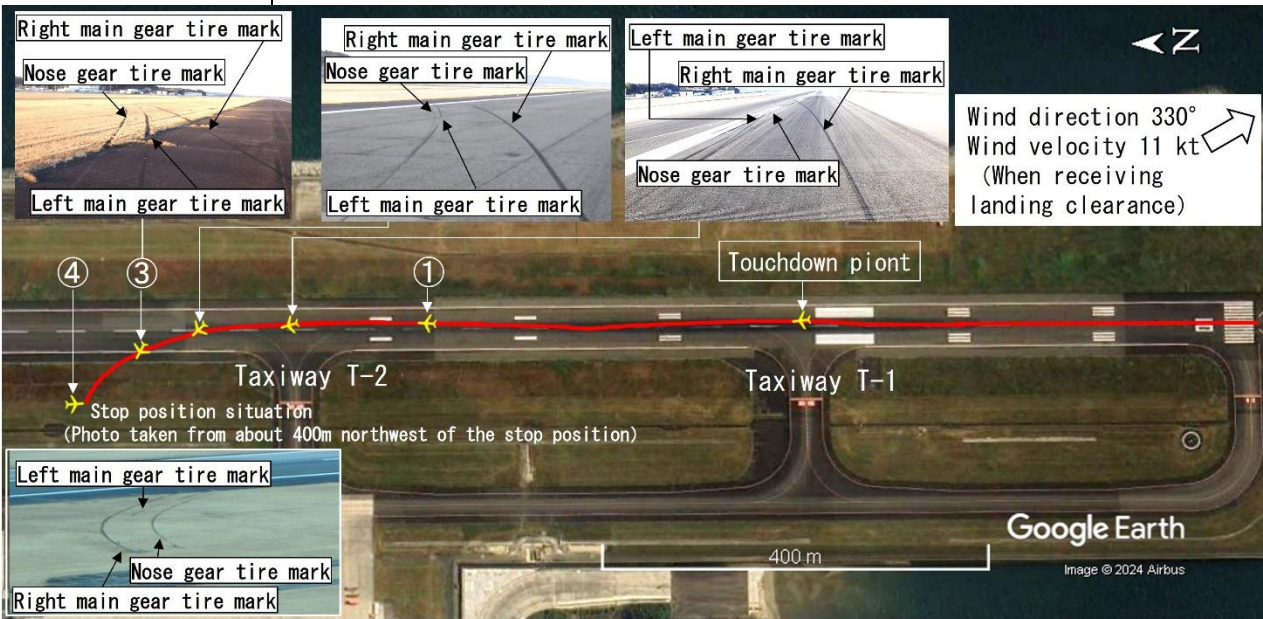
Figure 4 Estimated landing roll track

<p>At 14:11:03, an impact sounds were recorded on the CVFDR as well as a substantial change in amplitude of the vertical acceleration.</p> <p>The aircraft deviated from the runway to the left (see Figure 4, Figure 6 ③), and stopped when its nose heading changed approximately 180° counterclockwise (see Figure 4, Figure 6 ④) after entering the green area and was disabled to perform taxiing.</p> <p>The captain explained the situation to the tower control position at airport traffic control tower of Oita Airport and disembarked with two other people.</p> <p>The aircraft was slightly damaged, but no one was injured.</p> <p>This serious incident occurred at Oita Airport (33° 28' 38" N, 131° 44' 10" E) on January 28, 2024, at about 14:11.</p>

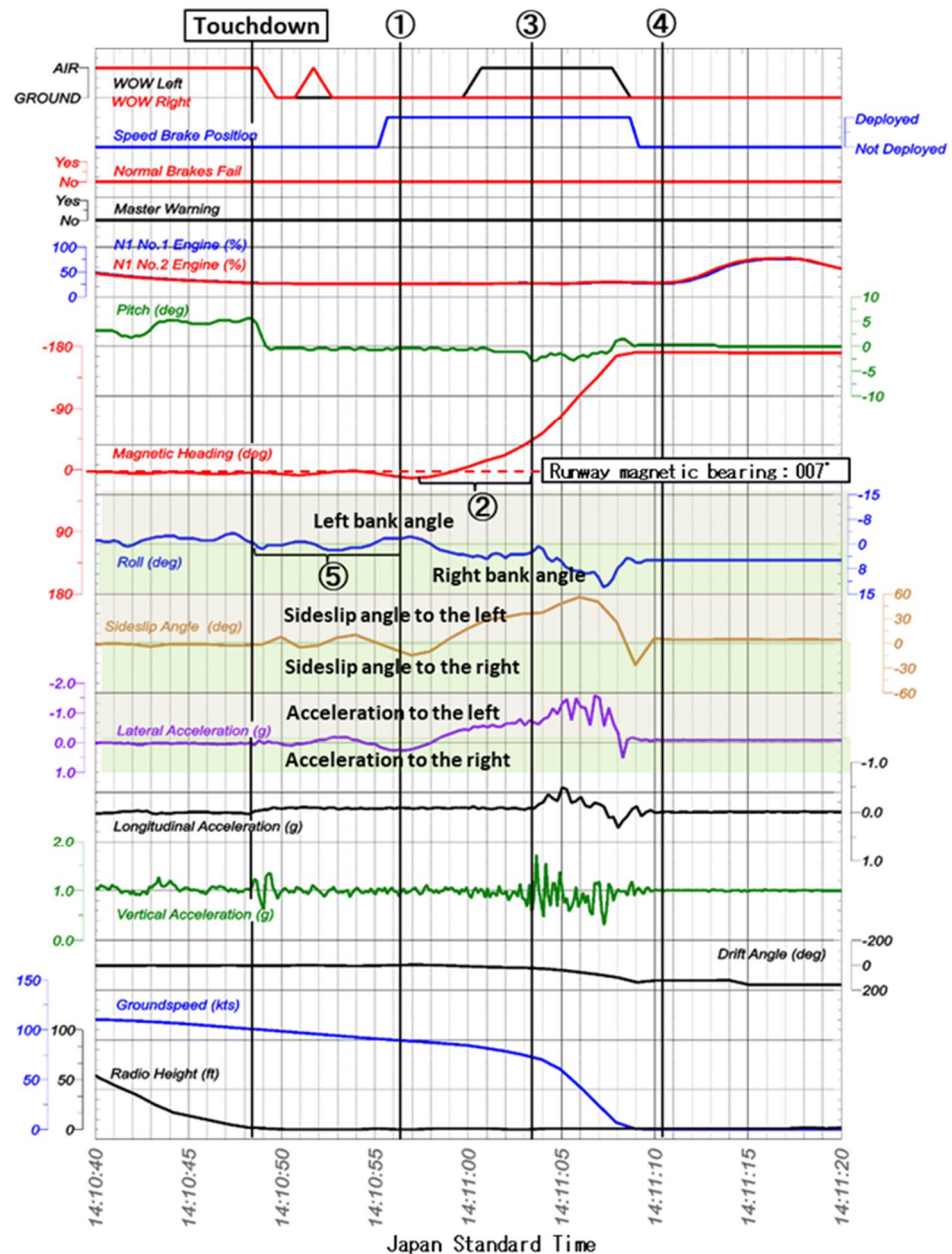
Figure 6 Records of CVFDR and CMF

to apply the right rudder pedal to correct the aircraft's heading. The CVFDR recorded that the aircraft heading, which had been 012.3° at 14:10:57, changed to 010.5° at 14:10:58. The captain had judged that the trainee's correction of the aircraft's travel direction was possible because the trainee was able to control the aircraft' travel direction even when the aircraft was running on the ground in a slightly meandering manner during the continuous touch-and-go training. Meanwhile, the CVFDR recorded the observer's voice saying, " You may not bring it back to the center, you don't need to bring it back, do not bring it back, do not bring it back." when the observer recognized the aircraft's travel direction changing to the left between 14:10:57 and 14:11:03 (see Figure 6 ②.).

The JTSCB concludes that the force on the right rudder pedal was likely applied at this time, as the change in the aircraft's heading to the right was recorded one second after the deployment of the aircraft's speedbrake, according to the CVFDR's records. The change in heading to the left recorded one second later was likely caused by a decrease in right rudder pedal pressure or an increase in left rudder pedal pressure. Besides, the designer and manufacturer stated that no yaw or banking during ground roll due to speed brake deployment had been reported during test flights of the Honda Aircraft HA-420, however, the aircraft tended to bank to the left when the speedbrakes were deployed in the air during airworthiness inspections, and it is likely that this tendency also contributed to the change in the aircraft's heading. The trainee tried to correct the aircraft's travel direction; however, it is highly probable that because the trainee hesitated to apply the right rudder pedal and did not take proper action to correct the aircraft's deviation to the left when recognized the observer's comments about the travel direction, the deviation of the aircraft to the left was greater, as it was making a ground roll in a left crosswind. Furthermore, it is likely that the down slope from the runway centerline marking to the west side runway edge marking on the runway contributed to this deviation to the left. Besides, the aircraft is more likely to have deviated to the left while skidding, as the tire marks of the nose landing gear were left to the left side of the tire marks of the left main gear. From the impact sound recorded on the CVFDR at 14:11:03, it is more likely that the aircraft deviated from the runway and entered a grassy area at that time, then moved while changing its heading counterclockwise, stopped while facing the heading of 188°, and disabled to taxi. In addition, no malfunction in the steering system was recorded in the steering computer, however, it was not possible to determine how the nosewheel steering was operating at the time of the serious incident because the CVFDR did not record the operating status of the nosewheel steering.
