# AIRCRAFT ACCIDENT INVESTIGATION REPORT

## AIRCRAFT DAMAGE DURING LANDING

FUJI-BELL 204 B-2 (ROTORCRAFT), JA9383

Adopted by the Japan Transport Safety Board

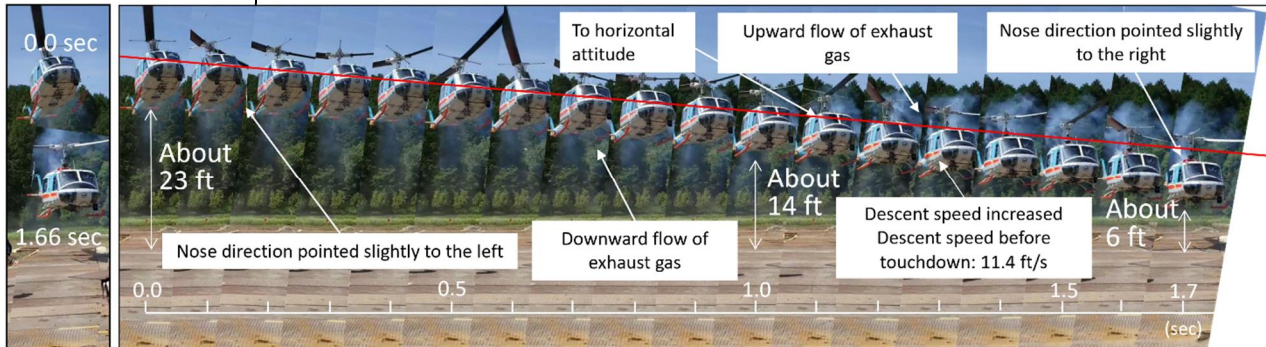
Figure 3 Images taken by Witness B just before the helicopter's landing  
(Comparison of sequential photographs)

Figure 3 shows a sequence of photographs clipped every 0.1 seconds from a 1.7 second video which was taken by Witness B, who was about 30 m north of the site where the helicopter touched down. The vertical height in the figure is the ground altitude during descent, estimated from the overall height of the helicopter.

The sequence of photographs in Figure 3 shows that the descent rate was roughly constant from the start of shooting until 0.9 seconds later, and then increased from 1.0 second later due to a decrease in engine power, but the helicopter was operated to maintain the attitude horizontal. In addition, the nose of the helicopter, which was turning to the left at the start of the video, was turned back to the right, there was no sideslip, and the helicopter was basically descending vertically. Therefore, it is probable that the cyclic<sup>\*5</sup> and rudder pedals were operated appropriately, allowing the helicopter to land vertically without rolling over. According to the pilot's statement, no collective was operated at the time of touchdown, so it is probable that the descent rate did not decrease just before touchdown. However, as the helicopter touched down without skidding, it is probable that it did not roll over and only the helicopter was damaged.

of 10.22 ft/s) as calculated by the design and manufacturer. In addition, the descent speed just before touchdown, calculated from the sequence of photographs in Figure 3, was 11.4 ft/s, which exceeded the vertical descent speed of 10.22 ft/s for the design load. Therefore, it is highly probable that a landing load exceeding the maximum design load was applied and the load was transferred from the forward cross tube to the bulkhead between the cockpit and the passenger cabin, resulting in a hard landing that caused destruction all the way down to the passenger cabin floor.

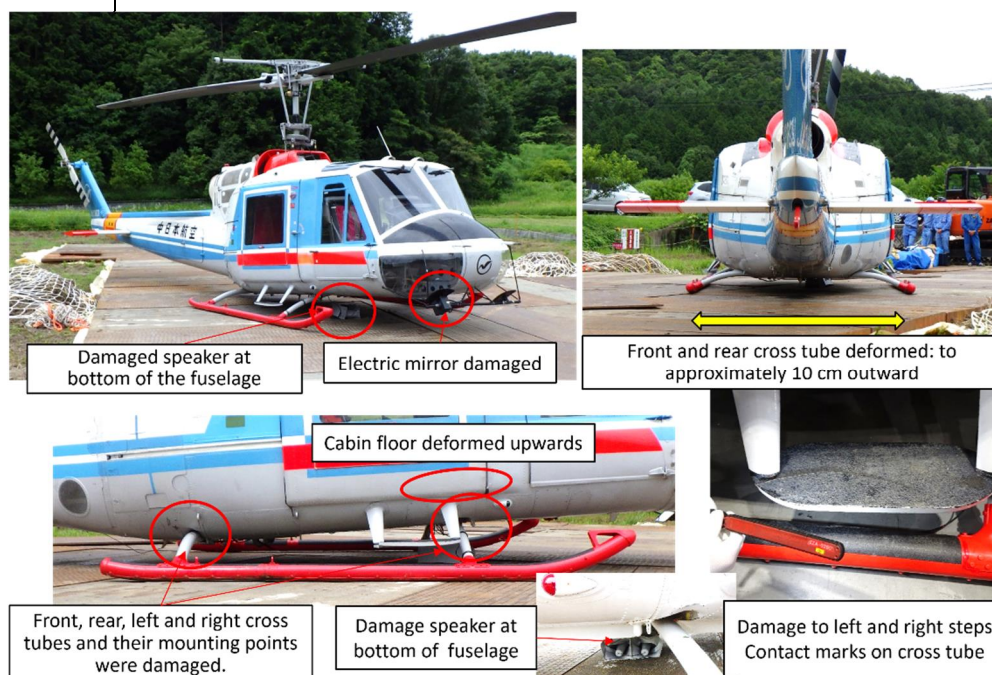
Figure 4: Damage to the helicopter and its touchdown conditions

- (1) Extent of Damage: Substantially damaged
  - a Primary structural components of the lower fuselage were buckled (cross tube attachments and others).
  - b The cross tubes of the landing gear (skid) had extended outward by approximately 10 cm.
  - c The left and right steps attached to the landing gear were damaged and there were contact marks on the cross tube.
  - d The speaker mounted in the centre of the forward cross tube had fallen and been damaged.
  - e Upon receiving the impact of the ground, the ELT (Emergency Locator Transmitter) was activated (threshold 6-8G).

\* Ground clearance when the helicopter is in a normal condition: Speaker 220mm, Front mirror 200mm (full fuel load)

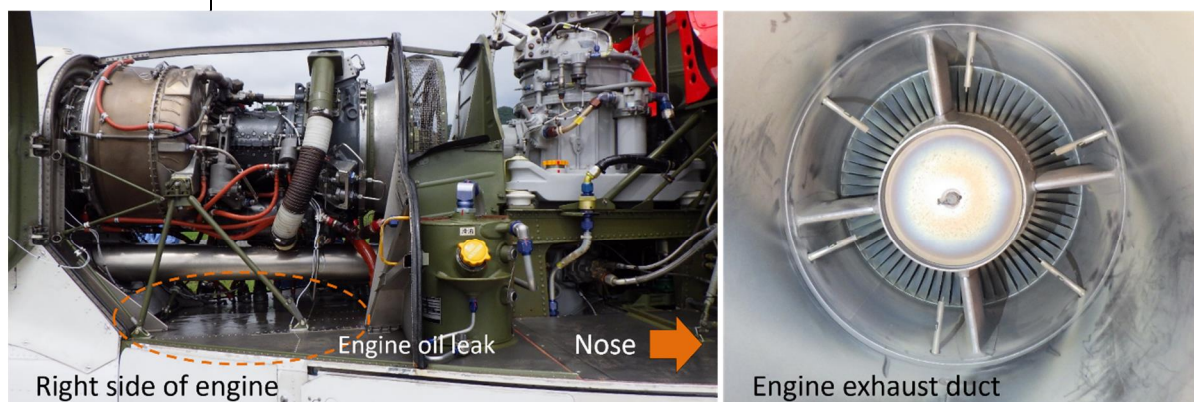
Figure 5: External engine damage

- (2) Damage to the Exterior of the Engine (see Figure 5, for damage inside the engine, see the attached Appended Figure)
- a There was no deformation or damage to the exterior of the engine.
  - b The exhaust duct was discolored, but there were no signs of impact.
  - c A large amount of engine oil was leaking into the bottom of the compressor.

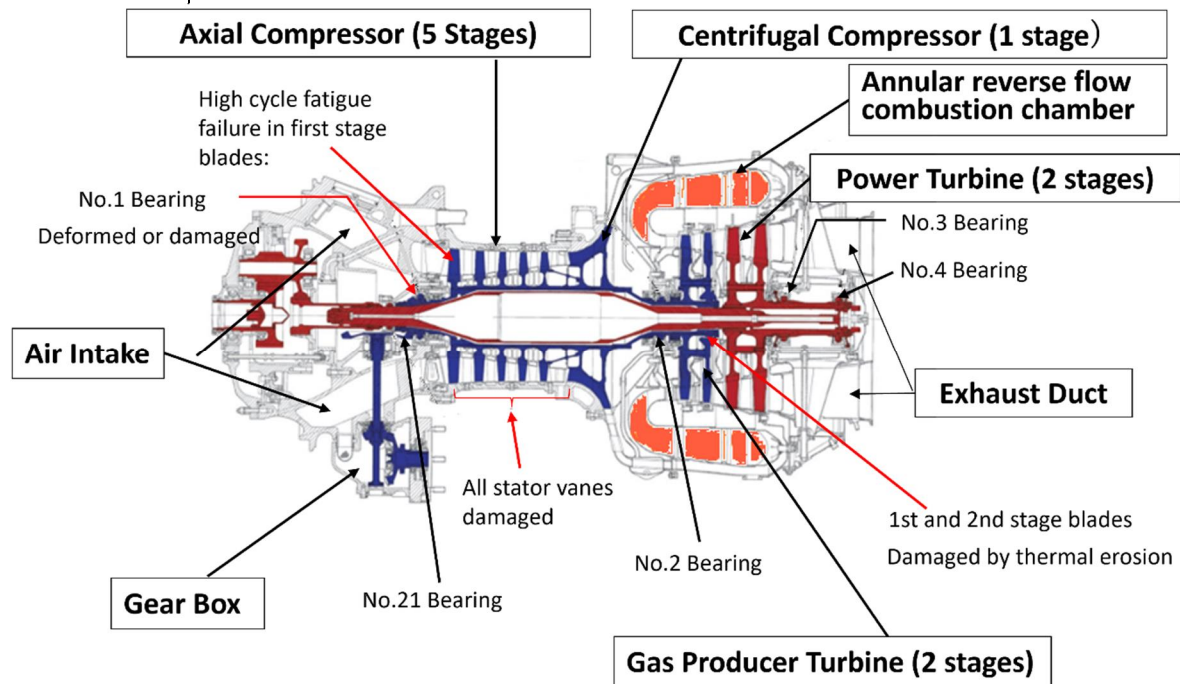
Figure 6: Engine structure and damaged areas

| <b>2.7 Teardown Investigation of the Engine and Maintenance Information</b> | <p>(1) Overview of Engine Damage</p> <p>In order to make a detailed examination for causes of the engine's power loss the disassembly investigation of the engine was performed. Under the witness of an accredited representative of the United States of America, the investigations were performed in the facility of the design and manufacturer company. The summary of the result was as follow:</p> |

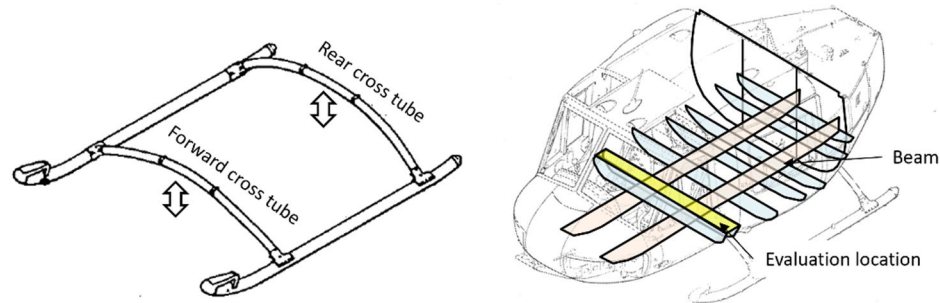
Figure 7: Deformation of cross tube and evaluation location of structural members

In this accident, the cross tubes had undergone plastic deformation, and the passenger compartment floor above the forward cross tube had deformed upwards, so a calculation of the estimated destruction load was made by the design and manufacturer company (Evaluation location: Figure 7, right).

a. Total estimated loads acting on the evaluation location: 7,754 lb.

b. Maximum design load on forward cross tube: 6,416 lb.

The reason for the damage to the helicopter upon landing is that, as the load on the cross tubes of the landing gear system were transmitted to the helicopter 's structural members (main beams), it is probable that a destructive load of 7,754 lb or more was applied to the landing gear forward cross tube, exceeding the maximum design load of 6,416 lb (assumed vertical descent speed

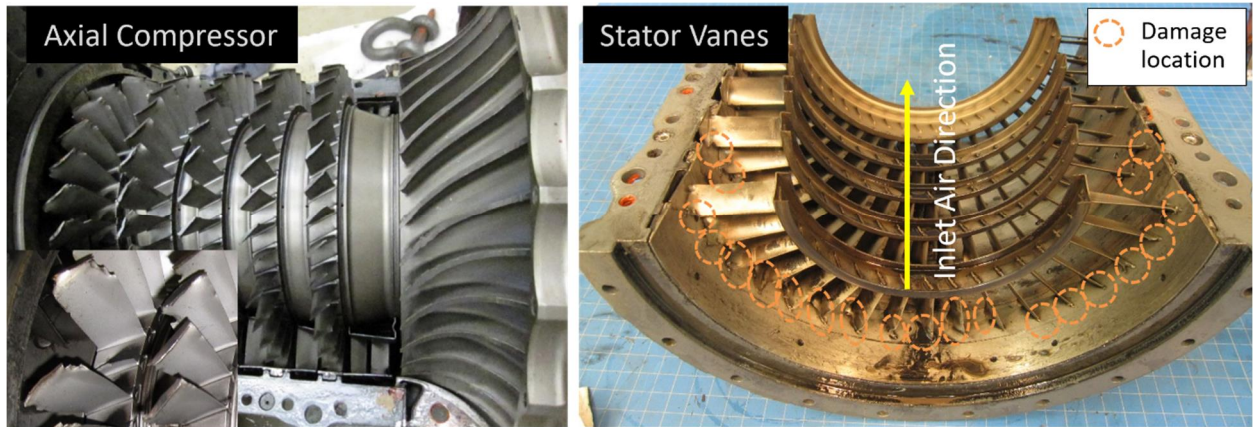
Figure A: Damage to axial compressor

a. Axial compressor (Appended Figure A)

(b) Blades downstream from the second stage blades: There were deformation and contact marks.

(c) Stator vanes: There were deformation and contact marks.

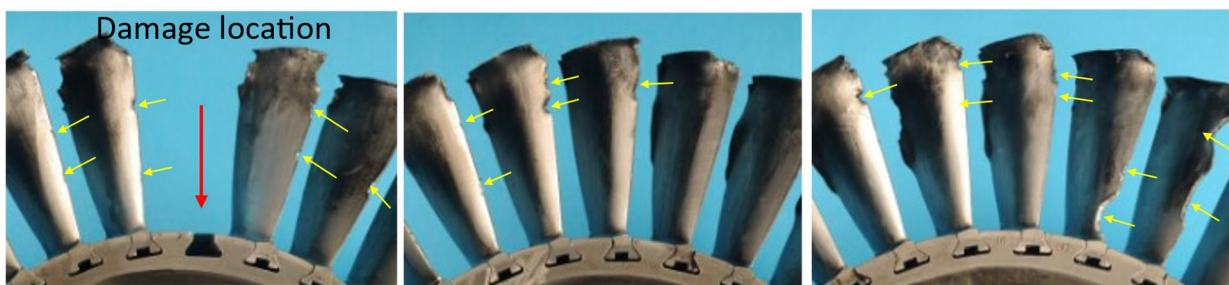
Figure B: Damage to the first stage blades of an axial compressor

a) One blade was fractured near the blade platform while all the remaining blades exhibited a combination impact damage, missing material, bent airfoils in the direction opposite of rotation, and blade tip rub and roll-over. No cracks were found in any other compressor blade. (Appended Figures B)

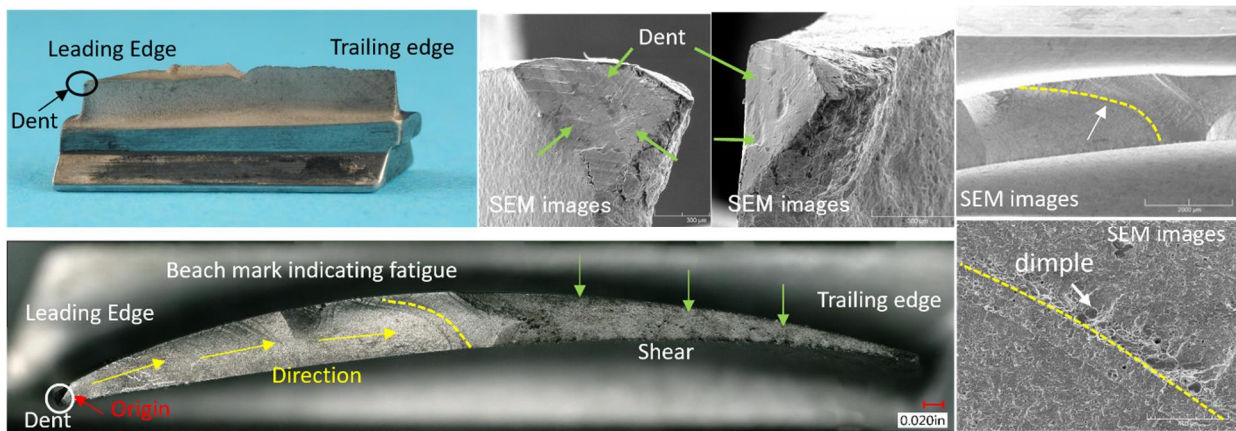
Figure C: Cross section of damaged area of first stage blades of axial compressor

b) Fracture surface of the broken blade (Appended Figure C)

- The fracture surface of the broken blade had a flat appearance, from the leading edge to the mid-chord of the blade, beach marks indicating high cycle fatigue failure were observed. (Yellow arrows and dotted lines).
- From mid-chord to the trailing edge, there were ductile dimples indicating eventual overload delamination, and shear failure (green arrows) was observed.
- The fracture characteristics of the blade fracture surface, there were dents observed at the front blade leading edge, were indicative of high cycle fatigue originating from subsurface damage at the leading edge (red arrow).

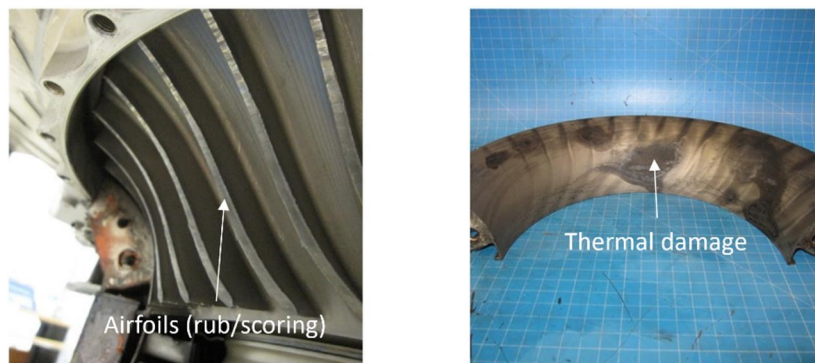
Figure D: Scratch marks on a centrifugal compressor

b. Centrifugal compressor (Appended Figure D)

(a) All the impeller blades were intact.

(b) There were exhibited rub/scoring along the tops of the impeller

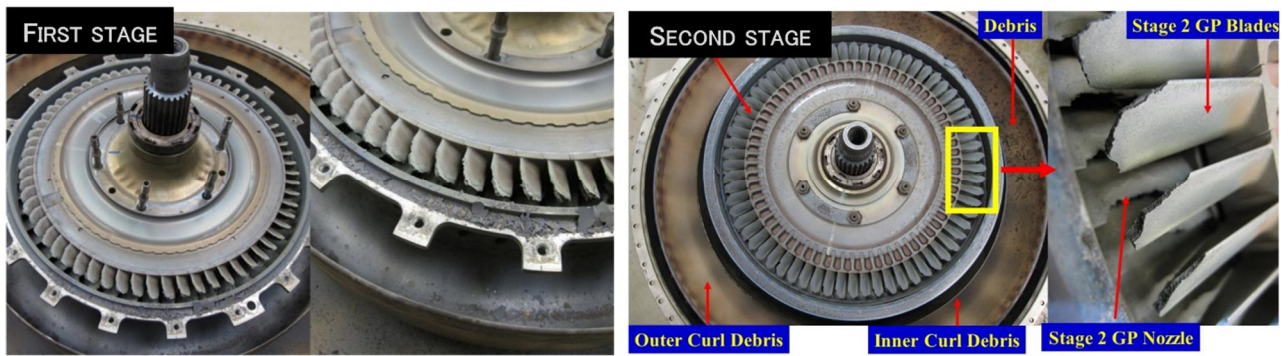
Figure E: Damage to Gas Producer Turbine

| | <p>airfoils.</p> <p>(c) The impeller shroud had areas of scratches, material transfer and thermal damage consistent with contact with the impeller.</p> <p>c. Gas producer turbine (Appended Figure E)</p> <p>(a) The first and second stage blades all exhibited the same characteristics, including thermal distress with material tip loss and erosion.</p> <p>(b) The first and second stage nozzle guide vanes exhibited material loss and heat damage, as did the blades.</p> <p>d. Power turbine (Appended Figure F)</p> <p>(a) The first stage nozzle guide vane airfoil was present and covered with material deposits. The leading edge showed heat damage and the trailing edge had impact damage and some missing material.</p> <p>(b) The annular plates, including the inner and outer combustion liners and the conical swirl plate, were intact and showed no signs of seizure or thermal damage.</p> <p>e. No. 1 bearing (Appended Figure G)</p> <p>(a) All ball bearings were within their cages. Several of the roller ball elements were no longer round and exhibited a combination of thermal distress, material loss, flat spots, or smeared material consistent with skidding *4damage.</p> <p>(b) There was no damage to the bearing cage.</p> <p>(c) There was no damage to the front side of the inner race.</p> <p>(d) The rear side of the inner race exhibited smearing, material transfer, raised metal around the edges, and bluing consistent with thermal distress.</p> <p>f. No.2 bearing (Attached Figure H)</p> <p>(a) All roller bearings were oil wetted, appeared undamaged, and the bearing rotated freely by hand.</p> <p>(b) All of the roller bearings were covered in debris and had a dark black appearance.</p> <p>g. No.21 bearing (Attached Figure I)</p> <p>The roller bearing was shiny, oil wetted and spun freely in the bearing support housing.</p> <p>h. Engine lubrication system (Appended Figure J)</p> <p>(a) The magnetic chip detector detected metal particles on the tip of the plug that were ferrous, but did not detect any materials than those engine related.</p> <p>(b) The red button on the oil filter bypass indicator did not pop out and did not indicate a higher than normal pressure differential.</p> <p>(c) Metal particles were found on the mesh screen of the oil filter.</p> <p>(2) Engine Maintenance Status</p> <p>a. Operating time of each engine part</p> <p>The overhaul interval for the same type of engine involved in the</p> |

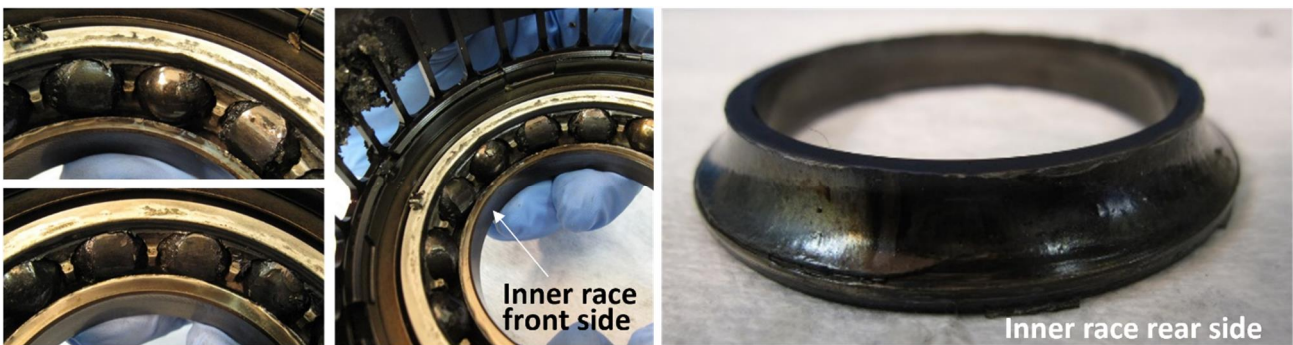
Figure G: Damage to No.1 Bearing

The engine failure in this accident is considered to have been one of the two cases above, with the majority similar failures to Case 1. Bearings are generally designed to be very robust and can withstand higher than normal loads for a short period of time before starting to fail. It is also known that bearing failures occur when foreign matter such as metal particles or contamination is present causing the rolling elements to skid instead of rotating. Skidding of the rolling bearing elements create high temperatures that damage the bearing. In this accident, because of the short time between the onset of the surge and the drop in engine power, it was unlikely that the No. 1 bearing would have been damaged in a manner similar to Case 2, failure of the No. 1 bearing following a compressor blade failure and release. It is more likely that, as in Case 1, a failure of the No. 1 bearing first, leading to a compressor blade release and subsequent surges resulting in a loss of engine power, but it was not possible to determine which was the cause. The metal fragment detected 125 flight hours earlier had been disposed of, so its relevance to this incident could not be confirmed.
