# AIRCRAFT SERIOUS INCIDENT INVESTIGATION REPORT

## CASE WHERE A SLUNG LOAD CARRIED EXTERNAL TO THE AIRCRAFT WAS RELEASED UNINTENTIONALLY AERO ASAHI CORPORATION BELL 412 (ROTORCRAFT), JA9584 ABOUT 1,150 FT OVER KIRYU CITY, GUNMA PREFECTURE AT ABOUT 11:00 JST, DECEMBER 22, 2021

August 8, 2025

Adopted by the Japan Transport Safety Board

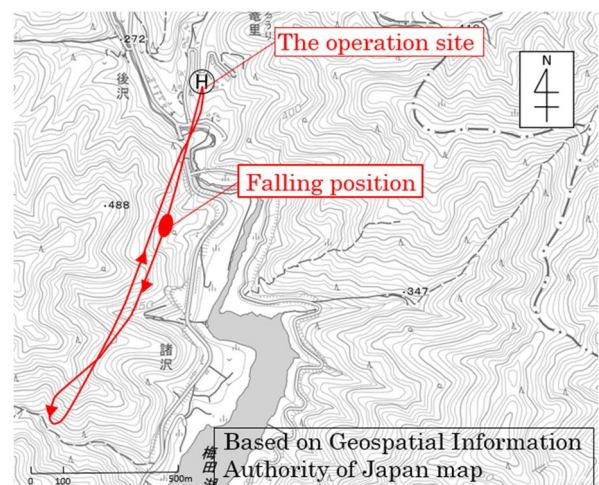
Figure 1: Estimated Flight Route

The serious incident occurred in the mountains about 540 m of south-southwest of the operation site (36° 29' 13" N, 139° 24' 40" E) at about 11:00: on December 22, 2021.

The fallen ready-mixed concrete weighed about 800 kg, but the fall did not

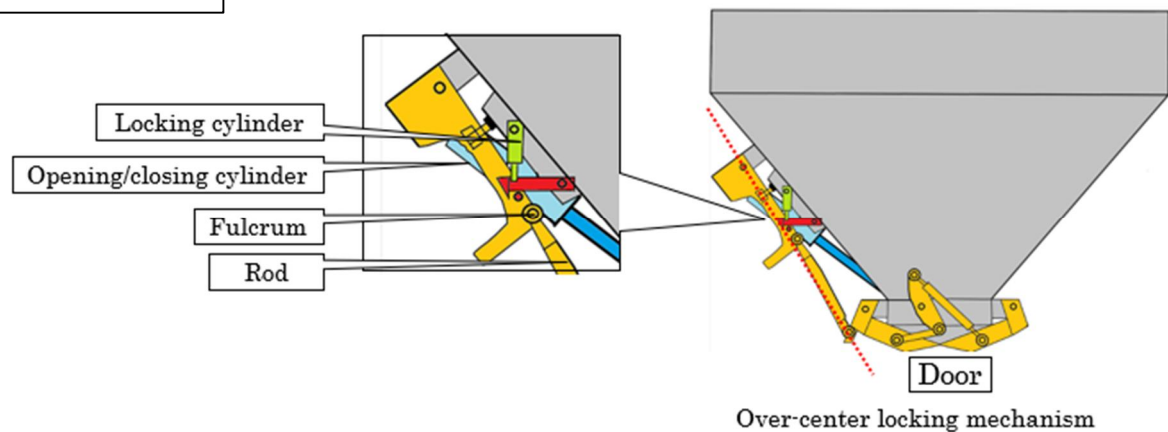
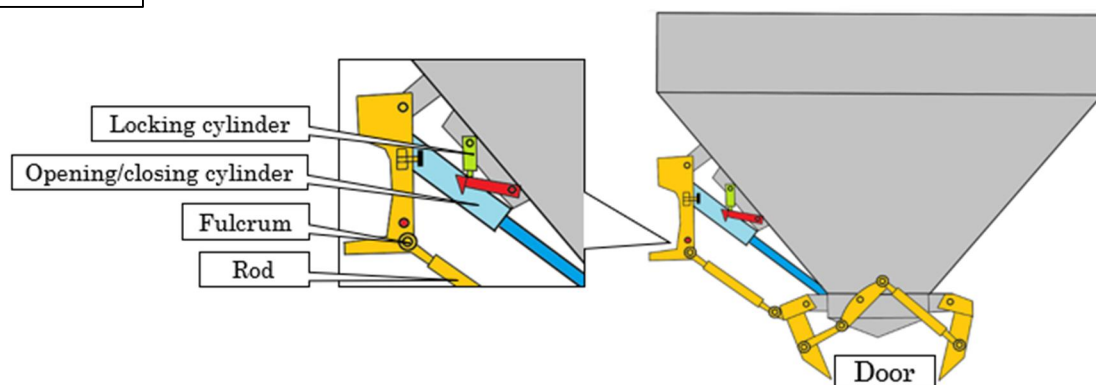
Figure 3: Summary Diagram of Opening/Closing of the Door

As shown in Figure 3, the door can open and close as the carbon dioxide pressure activates a rod connected to the opening/closing cylinder. In the door closing condition, the fulcrum is inserted inwards (bucket side) to be the over-centered condition, which acts as a locking mechanism, and the door is locked as the locking cylinder extends downward by the carbon dioxide pressure and would not be opened by the load of the ready-mixed concrete in the bucket. The door opens when the locking cylinder is contracted to disengage the lock, the opening/closing cylinder extends towards the OPEN side of the door, the fulcrum is moved outwards and the over-center locking mechanism is also disengages, thus the door opens via a rod connected to the door.

| | <p>(4) Condition of the Bucket after the Serious Incident</p> <p>After the major incident, the opening/closing cylinder was operating in the CLOSE position, but the door was approximately 3 cm open.</p> <p>No abnormalities were found during the visual inspection of the bucket components, the switch-to-bucket continuity check, the door operation check, the carbon dioxide gas leakage check and others carried out after the serious incident.</p> <p>(5) Validation of the Bucket</p> <p>After the serious incident, the validation of the bucket was carried out as follows:</p> <p>a. Validation of vibration and impact</p> <p>Instead of ready-mix concrete, about 870 kg of stone gravel was placed in the bucket, and the locking cylinder was set to the UNLOCK status, however, but the door did not open, even though vibrations and impacts were applied to the bucket while it was locked by the over-center locking mechanism.</p> <p>When it was switched to the OPEN side for one second, the door opened slightly and continued to open under the weight of the stone gravel, and the stone gravel flowed out vigorously, but with less stone gravel, the door was closed.</p> <p>b. Validation of exhaust path</p> <p>A validation was carried out assuming a malfunction with a clogged exhaust port. When the exhaust port was clogged in an environment with temperatures above 10 °C, the door did not open. However, as the outside air temperature at the time of the serious incident was 8 °C, when the exhaust port of the bucket placed in a low temperature environment (below 5°C) was clogged, the locking cylinder and the opening/closing cylinder were activated and the door opened. When the exhaust port was opened the door was closed.</p> <p>(6) Disassembly Investigation of Bucket Components</p> <p>Disassembly investigation of each cylinder and valve associated with the door operation revealed that the grease normally applied in the solenoid valve had solidified and adhered to them, and other minute foreign objects were also adhering to the spool.</p> <p>The composition of the minute foreign objects could not be identified (see Table 1).</p> |

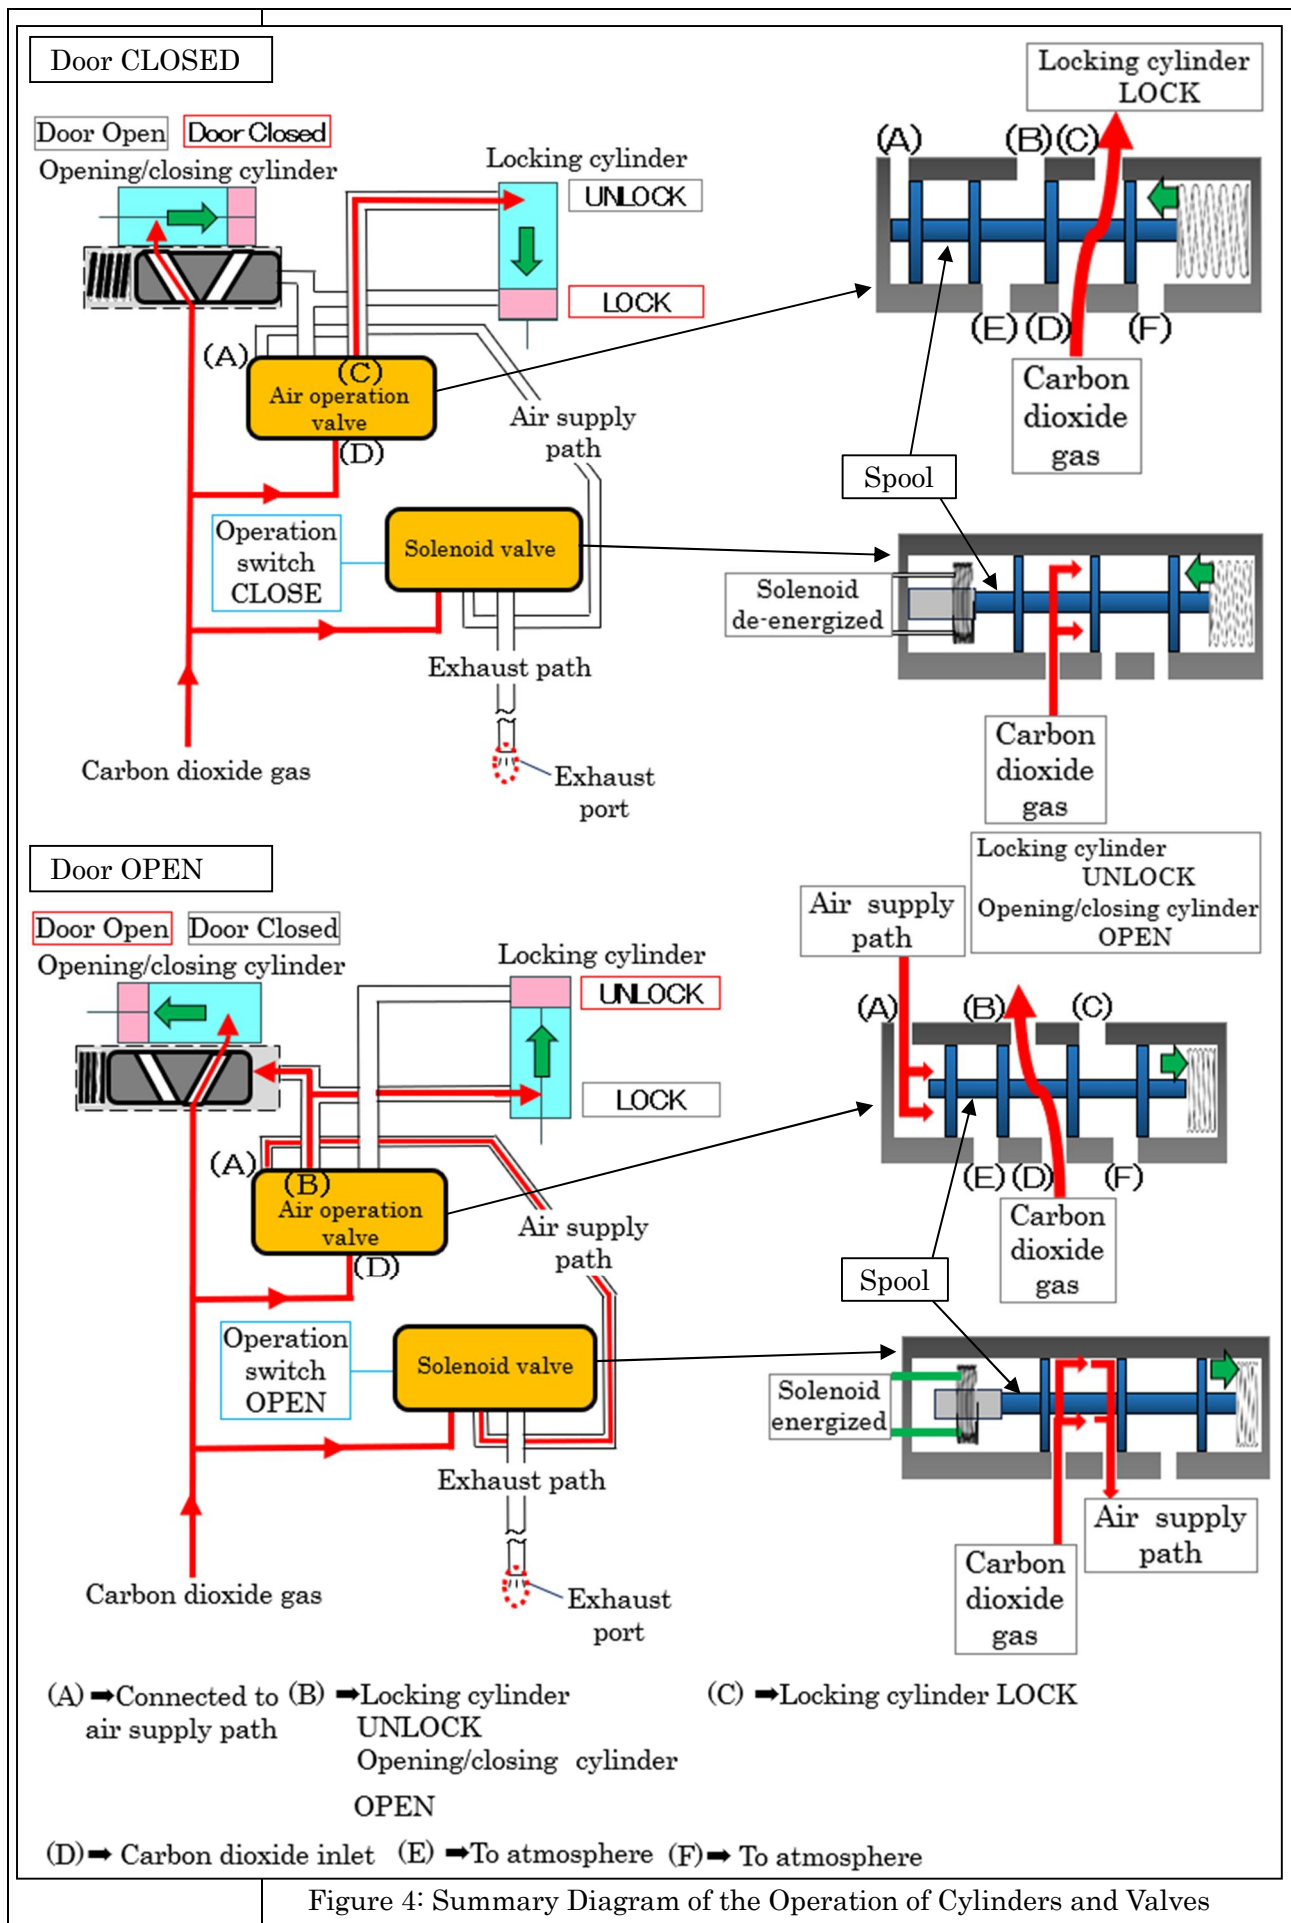
Figure 4: Summary Diagram of the Operation of Cylinders and Valves

- The opening/closing cylinder and the locking cylinder are designed to contract by switching the flow path of carbon dioxide gas for cylinder operation supplied to each cylinder, and to switch the OPEN/UNLOCK position and the CLOSE/LOCK position.
- In the default position, the opening/closing cylinder is held in the CLOSE

| | <p>position when the gas for cylinder operation flows from the carbon dioxide bomb to the CLOSE side, but when the control gas is supplied from the air operation valve, the flow path of the gas for cylinder operation is switched to the OPEN side and the cylinder extends to the OPEN position.</p> <p>c. The locking cylinder is supplied with gas for cylinder operation via the air operation valve from the gas bomb. When gas is supplied to the “LOCK” side, the cylinder extends to the “LOCK” position and when gas is supplied to the “UNLOCK” side, the cylinder contracts to the “UNLOCK” position.</p> <p>d. In the air operation valve, the spool in the valve is held in the CLOSE position by spring force by default. When the spool is in the CLOSE position, the gas for control flow path to the opening/closing cylinder is closed and the gas for cylinder operation is supplied to the LOCK side of the locking cylinder. Accordingly, the open/close cylinder is hold in the CLOSE position and the lock cylinder in the LOCK position, respectively. When the spool in the air operation valve is supplied with control gas from the solenoid valve, it moves from a default CLOSE position to the OPEN position. When the spool is set to the OPEN position, the opening/closing cylinder is supplied with control gas and the gas for opening/closing cylinder operation flows to the OPEN side, at the same time the locking cylinder is supplied with the gas for cylinder operation to the UNLOCK side.</p> <p>Accordingly, the opening/closing cylinder is set to the OPEN position, and the locking cylinder is set to the UNLOCK position, resulting in the opening the door.</p> <p>e. It is designed so that the solenoid valve is supplied with carbon dioxide gas from the gas bomb and when the operation switch on the onboard mechanic's seat is moved to the OPEN position, the solenoid is energized to push the spool in the valve, thereby supplying the control gas to the air supply path to the air operation valve.</p> <p>f. The solenoid valve is equipped with the exhaust path to discharge the exhaust air generated during spool operation into the atmosphere. On the other hand, the air operation valve is equipped with the exhaust outlet to discharge the exhaust from the locking cylinder to the atmosphere, but not the outlet to discharge the control gas supplied from the solenoid valve, therefore it is designed to discharge the control gas via the air supply path in between the solenoid valve from the exhaust path of the above solenoid valve.</p> |

| The door is designed be locked by the locking mechanism unless the switch is not operated, therefore, it is possible that when the spool of the air operation valve was temporarily switched, just as when the switch was operated, the locking cylinder and the opening/closing cylinder were operated, causing the door to open. | |

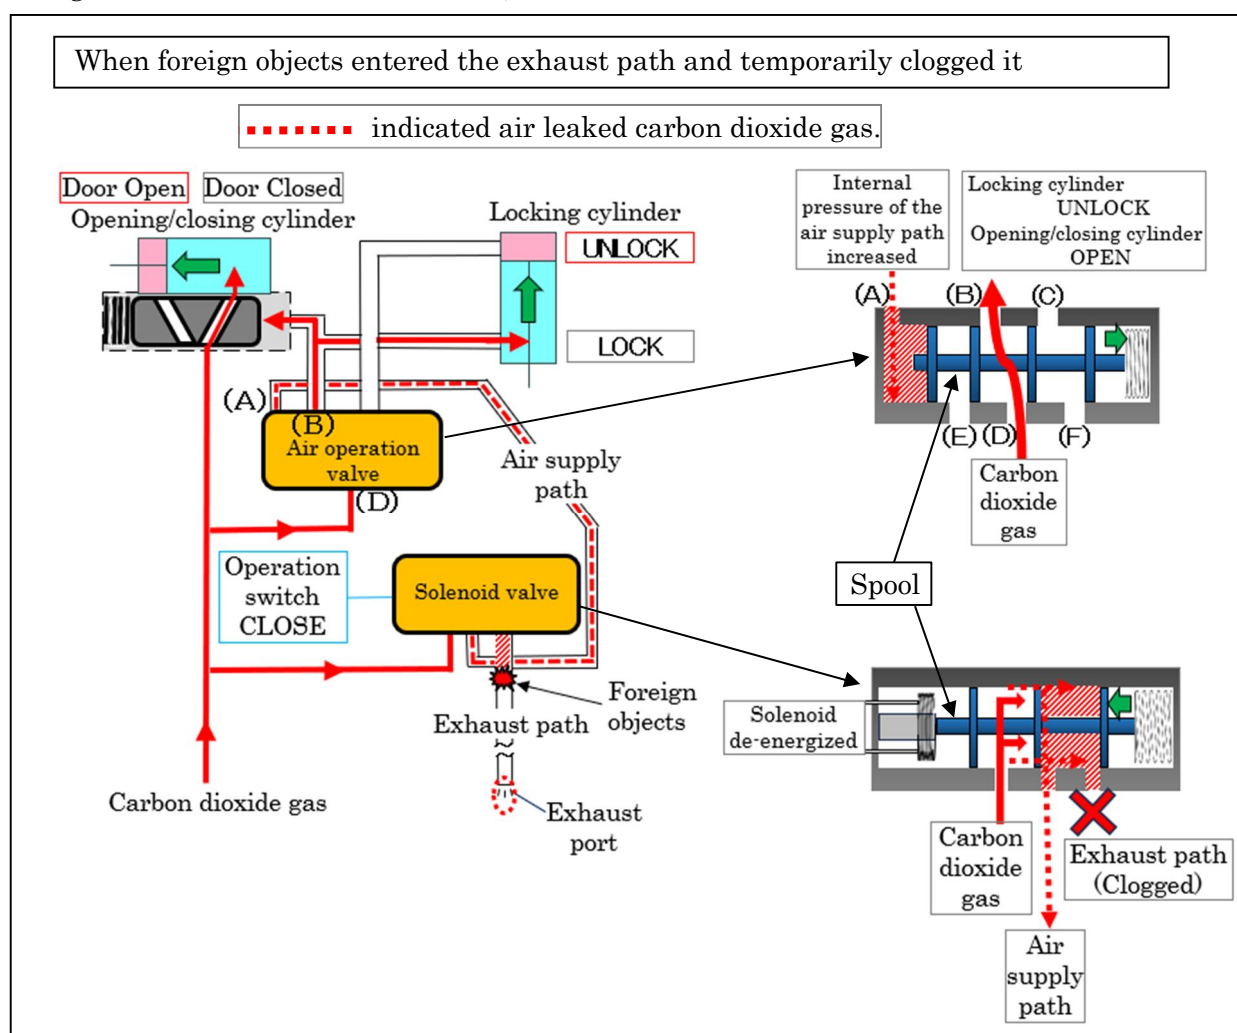
Figure 5: Situation when the Exhaust Path is Clogged (Summary Diagram)

| As shown in Figure 5, it is possible that when in the exhaust path closing condition, if carbon dioxide gas to be supplied to the solenoid valve leaks to the side connecting to the exhaust path in the valve, the internal pressure of the exhaust path will increase and through the path connecting | |

the solenoid valve and the air operation valve, the carbon dioxide gas will be supplied to the air operation valve. It is therefore likely that this has caused to the spool of the air operation valve to be switched to the door OPEN side and the opening/closing cylinder and the locking cylinder to be operated, causing the door to open.

As shown in Table 1, the results of the disassembly investigation of the solenoid, it is possible that foreign objects, such as solidified grease and others had adhered and mixed into the exhaust path, causing the exhaust path to temporarily clog and the carbon dioxide gas to leak into the valve.

Given the above, as a contributing factor to the air operation valve having moved to the door OPEN side, it is possible that the exhaust path has been clogged by the ingress of foreign matter, causing an air leak in the solenoid valve, however the details of the situation could not be clarified.

valve to operate. Therefore, it is important to carry out maintenance and management, such as cleaning the inside of the pipes and checking the valves periodically, as foreign objects are mixed into the pipes or valves of the bucket used to transport ready-mixed concrete, which could possibly affect the operation of the valves.

In addition, it is probably desirable for the operation of the door and safety devices such as the locking mechanism to be controlled by different systems, respectively.
