AIRCRAFT ACCIDENT INVESTIGATION REPORT
SERIOUS INJURY TO A GROUND OPERATOR DURING CARGO
SLING WORK,
AERO ASAHI CORPORATION
AEROSPATIALE AS332L1 (ROTORCRAFT), JA9678
NANTAN CITY, KYOTO PREFECTURE, JAPAN
AT ABOUT 13:30 JST, JUNE 15, 2023

May 10, 2024

Adopted by the Japan Transport Safety Board

Company	Aero Asahi Corporation
Type, Registration Mark	Aerospatiale AS332L1 (Rotorcraft), JA9678
Accident Class	Serious Injury to a ground operator during cargo sling work
Date and Time of the Occurrence	At about 13:30 Japan Standard Time (JST: UTC+9 hours), June 15, 2023
Site of the Accident	Nantan City, Kyoto Prefecture (35° 14' 39" N, 135° 31' 04" E)

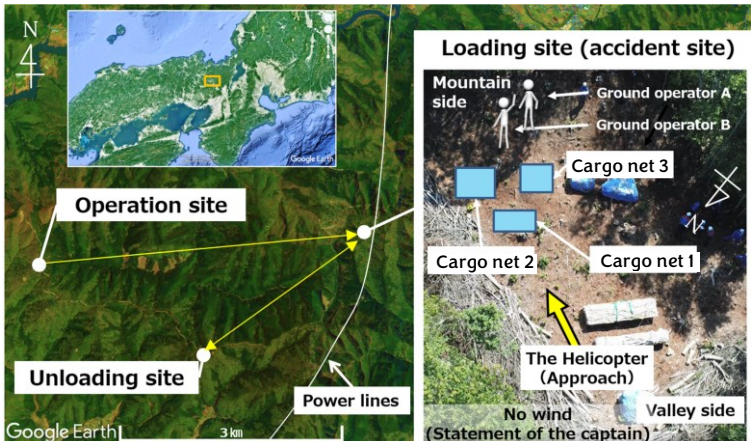
<p>Figure 1: Flight Summary of the Helicopter</p>

Event Occurred and Relevant Information	
(1) History of the Flight	
For external cargo sling operation of materials for the power line replacement work, the helicopter took off from an Operation Site in Hatago District, Hiyoshi Town, Nantan City, Kyoto Prefecture, and it was scheduled to sling up Cargo nets from a loading site near a transmission tower and unload it at a cargo unloading site in Hijitani District, Miyama Town, Nantan City. (See Figure 1)	
With the captain in the right cockpit seat and the onboard mechanic in the guide's seat in the left aft cabin on board, the helicopter took off from the Operation Site at about 13:15 to start its afternoon work, equipped with the sling wire ropes approximately 20m in length and hooks.	
At about 13:24, the captain visually confirmed the position of each Cargo net on the slope in order to lift the three Cargo nets (Figure 1, Cargo net 1 to 3) all together, made the helicopter enter above the loading site at about 40m AGL, descend to about 21m AGL and hover. After that, the onboard mechanic confirmed the position of Cargo nets with the two ground operators in the mountain side, and guided the helicopter so that

the hooks would be positioned between Cargo net 2 and Cargo net 3.

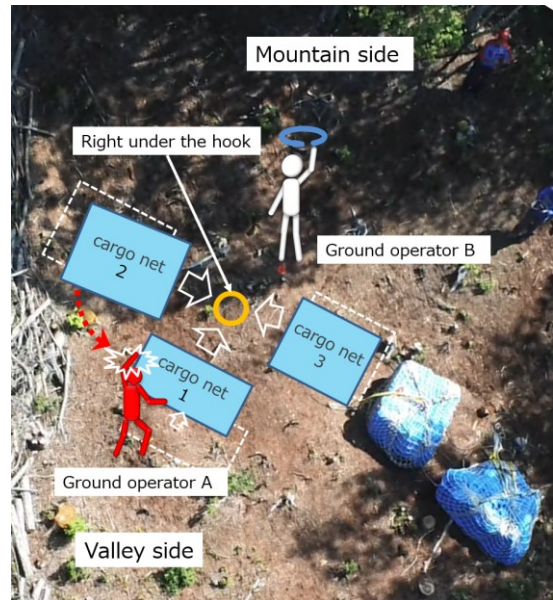
Figure 2: During Cargo Sling Working

Ground operator A moved to the position where Ground operator A would be able to reach the hooks that had descended and moved to the valley side after hooking the sling wire ropes connected to each of the three Cargo nets onto the cargo hook. After that, Ground operator B in charge of sending a signal to the onboard mechanic made a hand signal, "Climb" to the onboard mechanic.

Guided by the onboard mechanic, the captain started the climb procedure for the helicopter as if to bring Cargo net 1 in the valley side to the two Cargo nets put in the mountain side. As the helicopter climbed, the sling wire ropes connected to Cargo net 1 were taut, which caused Cargo net 1 to start coming close to right under the hook as if to drag on the slope.

As confirming that the rootstock was caught in the stitch of Cargo net 1 which had started to move, in order to remove it, Ground operator A performed the support work from the valley side, pushing up the left side (Cargo net 2 side) of Cargo net 1 to the mountain side.

The JTSB concludes that it is certain that Ground operator A, who had been performing the support work, was injured because when the helicopter was lifting the three Cargo nets, Cargo nets 2 was swinging around and came to contact with Ground operator A’ left arm.

As the helicopter climbed, Cargo net 2 was dragged to the mountain side and was most likely swinging around the point where it had touched the ground as a fulcrum to the valley side.

The swinging Cargo net came to contact with Ground operator A was most likely because without moving away to a safety position, Ground operator A was performing the support work in the area where the Cargo net could swing around despite the helicopter that had started to lift the Cargo nets. At this time, Ground operator B in charge of sending signals to the onboard mechanic did not notice that Ground operator A approached the Cargo net.

The company is required to secure the ground work safety in cooperation with the ground work contract company by ensuring thoroughly that when the support work is unavoidable, the ground operator shall fully inform the onboard mechanic of the intention to perform the support work from the ground operation side in advance and the helicopter shall stop climbing.

As described in “ANALYSIS”, it is necessary for the external cargo sling operators to ensure thoroughly that the ground operators shall never approach cargoes without sending a sign to the onboard mechanic, and that when finding the ground operator has not moved to a safe position during the monitoring of ground work, the onboard mechanic shall secure the safety for the ground work in cooperation with the captain.

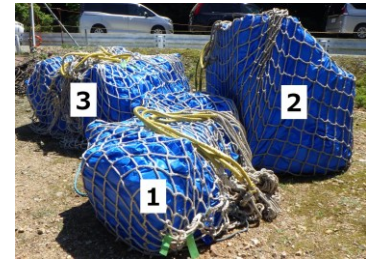
Figure 3: Cargo nets
(Taken at the unloading site)

All three Cargo nets have tools wrapped in blue sheeting, and their sizes (length, width, height) and weights were approximately as follows:

Cargo net 1: 180 cm, 90 cm, 70 cm, 500 kg

Cargo net 2: 170 cm, 130 cm, 110 cm, 1,000 kg

Cargo net 3: 140 cm, 120 cm, 90 cm, 600 kg
