**AIRCRAFT ACCIDENT
INVESTIGATION REPORT**

GIFU AIR RESCUE TEAM

J A 9 6 G F

**GIFU AIR RESCUE TEAM
BELL 412EP (ROTORCRAFT), JA96GF
TAKAYAMA CITY, GIFU PREFECTURE, JAPAN (NEAR MT.
OKUHOTAKA-DAKE OF NORTHERN ALPS)
AT ABOUT 15:22 JST, SEPTEMBER 11, 2009**

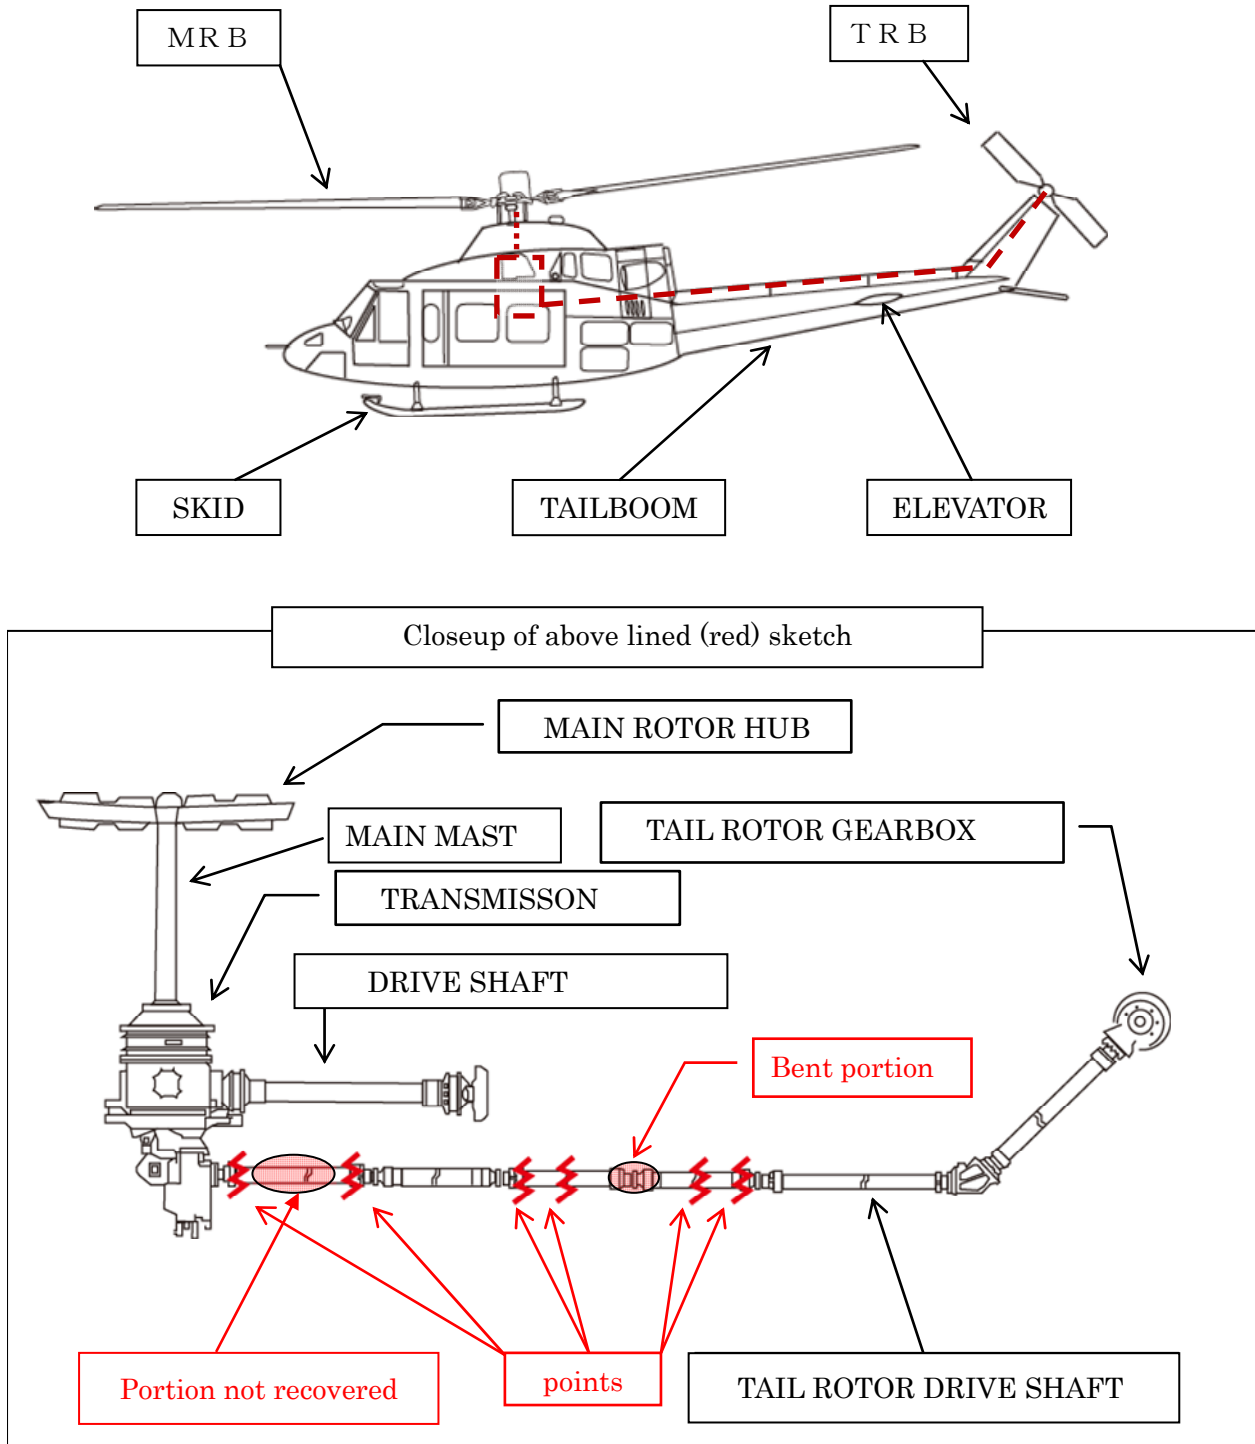
Figure 3 BELL 412EP Sketch and Damaged Part

The fuselage and the cockpit Broken and seriously burned beyond recognition.

All of the four blades were fractured.

The engines Broken and burned.

The tail boom had been broken and detached in a rivet-connected area about 3.7 m from the tail skid in the direction to the nose. In an area about 0.5 m backward from the opened part of the detached tail boom, outer skin had been broken from the upper part on the left side to the upper part on the right side.

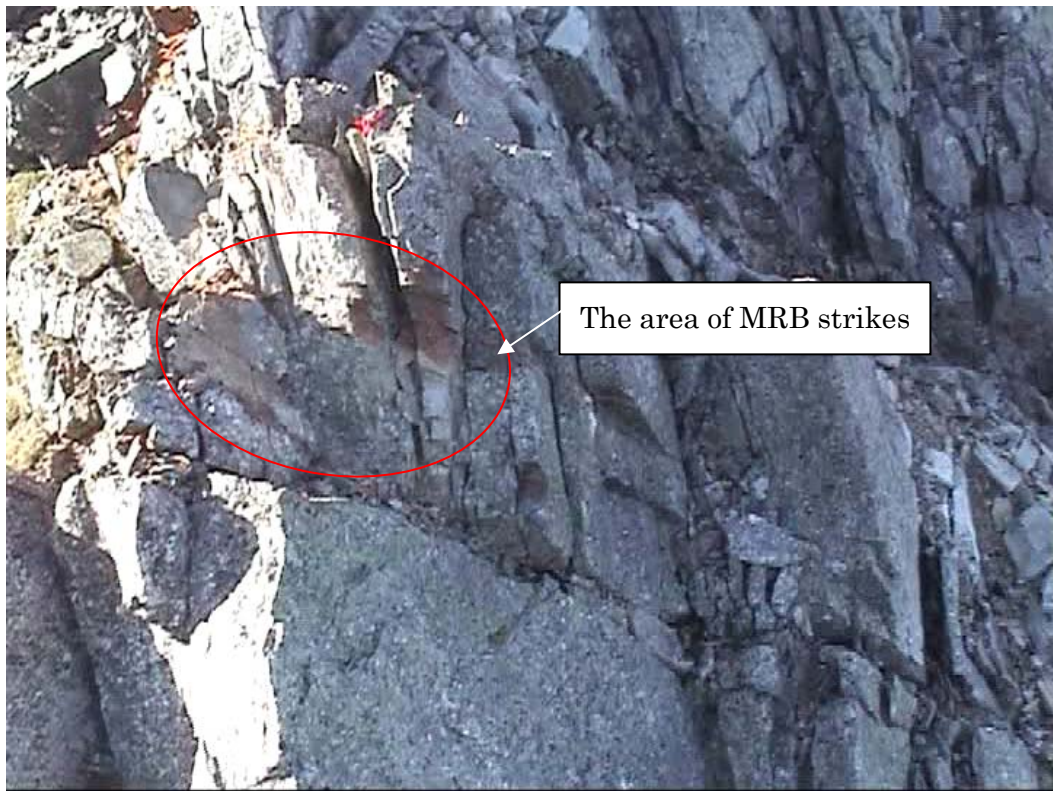
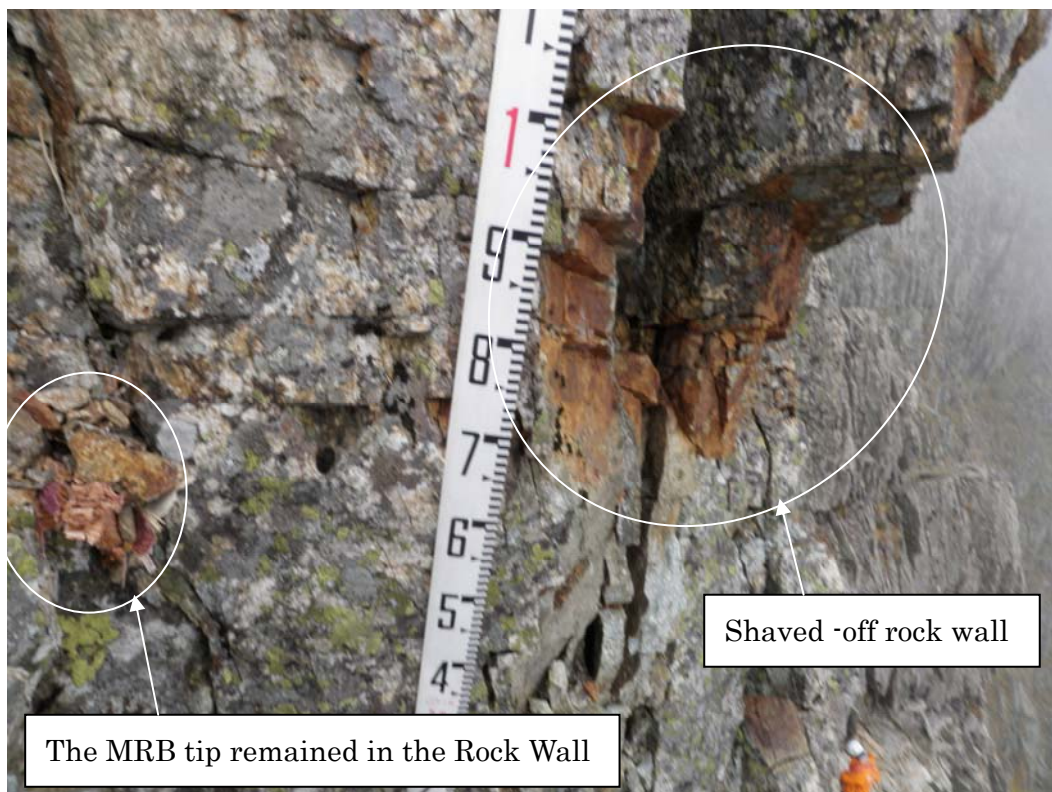
Photo 3-1 Traces Left with the Blow of MRBs

The hit marks left by the MRBs were found at the tip of a rock north-northwest of the

top of the East-West Rock Wall. The hit marks indicated the MRBs had hit the rock wall horizontally. There were no such hit marks on surrounding rock walls. Metal pieces of the tip of the MRBs were found stuck on the rock, while broken pieces of the blades had been widely scattered in the vicinity. The hit marks left by the blow of the MRBs were found at a place with an elevation of about 3,148 m, with a difference of about 40 m from the height of the place where the Rescue-Requiring Person was. The point right above the place where the person was and the place where the hit marks were found had a horizontal distance of about 21 m. The TRBs and the furthest part of the tail boom, which was about 4 m long, were found hanging on a rock on the North-to-South Rock Wall at a point about 11 m horizontally to the northeast from the place where the hit marks were found, with an elevation of about 3,128 m. The remaining parts and the airframe had fallen about 50 m almost straight down from the MRB hit marks. Other components of the fuselage had been scattered along the stream down the valley on the northern side. The floor structure of the airframe, including the engines, was found burning at a place down the valley.

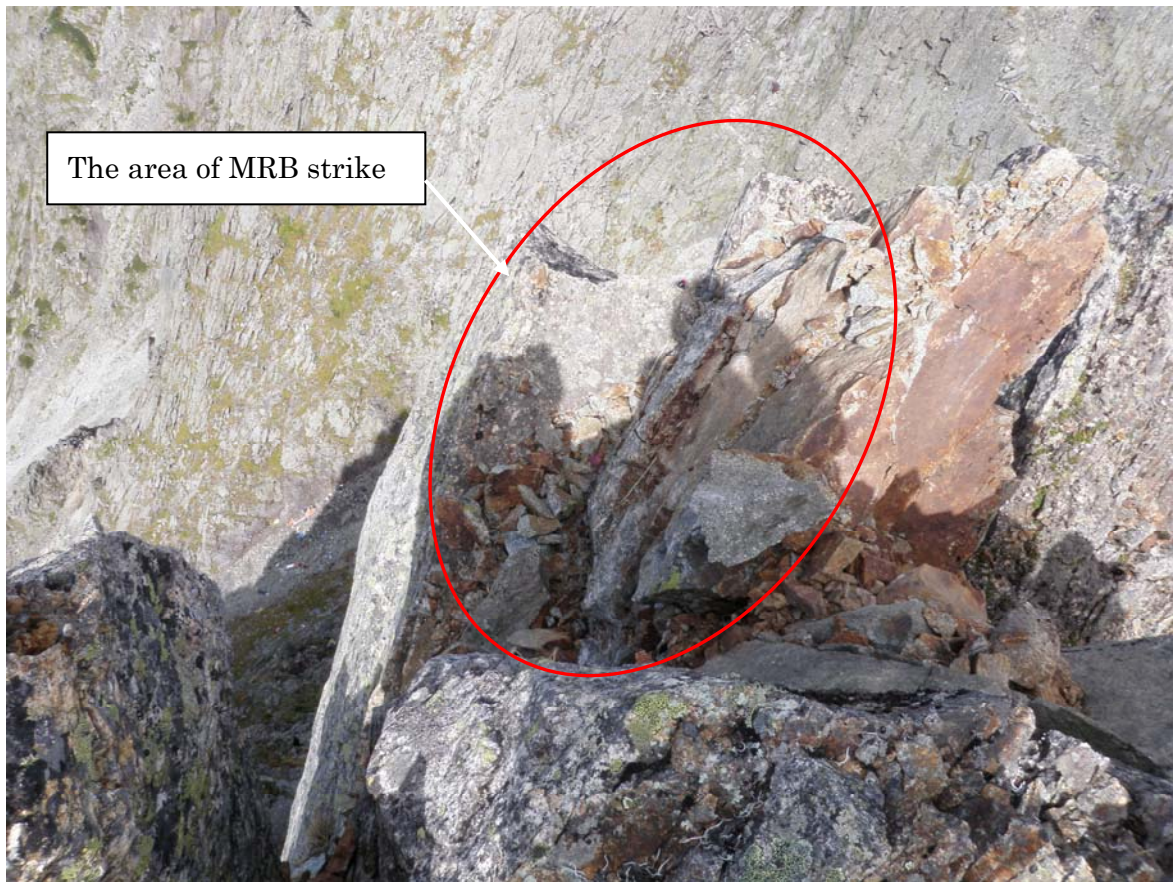
Photo 3-2 Traces Left with the Blow of MRB (2)

As described in 2.7.2 (2), the damage to the MRBs was conspicuous on the tip. As described in 2.7.1 (1), the hit marks left by the MRBs when they hit the rock wall were found at the tip of a rock north-northwest of the top of the East-West Rock Wall. Metal pieces of the tip of the MRBs were found stuck on the rock, indicating the MRBs had hit the rock horizontally. Therefore, it is considered highly probable that the tip of the Aircraft's MRBs had hit the rock. Because the radius of the Aircraft's MRBs is about 7 m and also because the hit marks were found at the tip of a rock north-northwest of the top of the East-West Rock Wall, it is considered highly probable that when the Aircraft hit the rock, it was at a place about 7 m to the north-northwest from the rock wall where the traces were found and at an altitude of about 3,148 m. The wind at that time, which was blowing at about 10 kt from the west, was within the critical wind direction range for the Aircraft, but it is considered highly probable that it was within the maximum allowable wind velocity range.

The area of MRB strike Viewed from above

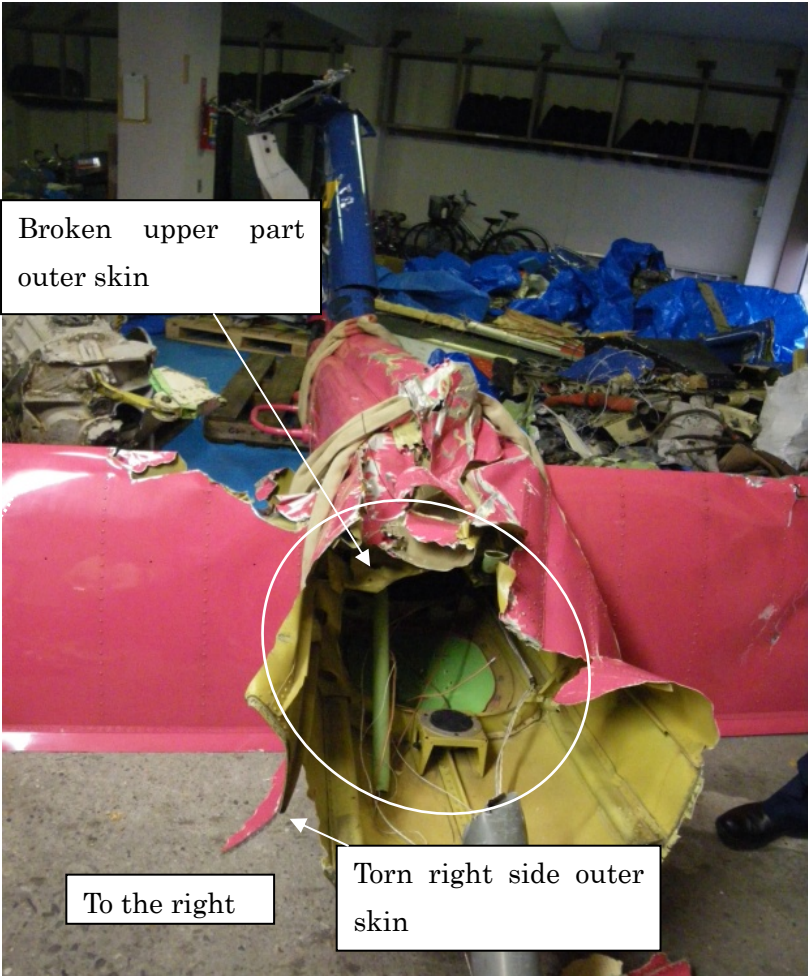
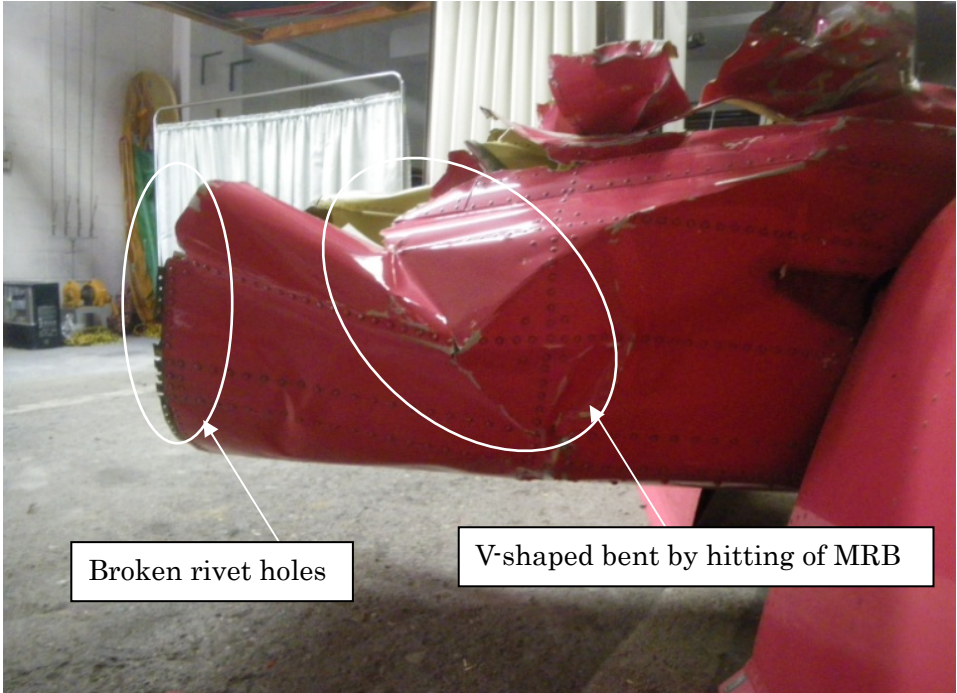
Photo 5 Detached Tail Boom

Regarding details of the condition of the area where the tail boom was broken into two parts, right side outer skin was found torn with an apparent bending to the right, from the rear part to the front part of the airframe. There were a V-shaped bend with a force applied diagonally from the left above in the upper part on the left side, and cracks and distortion were found in outer skin around the bent area. In the opened area, rivet holes in the upper part of the left and right sides were found broken. But the lower part and the right side part remained with only rivets lost. The tail rotor mast cover in the area above was found crushed with abrasion marks. The bottom part remained almost intact, while the lower part of the vertical stabilizer was found severed by the TRBs.

As described in 2.7.2 (7), among the components of the detached tail boom, outer skin had been broken from the upper part on the left side to the upper part on the right side. The tail rotor drive shafts were found broken on the same path. Particularly, there was a V-shaped bend in the upper part on the left side, while outer skin near the bent area had cracks and deformation. Outer skin on the right side was torn with a force applied to the right toward the direction of the Aircraft's movement. There were no traces that indicate the Aircraft's tail boom had touched or hit the rock walls nearby.

With these facts, it is considered probable that because the right side of MRB's rotating plane hit the rock wall and the transmission leaned backward, and at the same time the MRBs hard hit the left side of the tail boom, resulting in a fractured tail boom. Regarding the fact that the tail boom had flown to the rock wall on the east side, it is considered probable that the fuselage had turned to the right with a torque force applied when the MRBs hit the rock wall and as a result, the broken tail boom got detached when it was directed to the east.

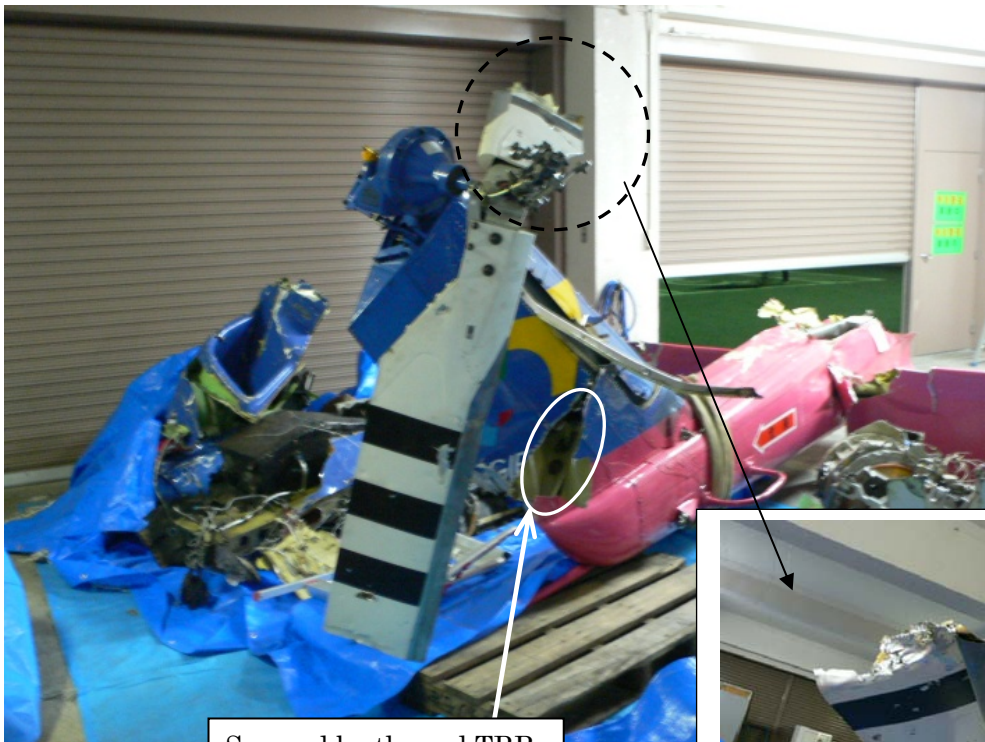
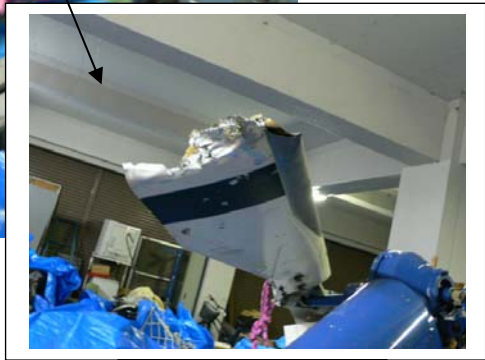
Photo 6 TRBs

Of the two blades, the red one was found fractured at a point about halfway, but there was no major damage to the white one.

Of the two TRBs, the red blade was found broken at around the middle point, but there was no major damage to the white blade. The red blade severed the lower part of the vertical stabilizer leaving its tip inside the stabilizer.

Severed by the red TRB

Broken red TRB

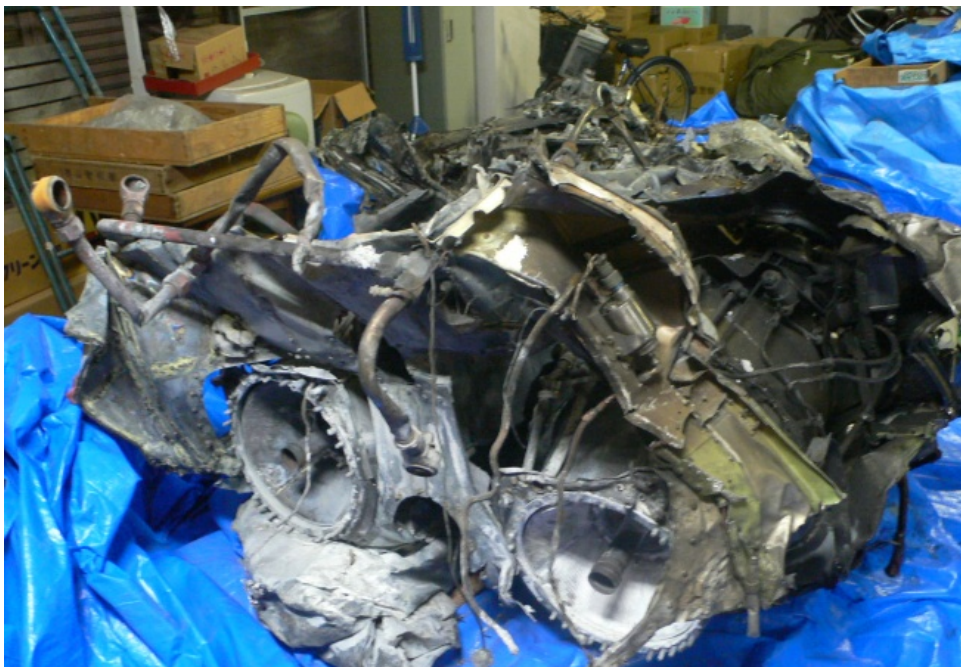
Photo 7 Engines

There were no distortion in the cases for the No.1 and No.2 engines, but the air intakes and exhaust pipes had been deformed and their outside had been burned.

The gas producer turbine for the No.1 engine was not manually rotated because the gear box had been deformed. But a bore scope inspection (BSI) found no abnormality with the turbine blades. The power turbine was rotated without a hitch, and a BSI found no abnormality with its turbine blades, either.

The gas producer and power turbines for the No.2 engine could be manually rotated without a hitch. A BSI found no abnormality with the blades for either of the gas producer and power turbines.

As described in 2.7.2 (3), the gas producer turbine for the No. 1 engine, which had been recovered along with the No. 2 engine, could not be manually rotated, because its gear box had been deformed due to the impact of the crash. But other turbines could be manually rotated without a hitch. A BSI found no abnormality with any of the turbine blades. As described in the statement in 2.1.3 (3), the mountain guide felt nothing unusual with the Aircraft's behavior when it was hovering. Therefore, it is considered probable that its engines were normally operating and that there was no abnormality with the fuselage. It is considered highly probable that the fire broke out due to an impact at the time of the crash.

Engines from the rear (Right: No.1, Left: No. 2)

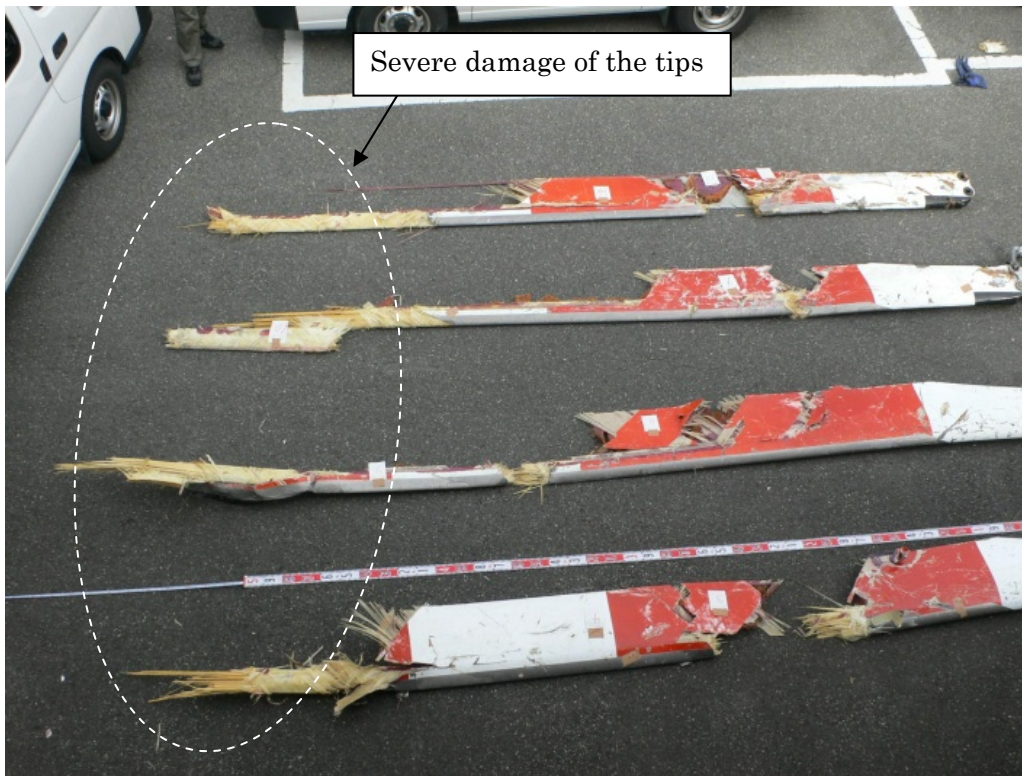
Photo 8 MRBs

The blue MRB had been broken into three parts at points about 2.5 m and about 5.5 m from the root. A section about 1.5 m long on the tip was not recovered. The orange MRB was found broken into three parts at points about 4 m and about 6.5 m from the root. A section of about 0.5 meter on the tip was not recovered. The red MRB was found broken into three parts at points about 2.1 m and about 5.5 m from the root, and a section of 1.5 m on the tip was not recovered. The green MRB was found broken into three parts at points about 2 m and 5.3 m from the root, and a section of about 1.7 m on the tip was not recovered. Of the green MRB, a section of about 2 m from the root and its hub were found retained to the main rotor mast, but the blue, orange and red MRBs had been broken and separated at the yoke.

Severe damage of the tips

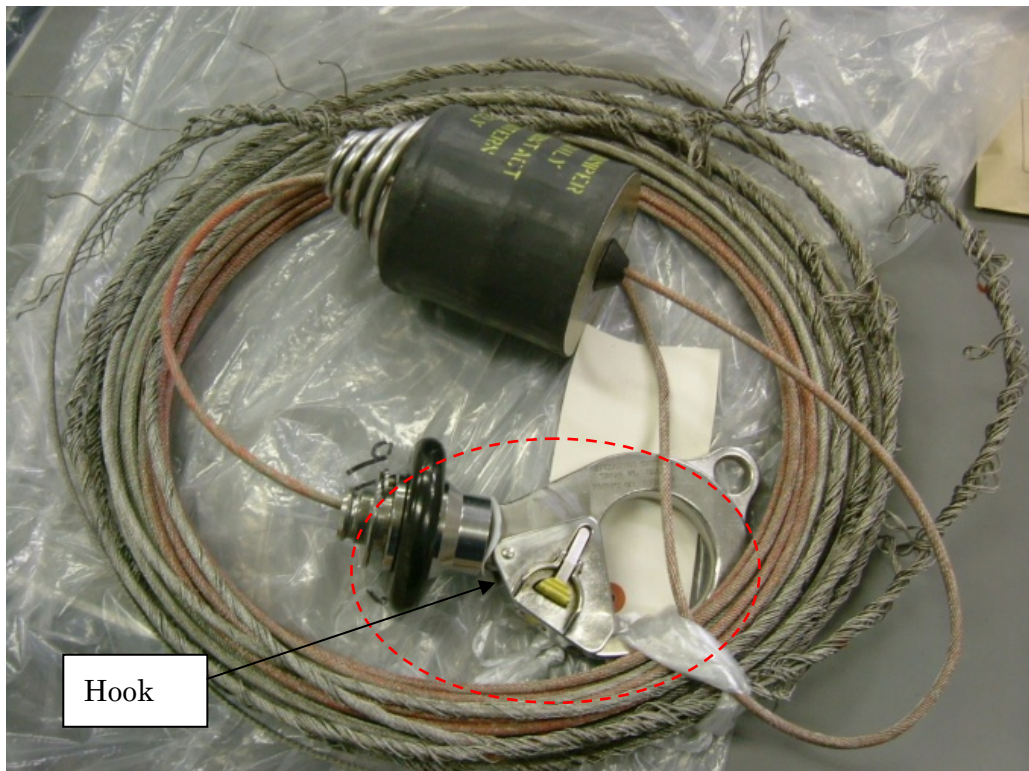
Photo 9 Hoist

The hoist cable was found fractured at four points, about 26 m, about 36 m, about 44 m and about 48 m respectively from the Hook end. The cross section of the broken cable looked torn off in three of the points which were closer to the Hook end, while the remaining point, about 48 m from the tip, had shown a sharply cut face just like done with a wire cutter. On the other hand, about 28.2 m of the hoist cable remained in the winder.
