**AIRCRAFT ACCIDENT  
INVESTIGATION REPORT**

**OGAWA AIR INC.**

**J A 9 7 5 5**

OGAWA AIR INC.  
AEROSPATIALE AS350B (ROTORCRAFT), JA9755  
SEA SURFACE OFF CAPE OMASAKI  
OMA-CHO, SHIMOKITA-GUN, AOMORI PREFECTURE  
AT ABOUT 11:45 JST, JULY 6, 2008

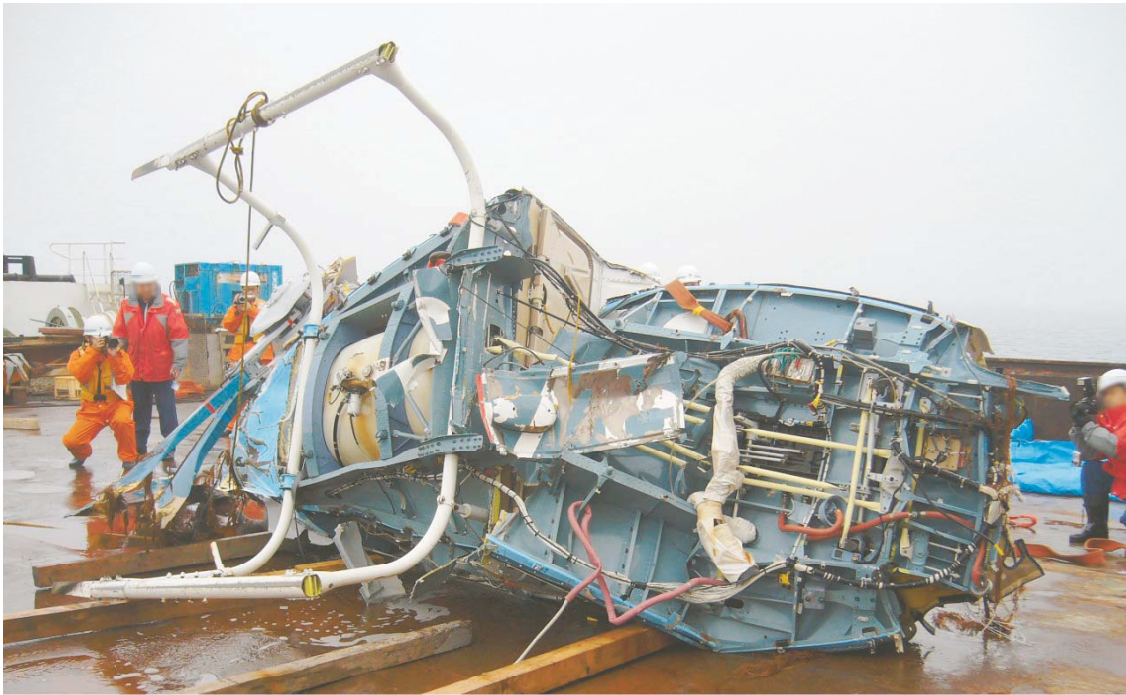
Picture 1 Accident aircraft (bottom fuselage)

Parts covering its nose section to the forward bulkhead (windshield, instrument panel and ceiling) were separated from the fuselage. The cabin floor was deformed and was separated along the connecting part with the forward bulkhead. Right and left floor support beams were separated from the floor panel a little forward of the above mentioned part exhibiting the force applied upward. The fuselage lower skin was missing and the control rods situated under floor were damaged. The fuselage lower skin forward of the tailboom connecting part was pushed inward to a great extent. In general the left side exhibited greater damage than the right side; the left aft cargo compartment floor was bulged upward; however, the right cargo room floor exhibited no deformation.

The left cyclic grip was fractured. The collective lever was at the lowest position. Only base of right cockpit seat remained attached. The left cockpit seat was damaged as if its base had been squashed and its seat back was broken into two pieces and bent

Both skids were snapped and lost at the area forward of forward cross tube connections. The broken surface of the right skid exhibited the force applied from the left, which caused snapping.

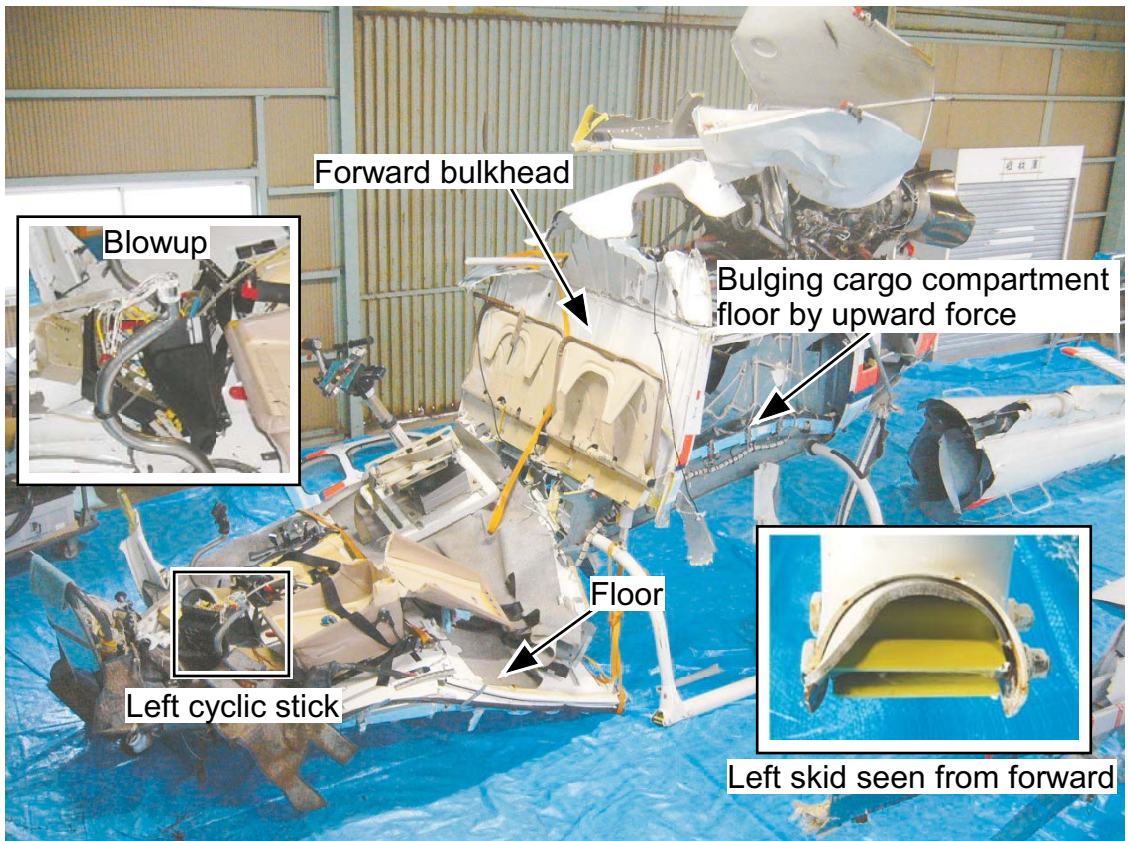
Picture 2 The aircraft (upright position)

Given the fact that the portion extending from the nose section to the upper section of the fuselage was separated and the connecting portion of the cabin floor and the forward bulkhead was bent upward and separated, it is considered probable that the Aircraft crashed into the sea surface at high speed with the nose section first, followed by the fuselage lower section. Judging from the fact that both forward sections of both skids were broken forward of the connecting points of the cross tube

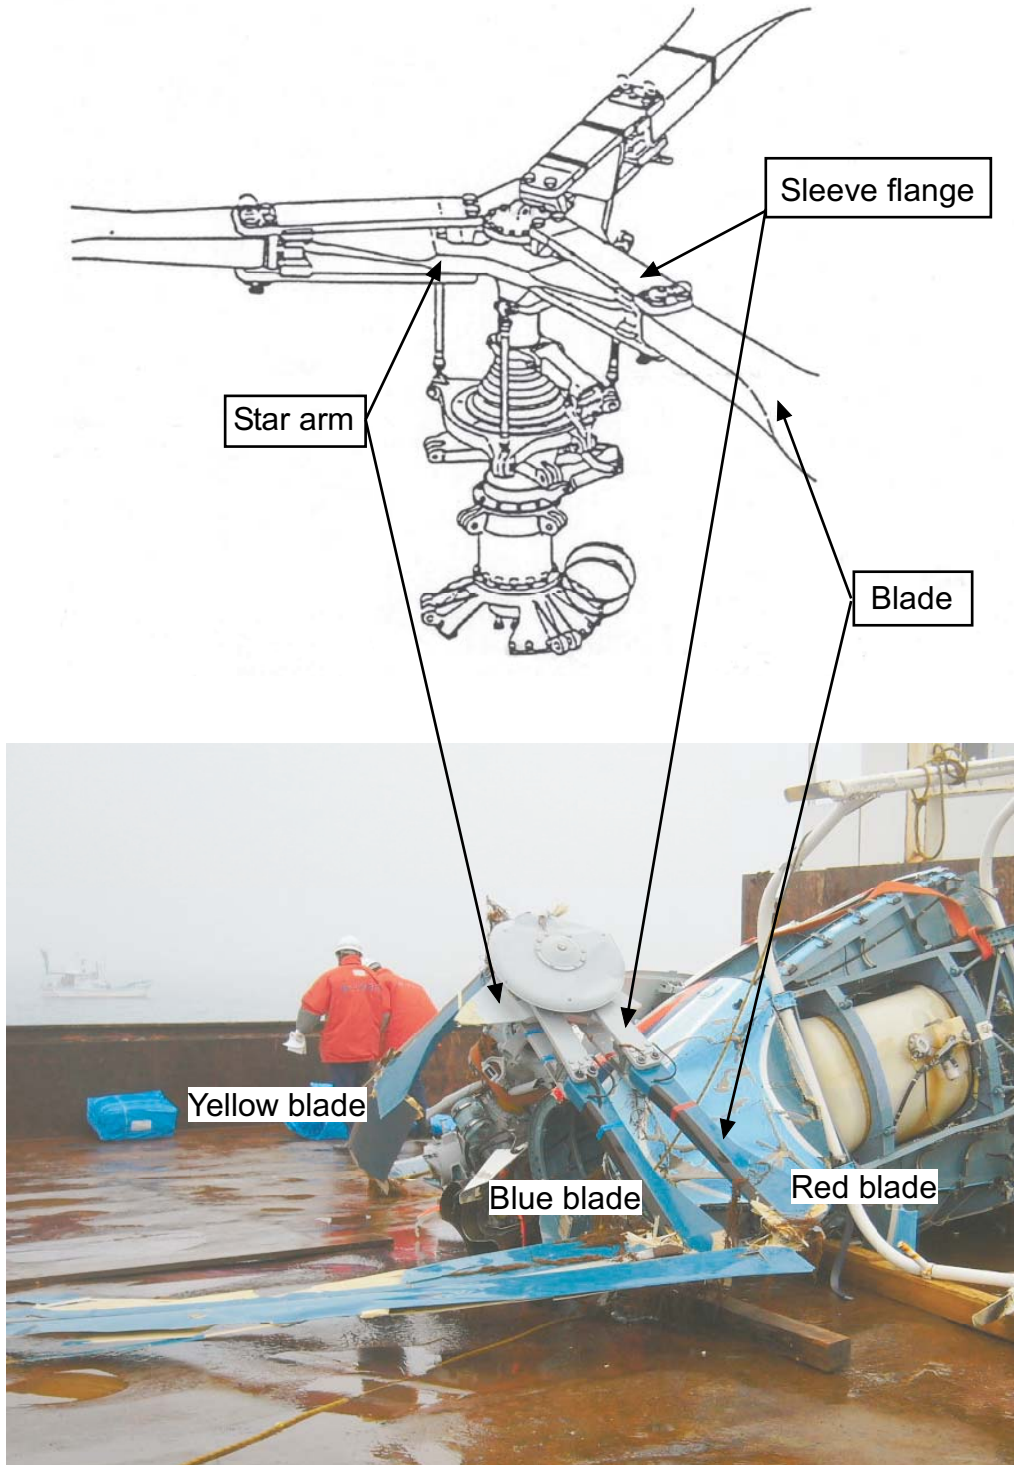
Picture 3 Main rotor hub and blades

The sleeve flange to which a yellow blade is attached exhibited conditions of splintered bamboo stalk and the star arm was destroyed. The blade was broken at the point 1.5 m from its root. A part of leading edge 1.4 m from the blade tip had dents with blue paint scratches.

The sleeve flanges of blue and red blades were not broken. Both star arms were damaged at their spindles. Both blades were broken at points 1.5 m and 1.6 m from blade tips respectively.

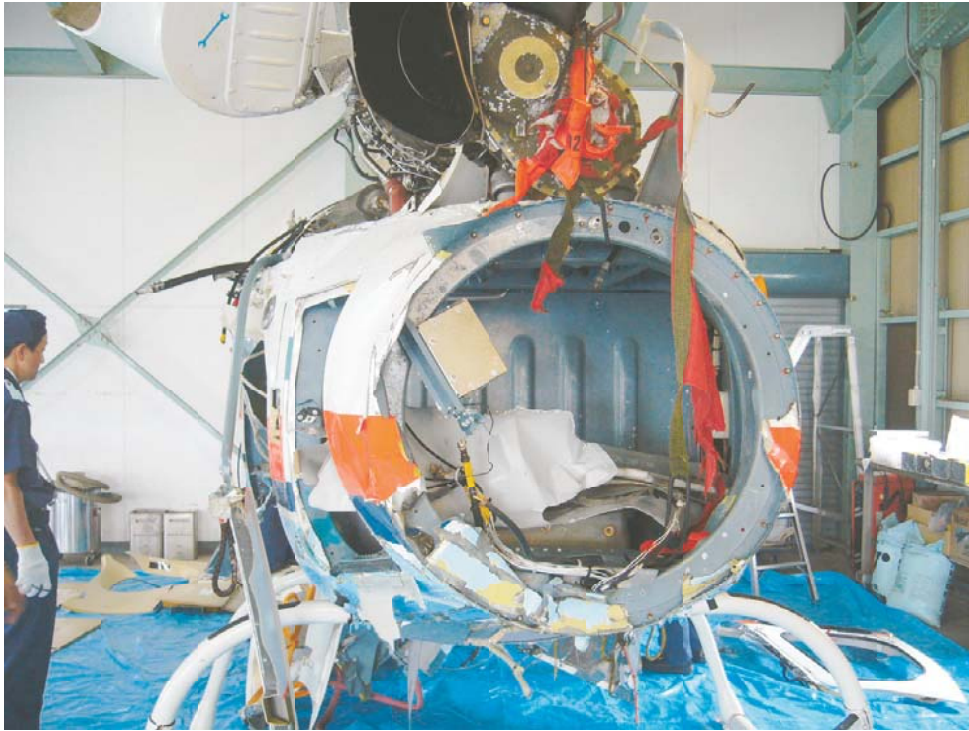
Picture 4 Tailboom connecting part

The tailboom was detached from the fuselage. When viewed from aft and upside is assumed 12 o'clock, the circular connection to the fuselage exhibited expansion

in the range of 11:30 to 5:30, while remaining half exhibited compression.

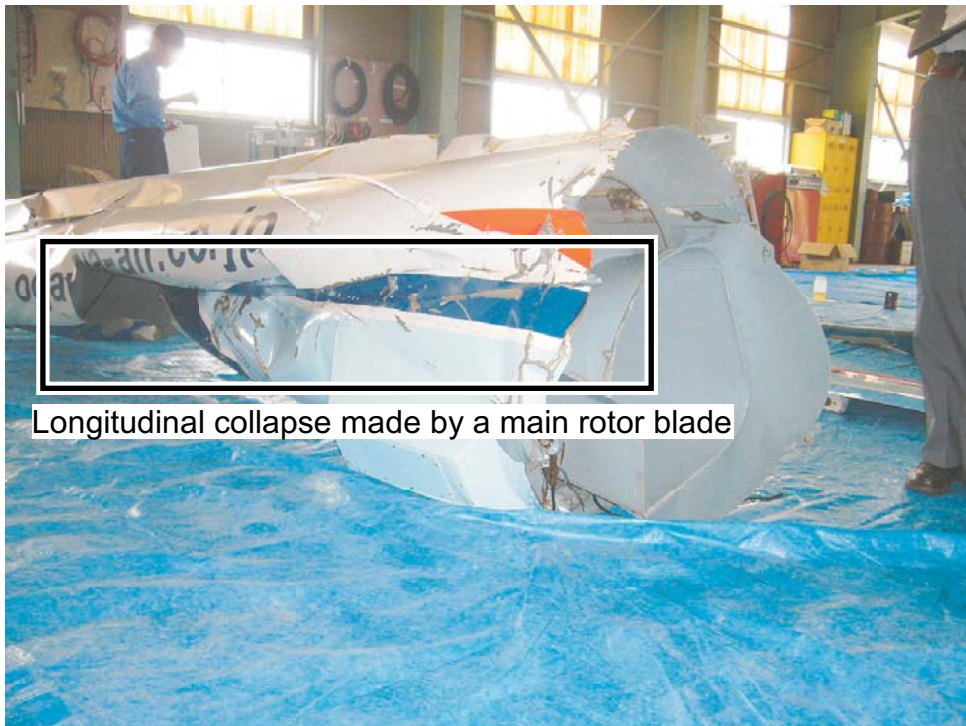
Picture 5 Damaged tailboom

Right forward side of the tailboom had an about-3 m-long linear collapse hit by something long along the tailboom longitudinal axis and a small area of blue paint about 1.4 m from the aft end of the collapse was peeled off.

The aft end portion of the tailboom with a length of about 1.4 m was detached. This portion, which holds a tail rotor gearbox and an upper vertical fin, was not salvaged.
