**AIRCRAFT ACCIDENT  
INVESTIGATION REPORT**

**NAGANO FIRE AND DISASTER  
PREVENTION AVIATION CENTER  
JA97NA**

COLLISION WITH TREES AND CRASH  
MT. HACHIBUSE, MATSUMOTO CITY,  
NAGANO PREFECTURE  
AT AROUND 13:41 JST, MARCH 5, 2017

NAGANO FIRE AND DISASTER PREVENTION AVIATION CENTER  
BELL 412EP (ROTORCRAFT), JA97NA

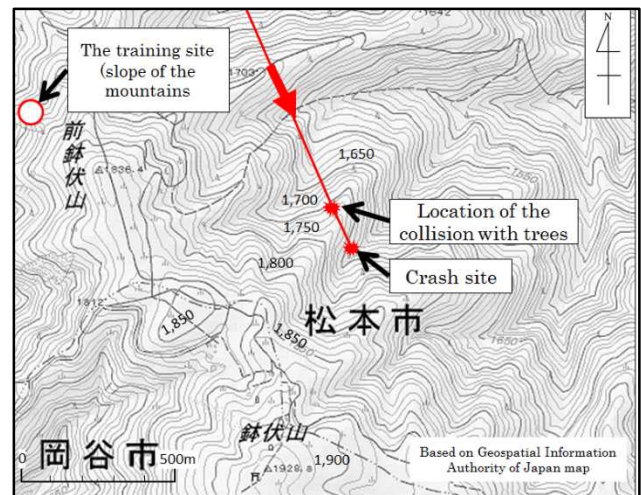
Figure 4: the accident site

There are marks indicating the helicopter collided with approximately ten-meter-high trees on a ridge of an elevation of approximately 1,730 m, approximately 140 m north-northwest of the crash site. Several trees were cut off, and the left cockpit door, the lower fuselage parts, the MRB parts, and other items of the helicopter were scattered nearby. Pieces of the MRB and the fuselage, the left pilot seat's collective pitch control lever (hereinafter referred to as "the CP Lever") head and other items were scattered within approximately 40 m wide from the site of the collision with the trees to the crash site. Around the helicopter, log papers reading "In flight engine data table" and captain's camera (his name was written on it) were scattered.

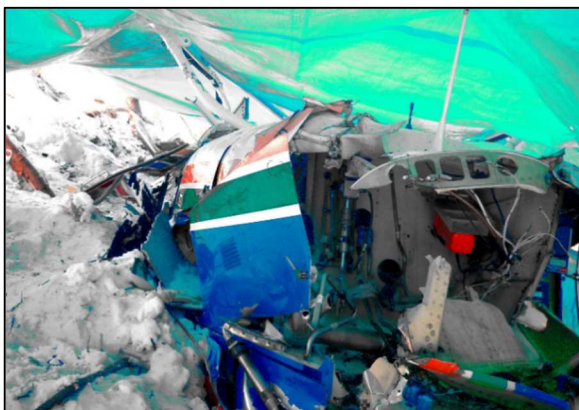
Photo 8: the accident helicopter (accident site)

The crash site was an approximately 40-degree north-facing slope covered with snow at an elevation of approximately 1,700 m, approximately 700 m north-northeast from the summit of Mt. Hachibuse (elevation: 1,928.8 m). The helicopter was turned upside-down with the nose pointing southwest. The TB had broken off from its base to be under the fuselage. The four MR blades (MRB), which were severely fractured and bent, were located near the fuselage. Trees situated north-northwest of the crash site were broken. There was no sign of fire.

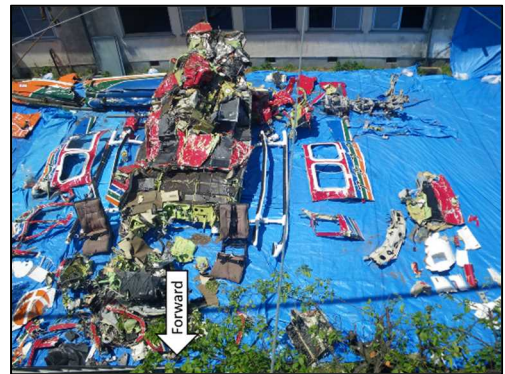
Photo10: the accident helicopter (entire helicopter)

Much of the cabin was damaged by the force of impact from the front and above. Most of the aft fuselage was severely damaged with the engine attached to the engine deck. All of the windows and doors were severely damaged by the force of impact. The landing gear was relatively undamaged.

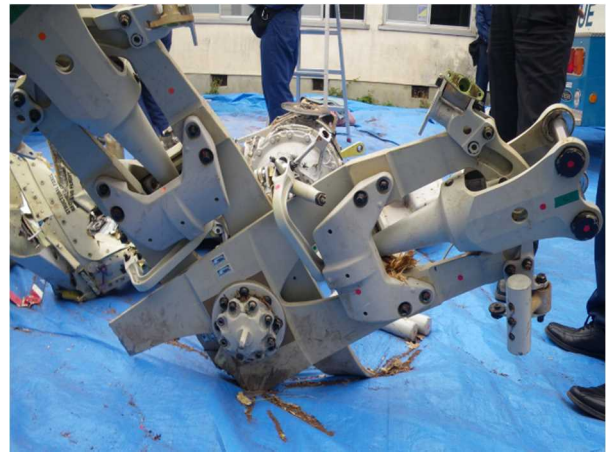
Photo 12: MR hub

The four MRBs, which rotate counterclockwise when viewed from above, are identified by the colors of green, blue, orange and red. The yokes of the green MRB and blue MRB were bent downward and were fractured near the spindle. The yokes of the orange and red MRBs were bent upward. The pitch link of the green MRB was fractured at the end of the pitch horn but joined at the rephasing lever. The pitch link of the blue MRB was joined with the pitch horn but fractured at the end of the rephasing lever. The pitch link of the orange MRB was fractured at both ends. The pitch link of the red MRB was fractured at the end of the pitch horn but joined at the rephasing lever.

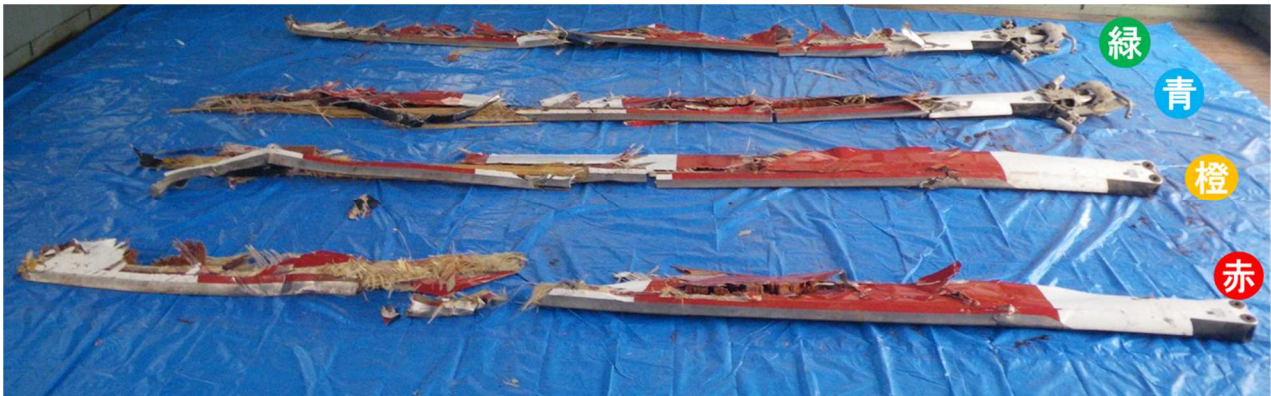
Photo 13: MRB

All of the MRBs were severely damaged overall.

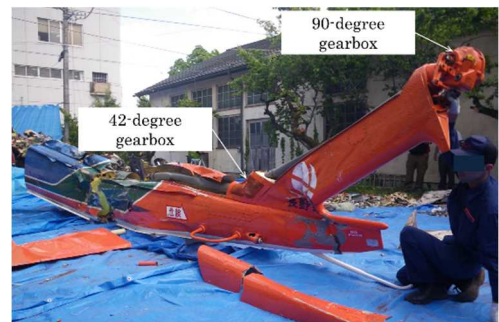
Photo 14: TB

The TB broke off from the aft end of fuselage and was fractured together with the TR's driveshaft at the front of the elevator. The TB was deformed and damaged on the whole. The 42-degree gearbox could not be turned manually because of damage to the TR driveshaft. The 90-degree gearbox rotated manually, but its rotation was limited by the damage to the TR driveshaft.

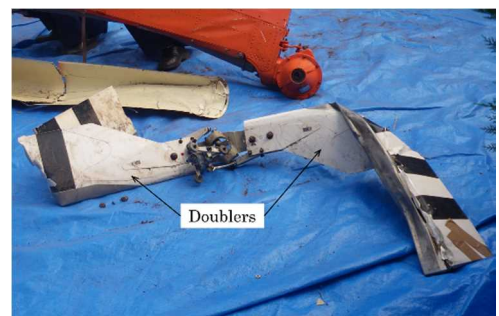
Photo 15: TR

The two TRBs were bent at the tip sides of their doublers and damaged.

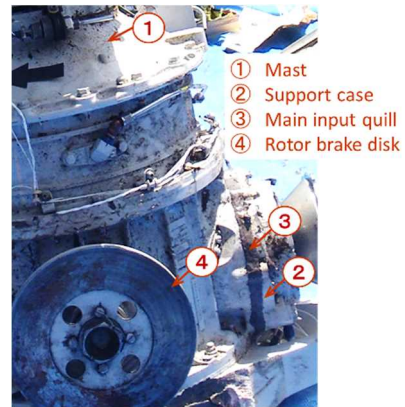
Photo 16: transmission

The transmission fell off together with its support case and was damaged. It was verified that the drive system was connected by rotating the main input quill and observing movement of the mast through the transmission with movement of the rotor brake disc.

The sump (lubricating oil reservoir) was broken from the support case; however, lubricating oil was present inside the transmission. The sump's chip detector (metal particle detector) was removed and no chips were observed in a visual inspection. The mast and lower chip detectors were removed and no chips were observed in a visual inspection. The oil filter had no chips or foreign material and indicated that it was not being bypassed (normal function).

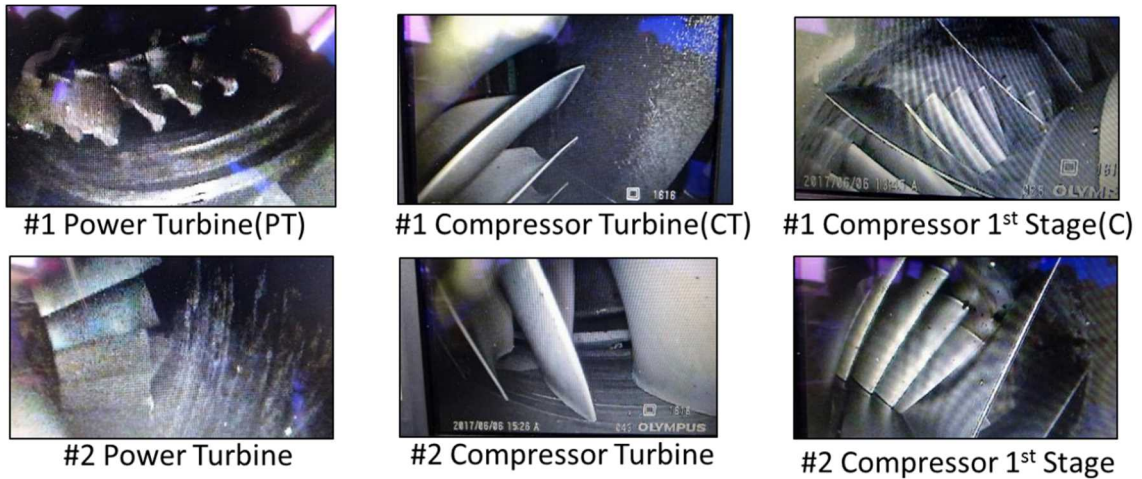
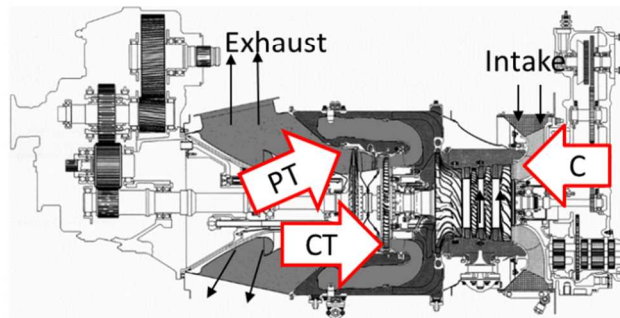
Photo 17: engine interior

It was confirmed whether manual rotation was possible or not, but found that it was not possible for both engines. When an observation of the engines' interior was conducted using a borescope, scratches were found within the axial compressor's first stage and compressor turbine case of both engines. The power turbine blades of both engines were fractured and scratches were found inside their cases.

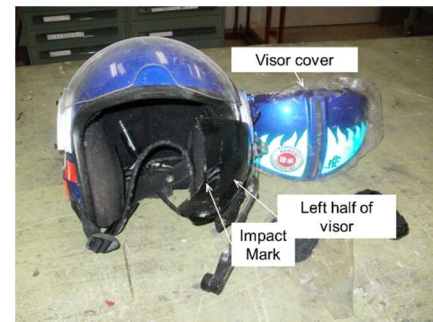
Photo 18 captain's helmet

The helmet worn by the captain was found still being worn by the captain near the crash location. The visor was lowered at the time of its discovery. There was an impact mark near the center of the visor, and approximately half of the visor's right side was missing. The visor cover had fallen off the helmet, but there was almost no sign of impact marks or the like. Additionally, almost no damage to the main body of the helmet was found.
