**AIRCRAFT ACCIDENT
INVESTIGATION REPORT**

**TOHO AIR SERVICE CO., LTD.
J A 9 9 9 1**

BELL 412 (ROTORCRAFT)

JA9991

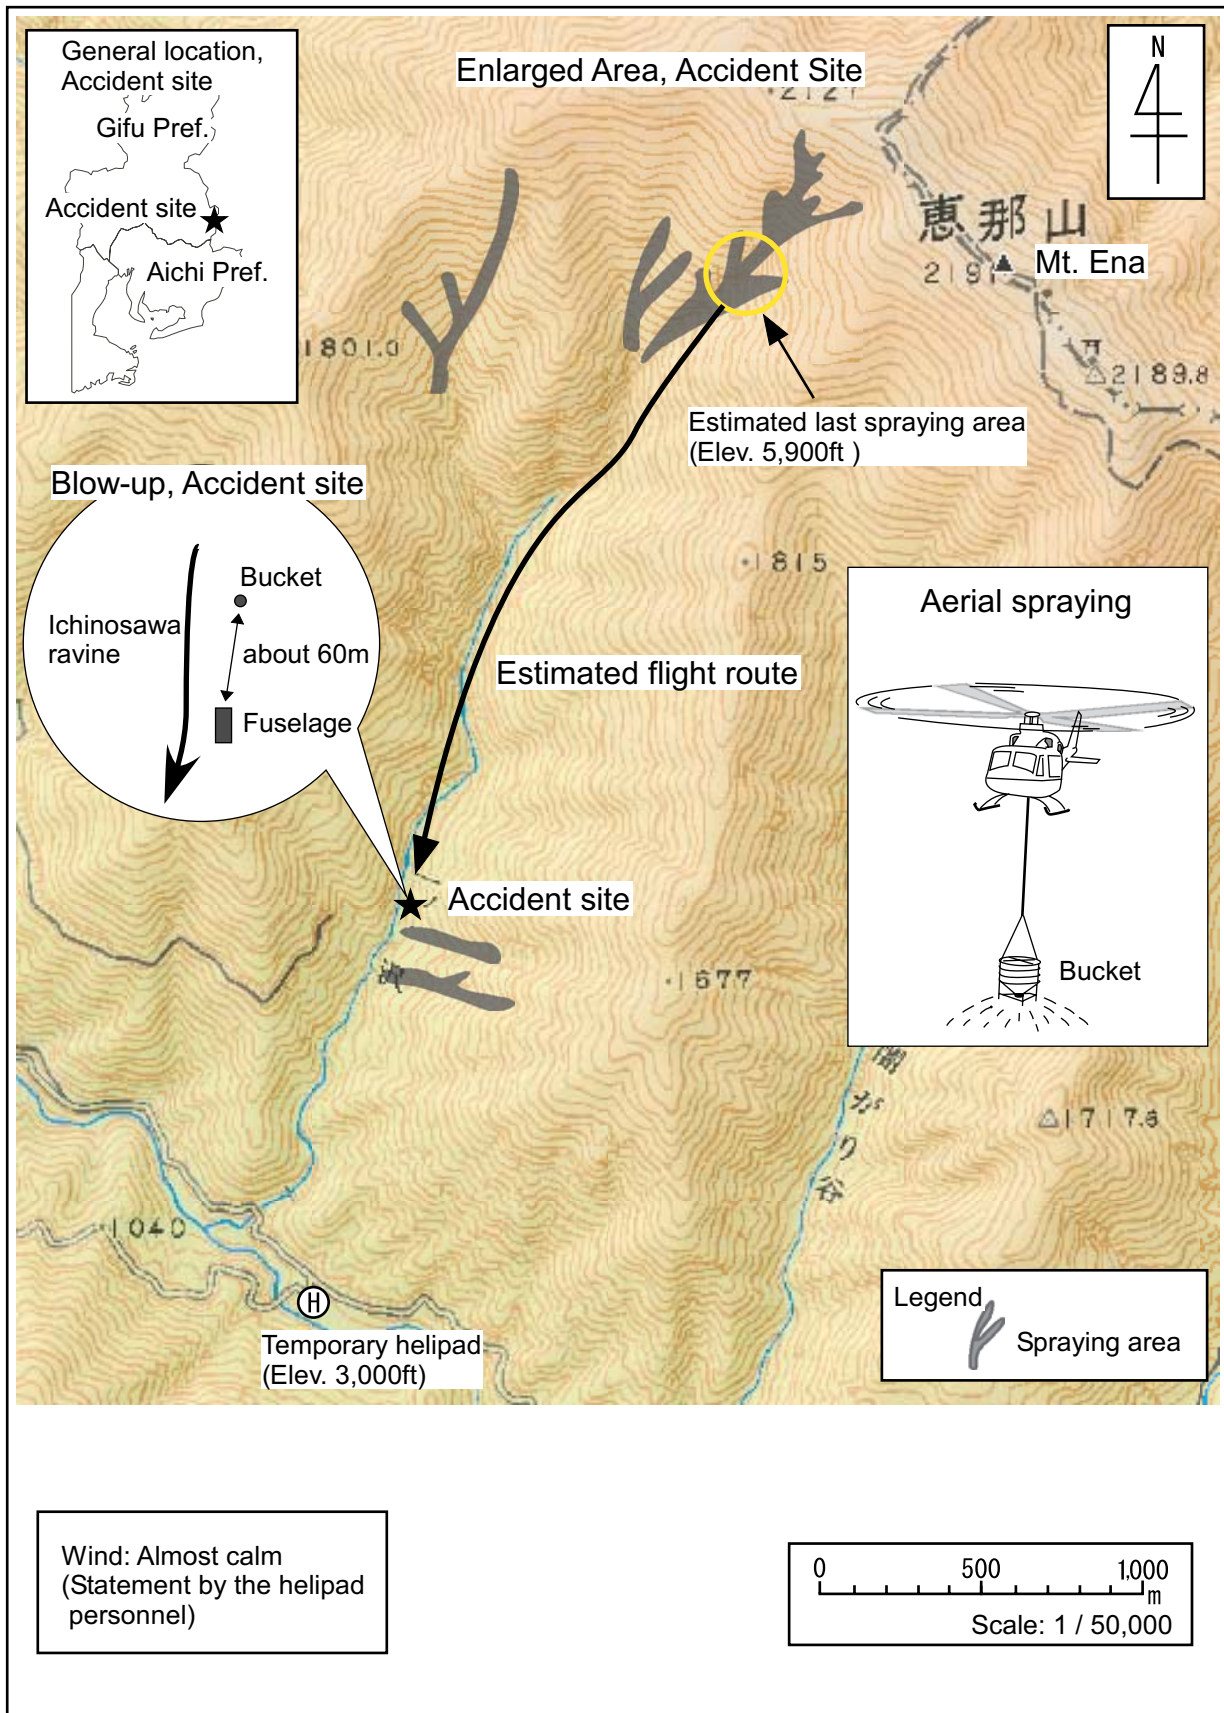
Figure 1 Estimated Flight Route

The accident site (39° 25' 35"N, 137° 34' 39"E) is located on the left slope of Ichinosawa ravine about 1.3km north from the helipad. The accident occurred around 15:39. (See Figures 1, 2 and Pictures 1,2)

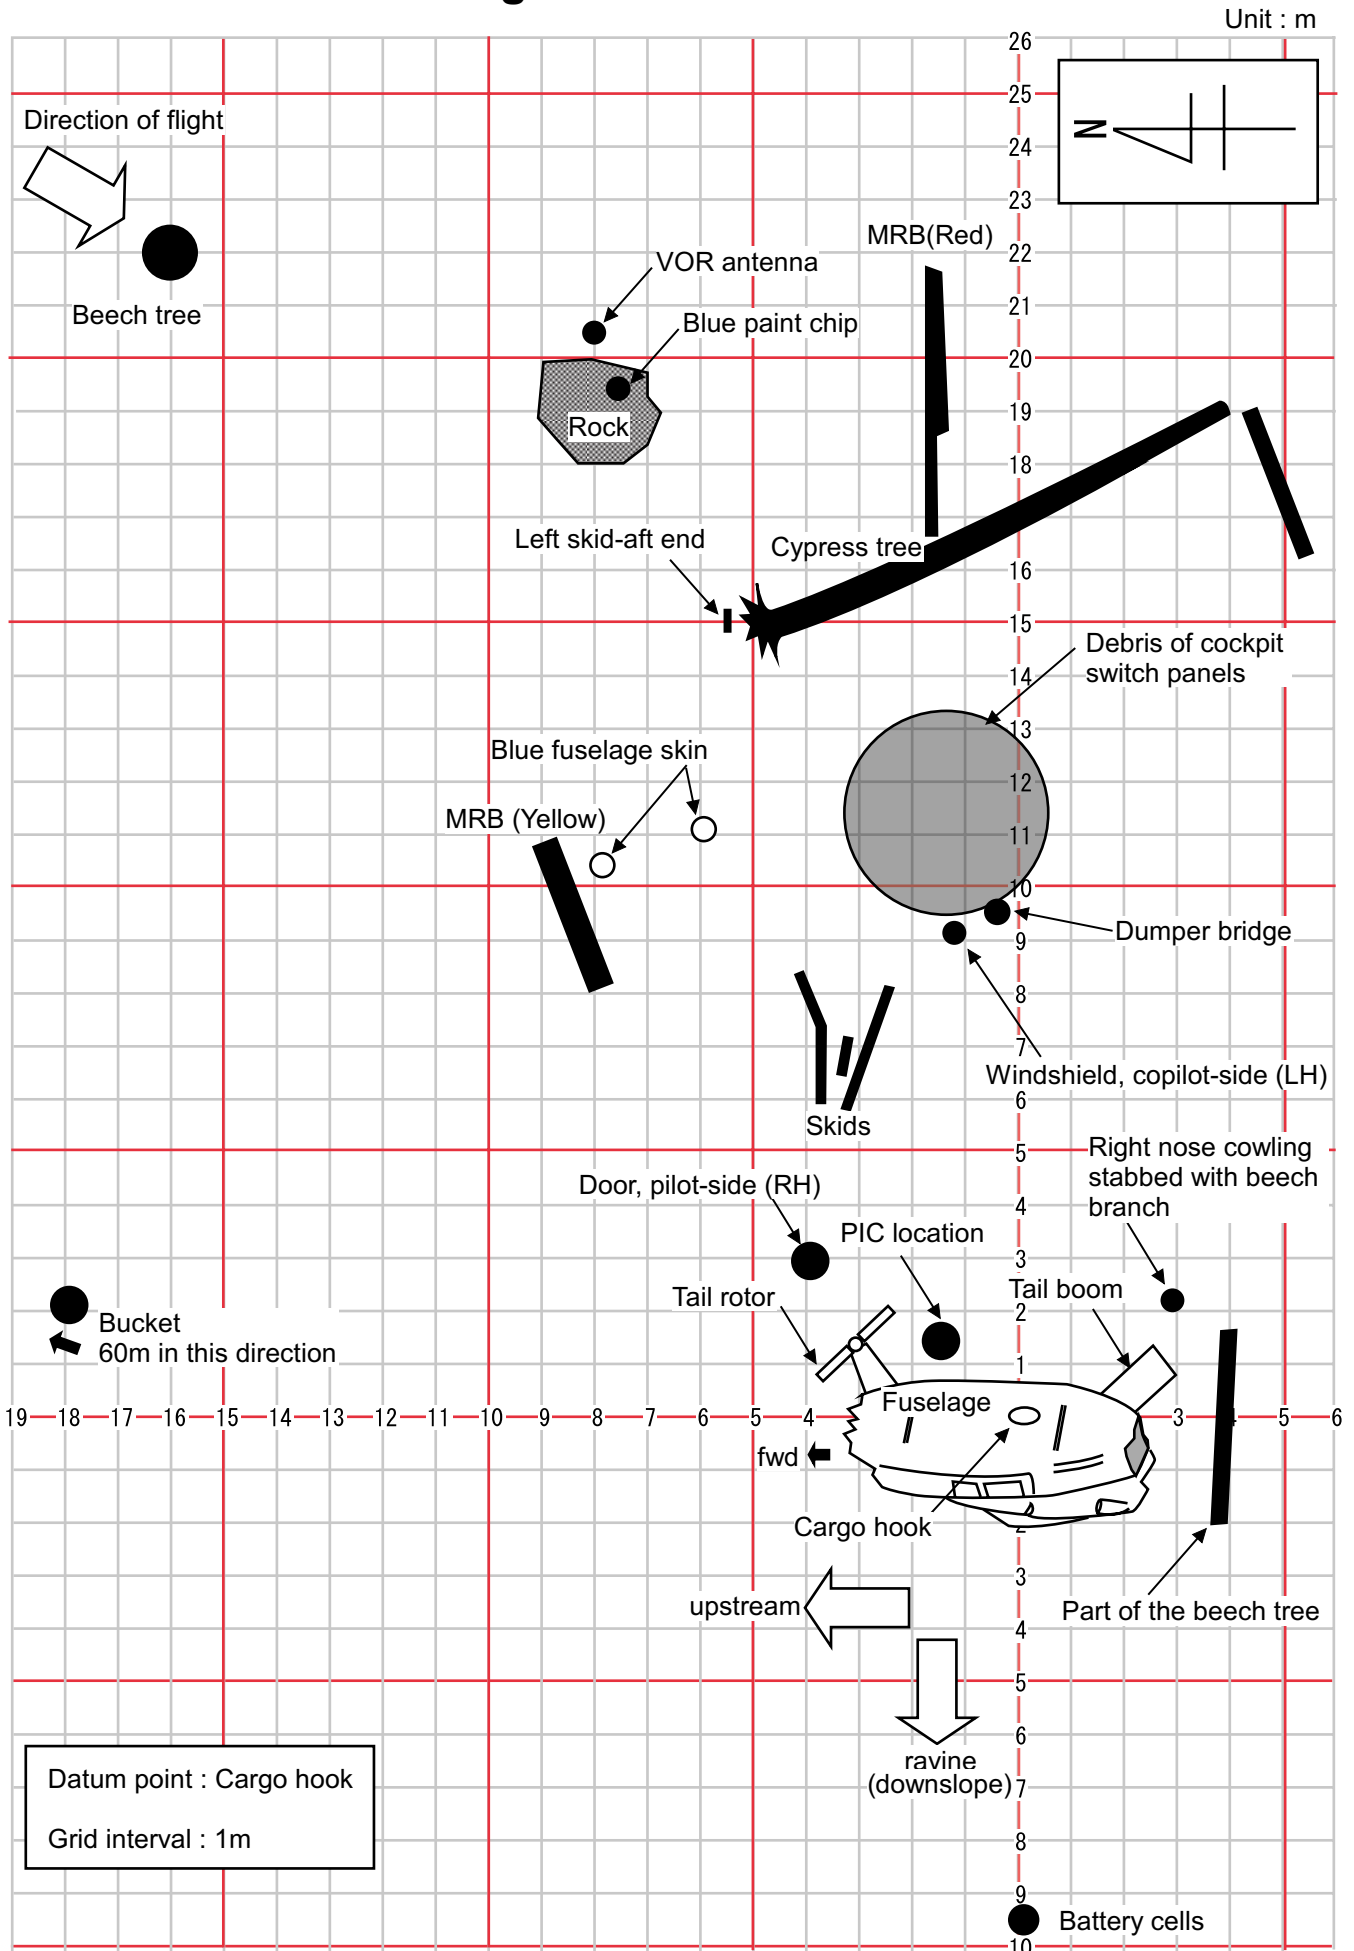
Figure 2 Accident Site

The accident site is located on the left slope of Ichinosawa ravine, which originates and extends south west from the top of Mt. Ena. The distance from the mountain top to the site is about 2.7km. Conifers and broadleaf trees more than 20m tall grow all over the area and the ground is covered with underbrush. The average slope inclination is about 45° and elevation is about 1,100m. About 100m upstream of the accident site lies a flat riverbed with a width of more than 20m.

The Aircraft rested on the slope about 17m from the ravine stream, orienting to north (upstream) with left side of its fuselage on the ground and suspended by trees from tumbling down the slope. The tail boom was oriented to the opposite direction of the fuselage and its horizontal stabilizers were placed under the fuselage. No fuel leak was confirmed.

A beech tree stands 16m upstream and 22m upslope, its trunk was broken at a height of about 14m from the ground. Part of the broken trunk lied 1m downstream from the fuselage. Surrounding the beech tree, there were no slashed-away traces of tree canopies by rotating main rotor blades.

There is a 2m by 2m rock 8m upstream and 19m upslope. The rock had a scratch marks with blue paint that is identical with the Aircraft's lower fuselage paint. Left VOR antenna and debris of anti-collision light attached forward of the cargo hook were found upslope from the rock.

A cypress tree of about 20m tall, 5m upstream and 15m upslope, was pushed down downstream and the trunk was broken at a height of 10m from the ground. Upslope of this tree there was a 5.8m-long main rotor blade (Red²) (measured from the blade tip). At the root of the cypress, 40cm-long aft end of the left skid was found buried.

A 3.6m-long main rotor blade (Yellow) (measured from the blade tip) was found 8m upstream, 10m upslope.

Within about 3m radius of the point 10m upslope, many debris of cockpit switch panels, a part of left windshield, support arms of a cargo mirror and the like were found.

Battery was found disintegrated and scattered 10m downslope.

The bucket slung by the Aircraft was found on the slope about 60m north.

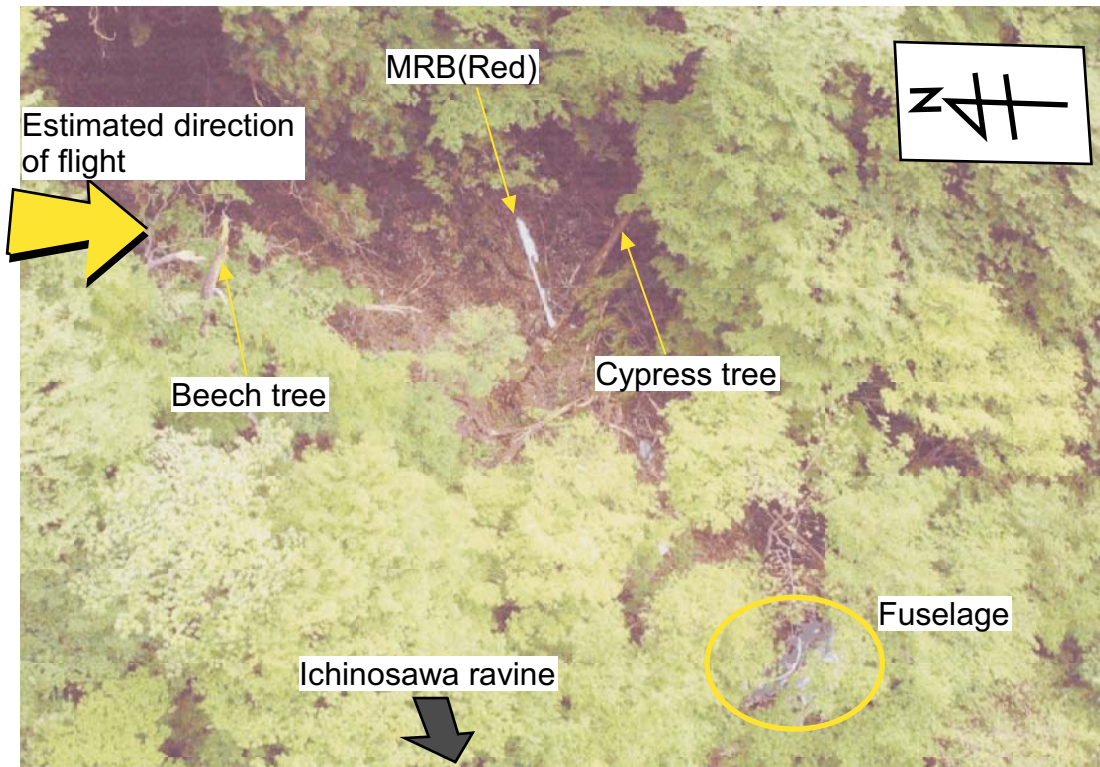
Picture 1 Accident Site

Note: The surface of the slope is exposed because trees were pushed down by the aircraft and the underbrush was stamped during the course of investigation activities.

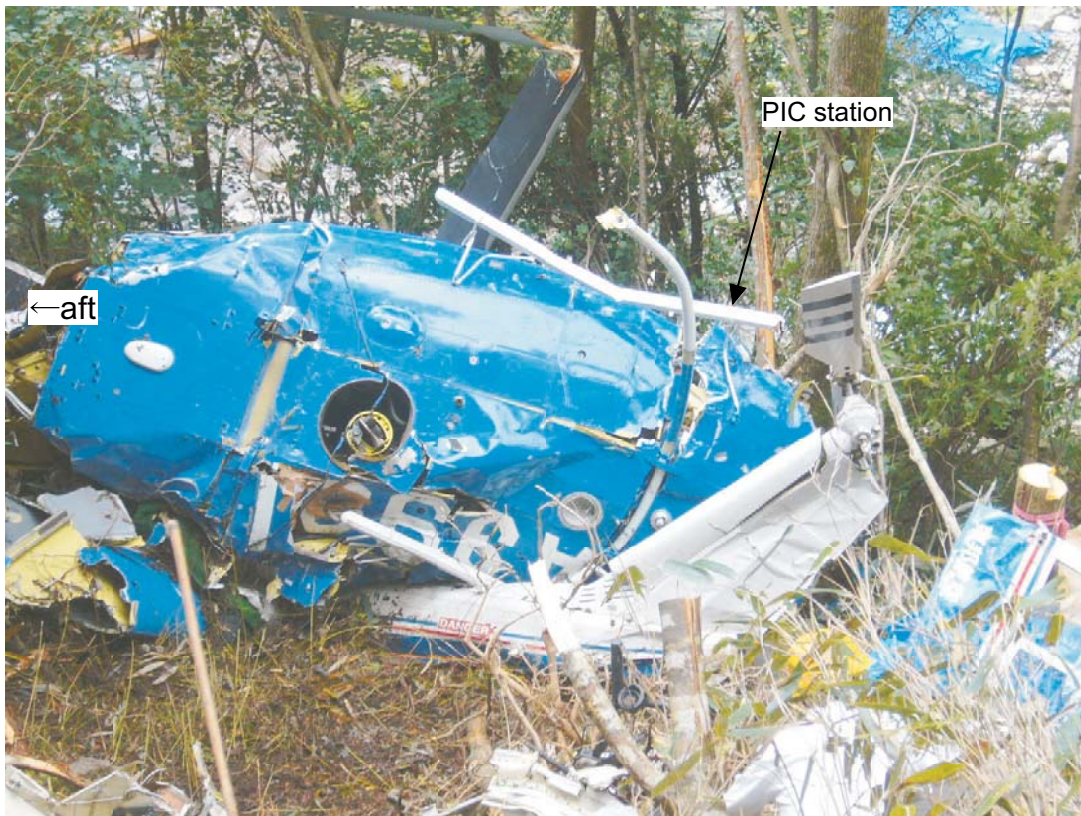
Picture 2 The Aircraft

(1) Fuselage: Forward fuselage ranging from nose to cockpit was crushed and destroyed evenly from the front. Cockpit was exposed. Left side of the fuselage ranging from left pilot seat to cabin and the aft lower fuselage up to tail boom attachment section were also substantially damaged.

(2) Landing gear: Forward and aft cross tubes attachment points to the fuselage were destroyed, but both cross tubes were not separated from the fuselage. Left and right skids were fractured into five pieces and four pieces respectively. Only aft-end of right skid remained attached.

(3) Main rotor blades: Red and Yellow blades were separated at the points 1.2m and 3.4m away from their roots respectively. Shreds of tree bark were found attached at respective separation points. Blue and Green blades were bent at the points 2.7m and 2.5m from their roots respectively. Leading edges of both blades showed no significant damage such as tree strikes.

Note: This photo was taken during the course of aircraft recovery. (Aft cross tube is already detached.)
