AA2016-5

**AIRCRAFT ACCIDENT
INVESTIGATION REPORT**

**CRASH
PRIVATELY OWNED,
ISHIJIMA MCR-01 (EXPERIMENTAL AIRCRAFT, TWO-SEATER)
JX0145
TSUKUBA CITY, IBARAKI PREFECTURE, JAPAN
AT AROUND 15:49, AUGUST 15, 2015**

May 20, 2016

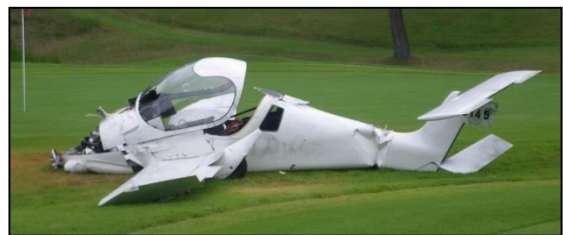
Photo 1 - the aircraft

Extent of damage of the aircraft: Destroyed

- Fuselage: Crack, Deformation
 - Both main wings: Crack, Deformation
 - Propeller: Two blades were ruptured in three blades.
 - Rudder: Fall off
- No fire outbreak

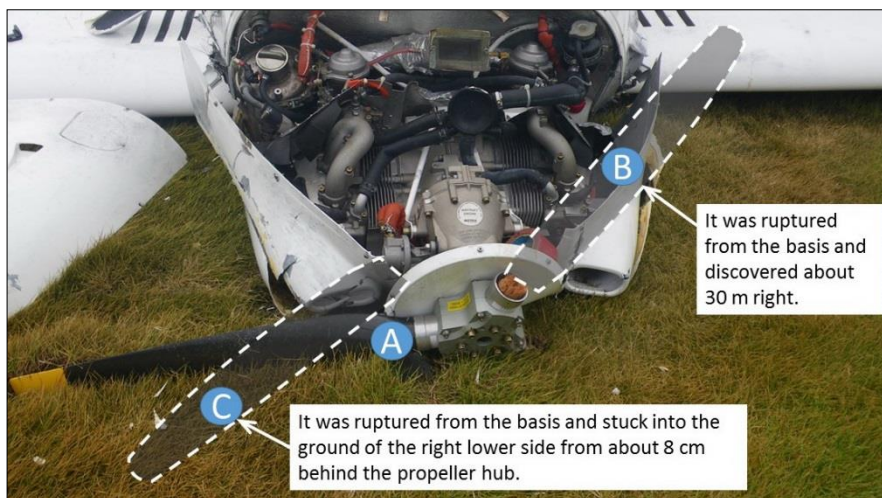
Photo 2 - condition of propellers (photographed from the forward)

down on the ground with the nose directed to the northwest and the landing gear damaged. Its sliding marks were hardly left on the ground. Seven marks by propellers rotating in the direction perpendicular to the shaft were left within about 1.3 m on the ground below the fuselage. The interval in the starting side was about 0.22 m. In three propeller blades, a blade B ruptured from the basis was discovered about 30 m almost right of the aircraft, a blade C also ruptured from the basis was stuck into the ground of the right lower side from about 8 cm behind the propeller hub, and an uncut blade A

was stopped in a condition of pressing the ground.

Based on the interval of three-propeller marks left on the ground (0.22 m), the indication of the tachometer (3,500 rpm), and the gear ratio of 2.43:1 in the engine and propellers, the estimation of the horizontal speed of the aircraft at the time of crash on the ground was about 60 km/h.

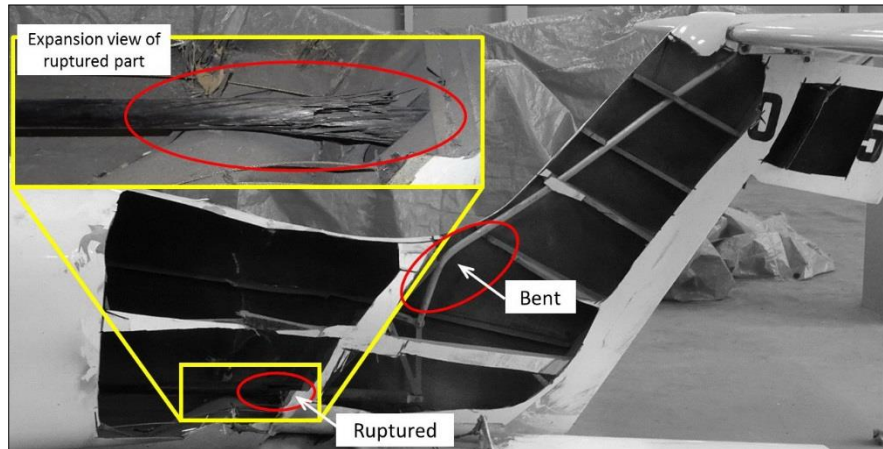
Photo 3 - condition of the elevator control rod (photographed after the external plate was cut)

The elevator exceeded the operation limit in the nose-up direction and was fixed on the vertical tail. The elevator control rod (aluminum alloy) inside the vertical tail was bent. The elevator control rod (composite material) inside the fuselage was ruptured.

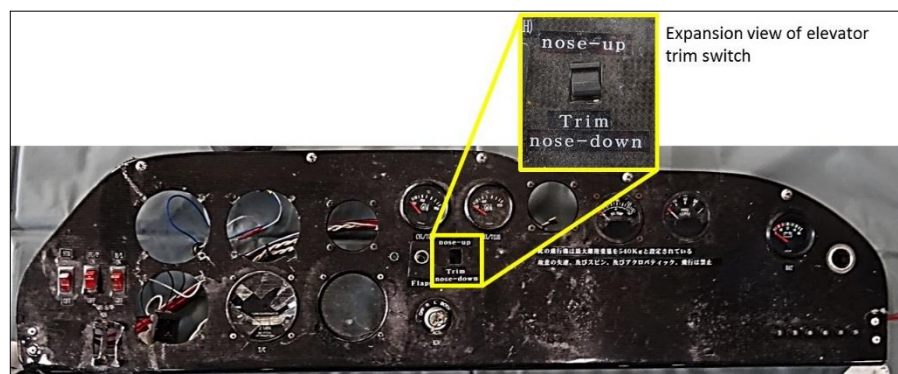
Photo 4 - the instrument panel

The ball screw type elevator trim actuator was stopped in the limit in the nose-up direction. Rubber parts holding the control stick in the neutral position with the elevator trim were properly installed. There was no trouble with the conduction between the elevator trim actuator and the trim switch. Although there was no trouble with the function of the elevator trim switch in the center of the instrument panel, the move to come back to the neutral position was mechanically unstable, therefore the switch did not sometimes come back to the neutral position. The throttle was fixed forward (high rotation side). The instrument panel fell off from the fuselage and most of the instruments fell off from the instrument panel. All the left and right sheets made of composite materials were broken in the lower surface.

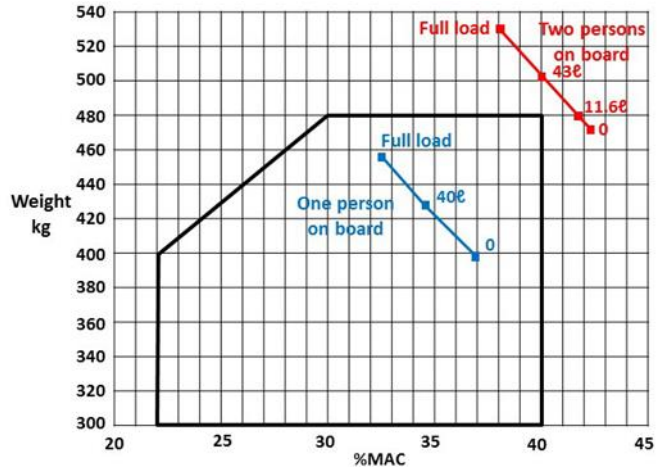
According to the flight manual of DynAero MCR-ULC (the similar aircraft) which is similar to the aircraft in dimension and shape, the maximum take-off weight is 480 kg, the limit in the range of the CG position is between 22% and 40% of the mean aerodynamic chord (MAC), and the chord length is 0.96 m, and the reference line is 0.0135 m forward from the leading edge of the left main wing. The weight and the CG position are calculated for cases that one person and two persons are on board based on these values, the values calculated by the mechanic as described in 2.8(1)③ and the weight of the boarded persons. They were transferred to Figure 2 – the weight and the CG position copied into the Figure 2 in which the ranges of the weight and the CG position of the flight manual; accordingly, its results are as follows:

If one person is on board, they are within the ranges of the weight and the CG position from full-load fuel quantity to zero, during which the position of CG gradually moves rearward. If two persons are on board, the weight exceeds the limit when fuel is 11.6 ℓ and over, and the position of CG exceeds the rearward limit when fuel is 43 ℓ or less.

weight and the CG position for the aircraft, and if the ranges of the weight and the CG position in the flight manual of the similar aircraft are applied to the aircraft, the weight exceeds the limit when fuel is 11.6 ℓ and over with two persons on board. Although the fuel quantity of the aircraft at the time of takeoff is unknown, it is probable that the aircraft did not load the fuel 30 ℓ and over, because it had a leak of fuel at the quantity. The CG position of the aircraft is already out of the rear limit at the takeoff and moves even more rear as fuel is consumed.
