# AIRCRAFT SERIOUS INCIDENT INVESTIGATION REPORT

MULTIPLE MALFUNCTIONS  
IMPEDING THE SAFE FLIGHT OF AIRCRAFT,  
GULFSTREAM AEROSPACE G-IV, N146BG  
PRIME JET, LLC  
AT AN ALTITUDE OF ABOUT 13,200 m  
ABOUT 300 km SOUTHWEST OF  
TOKYO INTERNATIONAL AIRPORT  
AT AROUND 19:58 JST, MAY 22, 2020

Adopted by the Japan Transport Safety Board

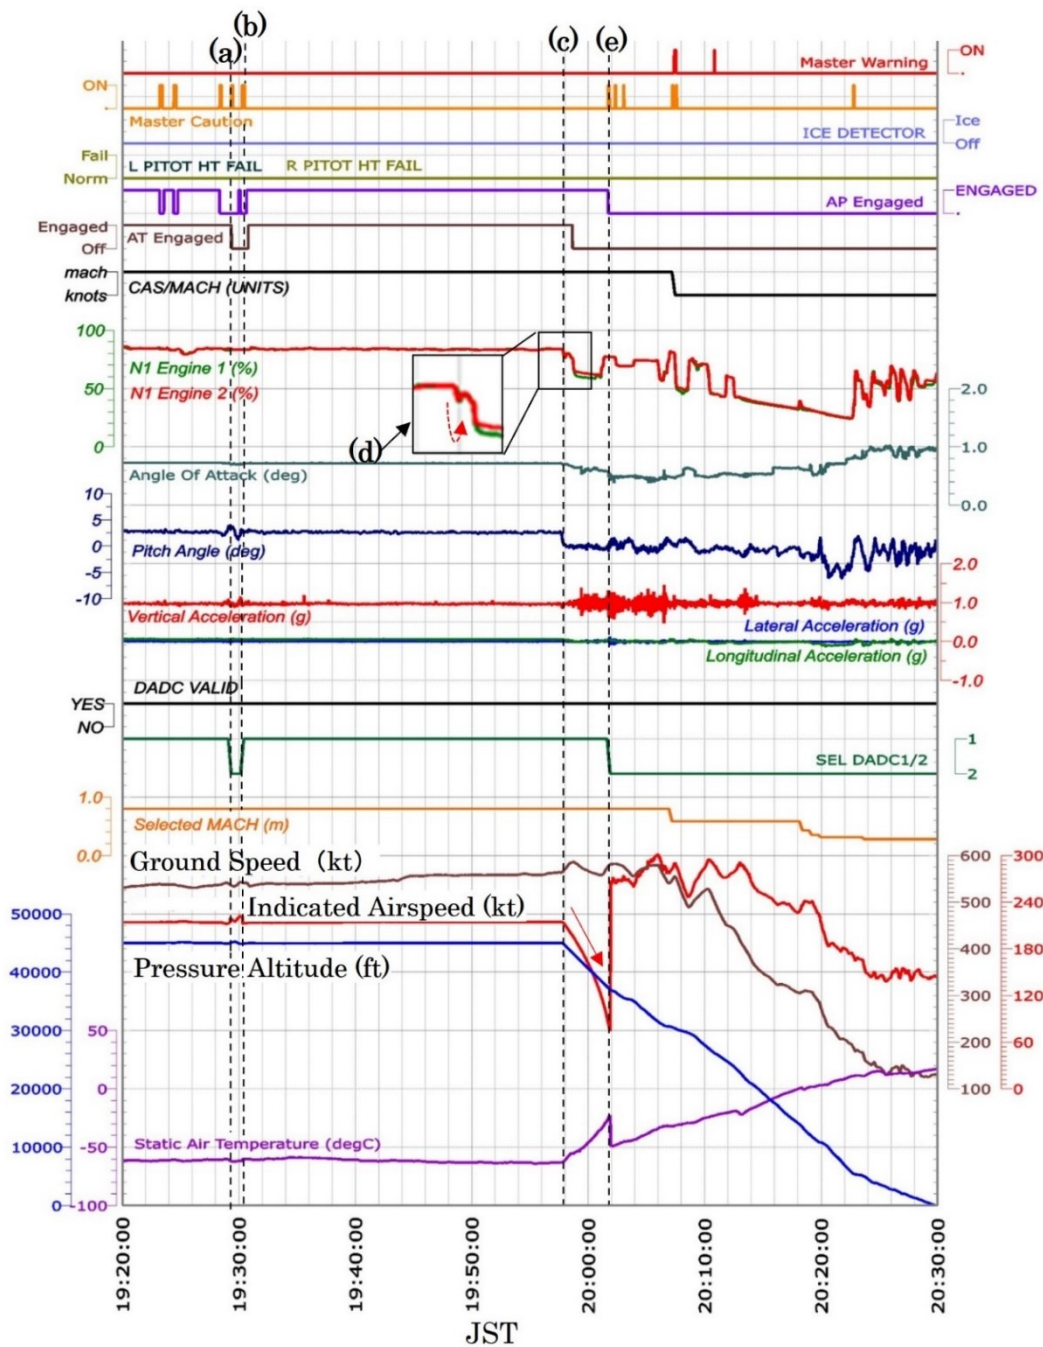
Figure 4 DFDR Records

side((a)~(b) in Figure4). The flight crew members deactivated No.1 DADC by pulling its circuit breaker to shut off the power.

At 19:30:00, the flight crew members suspected the No.2 DADC failure because when they attempted use the autopilot, part of its function did not work, then activated No.1 DADC by pushing in its circuit breaker and deactivated No.2 DADC by pulling its circuit breaker to shut off the power. At 19:30:39, the flight crew members attempted to use the autopilot again, and it operated normally. The captain and the CO selected No. 1 DADC on

<p>their respective display controllers and continued the flight((b) to (e) in Figure 4).</p> <p>At 19:57, the aircraft began the descent maintaining a constant Mach number from FL450 for Tokyo International Airport. Shortly after the aircraft began the descent, the indicated airspeed on the standby airspeed indicator increased while the airspeed on the left and right PFDs decreased (see (c) in Figure 4). At around 19:58, the flight crew members disconnected the autothrottle because the airspeed on the standby airspeed indicator further increased when the autothrottle which had reduced the engine thrust increased the engine thrust (see (d) in Figure 4).</p> <p>The flight crew members determined that the airspeed indications on the left and the right PFDs were unreliable and continued the flight controlling the attitude and the engine thrust while monitoring the standby airspeed indicator and the standby altitude indicator according to the procedure of QRH Suspected Erroneous/Unreliable Airspeed Indications (hereinafter referred to as “Unreliable Airspeed Indications”) which was used when an erroneous indication on an airspeed indicator was suspected. In addition, the flight crew members re-activated No.2 DADC and selected it by the display controller on the left seat in response to the situation where the airspeed indications became unreliable (after (e) in Figure 4).</p> <p>At around 20:08, the flight crew members followed the Unreliable Airspeed Indications procedure, requested priority handling of air traffic control, and the aircraft landed at Tokyo International Airport at 20:30.</p> <p>The serious incident occurred at about 19:58 on May 22, 2020, at an altitude of about FL 446 over about 300 km southwest of Tokyo International Airport (near 33° 36 '42” N, 137° 37' 12” E).</p>

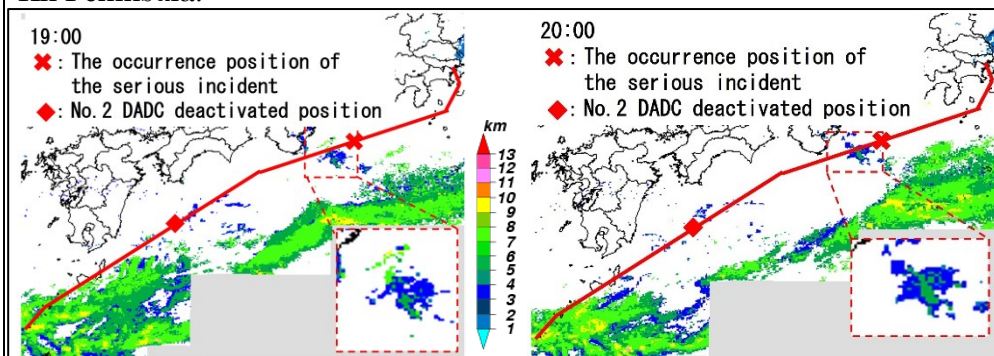
Figure7 Radar Composite Chart (Echo Top Height) (Excerpt)

In the period related to the serious incident, the radar echoes with a cloud top height of 9 to 10 km were observed over the sea south of Kyushu and those with a cloud top height of 7 to 8 km over the sea southeast of the Kii Peninsula.

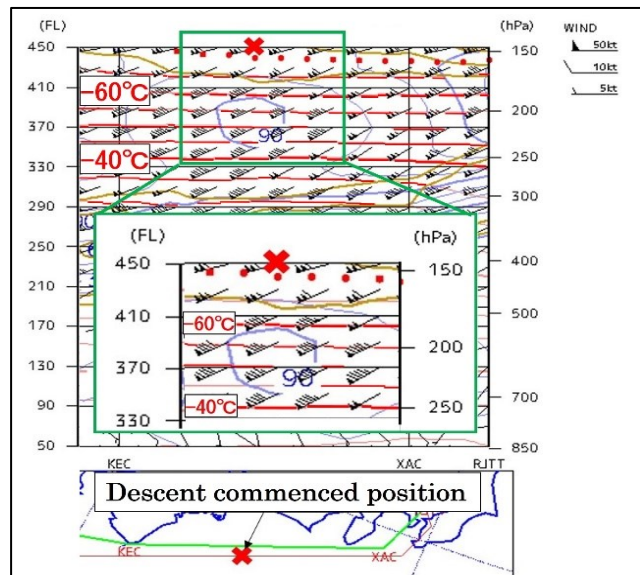
Figure 10 Hourly Analysis at 19:00 (Excerpt)  
(Cross section : Kagoshima—Tokyo )

According to the Hourly Analysis (Cross-section: Kagoshima-Tokyo) at 19:00, there was no remarkable change in wind direction between FL 450 and FL 430 around the estimated commencing descent point, and the wind direction was analyzed at 110 kt at each altitude.

In addition, the temperature was analyzed  $-65^{\circ}\text{C}$  and below at FL 410 and above.

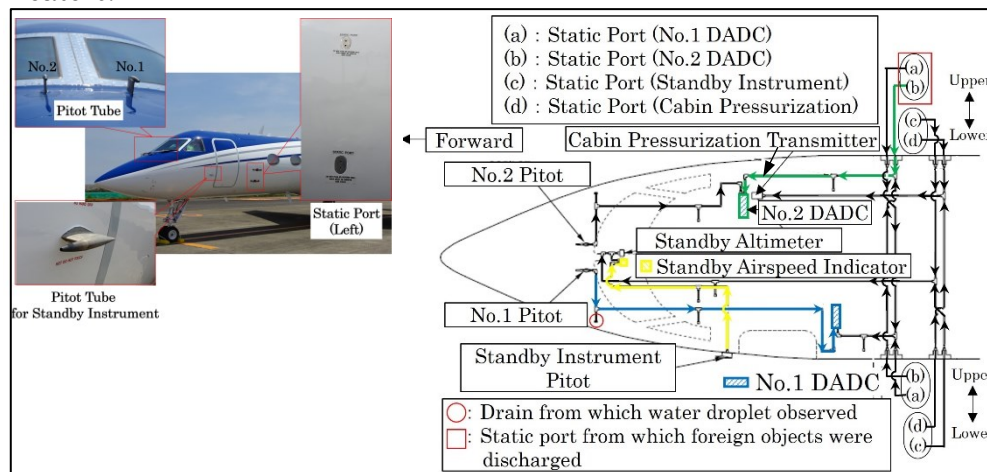
Figure 11 Pitot Static System

Furthermore, each pitot tube is anti-iced by an electric heater operated by a pilot switch, and when the switch is in the OFF position, the switch illuminates "OFF" in amber. In addition, when the switch is set to ON, the CAS message\*8 "L/R/STBY PITOT HT FAIL" will be displayed if the current to the heater falls below the specified value. According to the statements of the flight crew members, each pitot heater switch was set to ON and the message was not displayed. In addition, there is no record regarding the standby pitot tube, but the DFDR did not also record that the message was displayed concerning the left and right pitot tubes.

On the other hand, the four static pressure ports are not equipped with heaters.

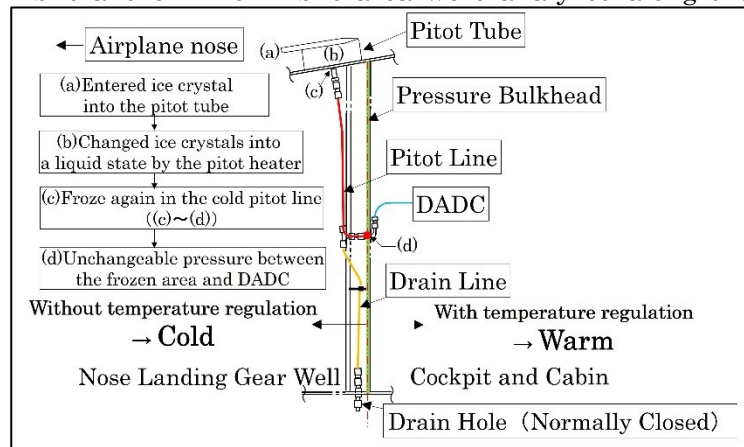
Figure 16 Image of Pitot Line Blockage

Regarding the blockage of the No.1 pitot line, it is possible that because the aircraft flew in the area where ice crystals existed from the fact which water droplets were discharged from its drain hole and cumulonimbus and cumulonimbus area were analyzed along the aircraft's route, ice crystals froze again in the non-temperature controlled portion of the pitot line

after the ice crystals were changed to a liquid state by the pitot heater when they had entered the pitot tube. Regarding the time when ice crystals infiltrated the Pitot tube, it is likely in the cruise before the aircraft started the descent because very little change in

speed during the cruise and the decrease in speed with the rise of static pressure just after starting descent were recorded on the DFDR.
