AIRCRAFT ACCIDENT INVESTIGATION REPORT

AIRCRAFT DAMAGE DURING TAKE-OFF

BOEING 747-400F, N404KZ (USA REGISTRY)

NARITA INTERNATIONAL AIRPORT

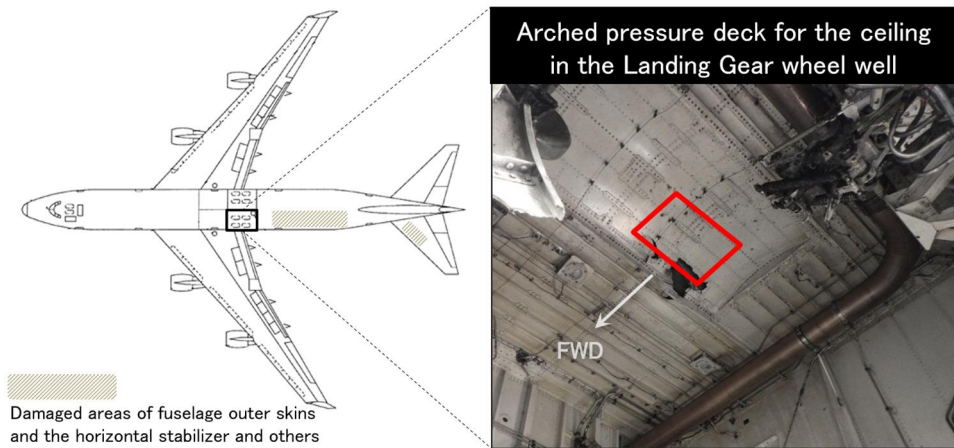
Figure 3: Damage Applicable to Major Repairs

2.2 Injuries to Persons	None
2.3 Damage to the Aircraft	<p>Extent of damage: Substantial</p> <ul style="list-style-type: none"> • Arched pressure deck for the ceiling in the landing gear wheel well was punctured by about 25 cm (about 10 in) from front to back and by about 38 cm (about 15 in) from left to right (this is applicable to major repairs: see Figure 3). • The Landing Gear’s No. 7 and No. 8 wheel assemblies were damaged. • The hydraulic system components of the Landing Gear’s shock strut were broken and buckled. • The Landing Gear’s door was partially missing. • There were about 80 cracks and dents of various sizes were found on the outer skins of the left lower fuselage, and the left horizontal stabilizer.

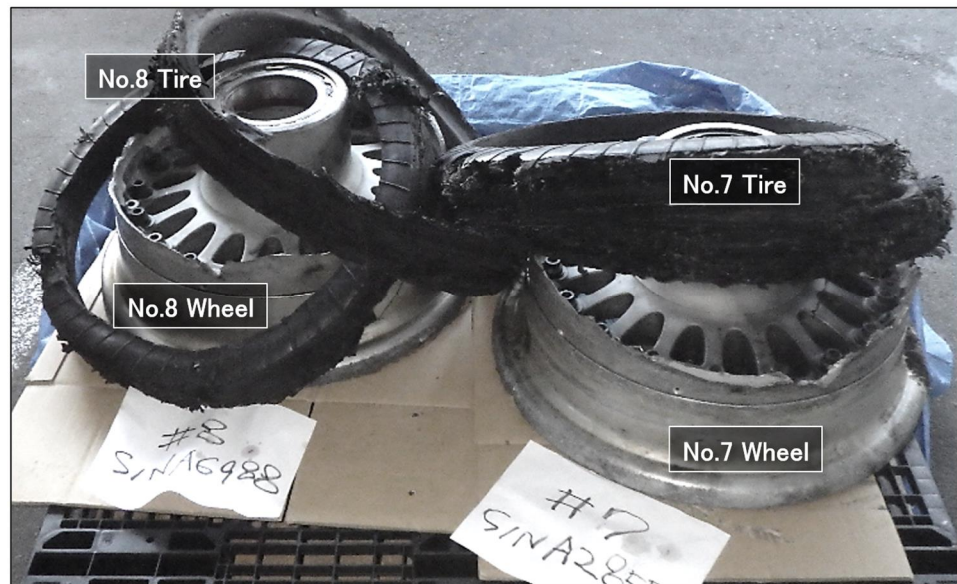
Figure 6: Damage to No.7 and No. 8 Wheel Assemblies

No. 7 and No. 8 (hereinafter referred to as the No.7 Tire and the No. 8 Tire, respectively) were damaged, with their detached components scattered across the runway and others.

According to the results of the investigation into the damaged the No.7 Tire and No. 8 Tire, which were sent to the equipment manufacturing company for analysis, manufacturing failures were not found in the retrieved components. It was also reported that the adhesion of the replacement surface during remolding (retreading: replacing the tread ply of the tire with a new one) was sufficient. In addition, the No.7 Tire showed signs of overall damage, including numerous exfoliations of the tread ply and nylon dissolution. However, such damage to the joint surface and others, as observed on the No.7 Tire, was not confirmed for the No. 8 Tire.

The JTSB concluded that, as debris from the aircraft wheels was found inside of the damaged arched pressure deck for the ceiling in the Landing Gear wheel well, when the Landing Gear was retracted during take-off, this debris most likely fractured and hit the arched pressure deck for the ceiling in the Landing Gear wheel well.

It is highly probable that, in this accident, as the aircraft continued to taxi with the No.7 Tire damaged, debris from the No.7 Tire damaged the Landing Gear brakes and its hydraulic system tubes, in addition, the components of the aircraft wheels were more likely to break and scatter from the damaged wheels, damaging the arched pressure deck for the ceiling in the Landing Gear wheel well. This resulted in the EICAS message indicating the high cabin pressure altitude.

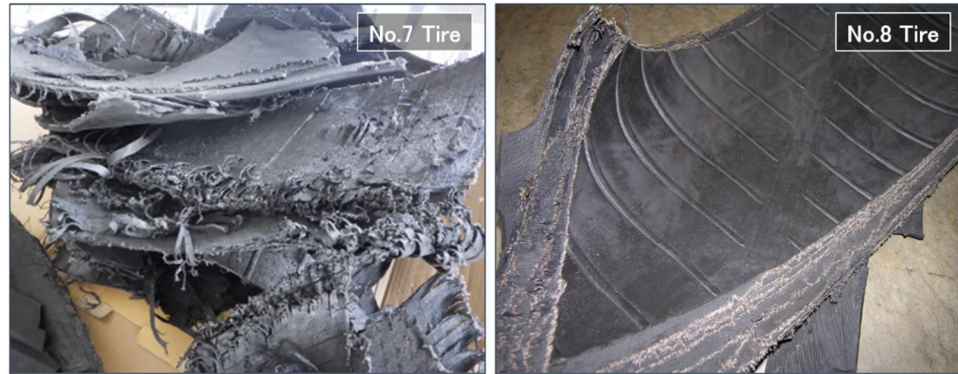
Figure 7: Damage to No.7 and No. 8 Tires

The No. 7 Tire had been remolded twice and was installed on the aircraft on June 21, 2024. Up to the time of this accident, it had undergone 89 cycles. And the No. 8 Tire had been remolded once and installed on the aircraft on August 9, 2024. Up to the time of this accident, it had undergone two cycles.

Regarding the No. 7 tire, the JTSB concludes that from the video records, some material that appeared to be part of the tire was rotating in sync with the No. 7 wheel, and there was also a “banging” sound, or something like an explosive sound, therefore the No. 7 Tire most likely burst while the aircraft was taxiing around W6 to W5 on Taxiway A.

Besides, the No.7 Tire was damaged overall, including numerous exfoliations of the tread ply and nylon dissolution. The contact patch was therefore flattened due to the insufficient tire pressure, and the load on the area between the tread ply of the tire and its sidewalls caused cracks in the tread ply, which most likely progressed to cause the damage.

On the other hand, almost no tread ply wear was observed on the No. 8 Tire. However, it is possible that the damage to the No. 7 Tire caused the No. 8 Tire to carry a greater load and bend, in addition, fragments of the No.7 Tire and debris left in the wheels would have damaged the No.8 Tire.

Regarding the damage to the No.8 Tire, it is possible that the pressure in the No.7 Tire was reduced, accordingly which caused the No. 8 Tire to carry a greater load and bend, in addition, the fragments of the No.7 Tire and debris left in the wheels damaged the No.8 Tire.

As for the cause of damage to the No.7 Tire, it is likely that the pressure in the No.7 Tire was reduced, however, the cause of this reduction could not be identified.

5.1 Safety Actions Required	It is desirable to appropriately identify trends in reducing tire pressure, leading to replacing the tire or searching for the cause of the failure. To this end, equipping aircraft with TPIS is effective, as it enables flight crew members to recognize abnormal tire pressure as soon as it occurs.
5.2 Safety Actions Taken after the Accident	After the accident, the company added the following changes to the tire pressure check items in the maintenance work instructions for daily periodic inspections.

<ul style="list-style-type: none"> a. As a general rule, the tire pressure checks should be conducted on cold tires in a stabilized temperature environment (i.e. after more than two hours have passed since the aeroplane was blocked in.) b. The work card should directly list the allowable tire pressure limits for hot and cold tire conditions, respectively. c. They deleted the item, stating that replacing the wheel assembly could be postponed, if replacing its tires or brakes would cause delays to flight operations. d. They specified clearly in the work card that when the tread ply (radial) is exfoliated or carcass ply (bias) is exposed at any location, these tires are not serviceable and must be replaced. e. They revised the maintenance document to be entered the daily check results for the electronic recordkeeping (maintenance management) system to make the tire pressure inspections results are traceable. f. They added the item to the work card to check wheels for missing tire bolts or nuts during tire and wheel checks. g. They made a requirement to record the tool traceability number and calibration date of the used tire pressure gauge for the daily check. h. They prohibited the use of remolded tires on Wheel Positions No.7, 8, 11 and 12 (see Figure 4).

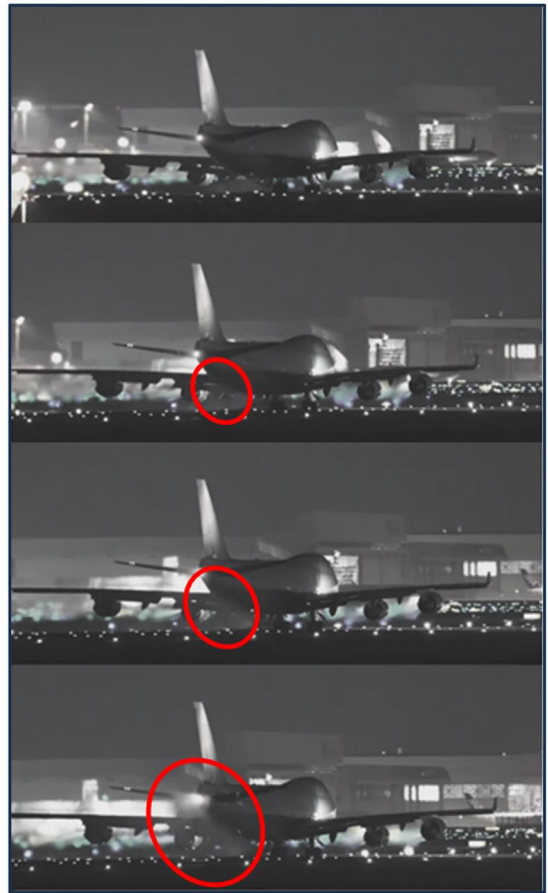
Figure 9: The Aircraft during its Take-off Roll

Besides, the video recorded thin, spray-like white smoke rising from the vicinity of the landing gear while the aircraft was executing a take-off roll, accompanied by what appeared to be a banging sound.

The video recordings confirmed that while thin, spray-like white smoke (see Figure 9) was rising while the aircraft was executing a take-off roll, it is therefore most likely that the brake hydraulic system tubes were damaged at this time, resulting in subsequent hydraulic system failures.
