AIRCRAFT ACCIDENT INVESTIGATION REPORT

Northwest Airlines
Boeing 747-251B N637US
New Tokyo International Airport
March 1, 1994

November 29, 1996

AIRCRAFT ACCIDENT INVESTIGATION COMMISSION

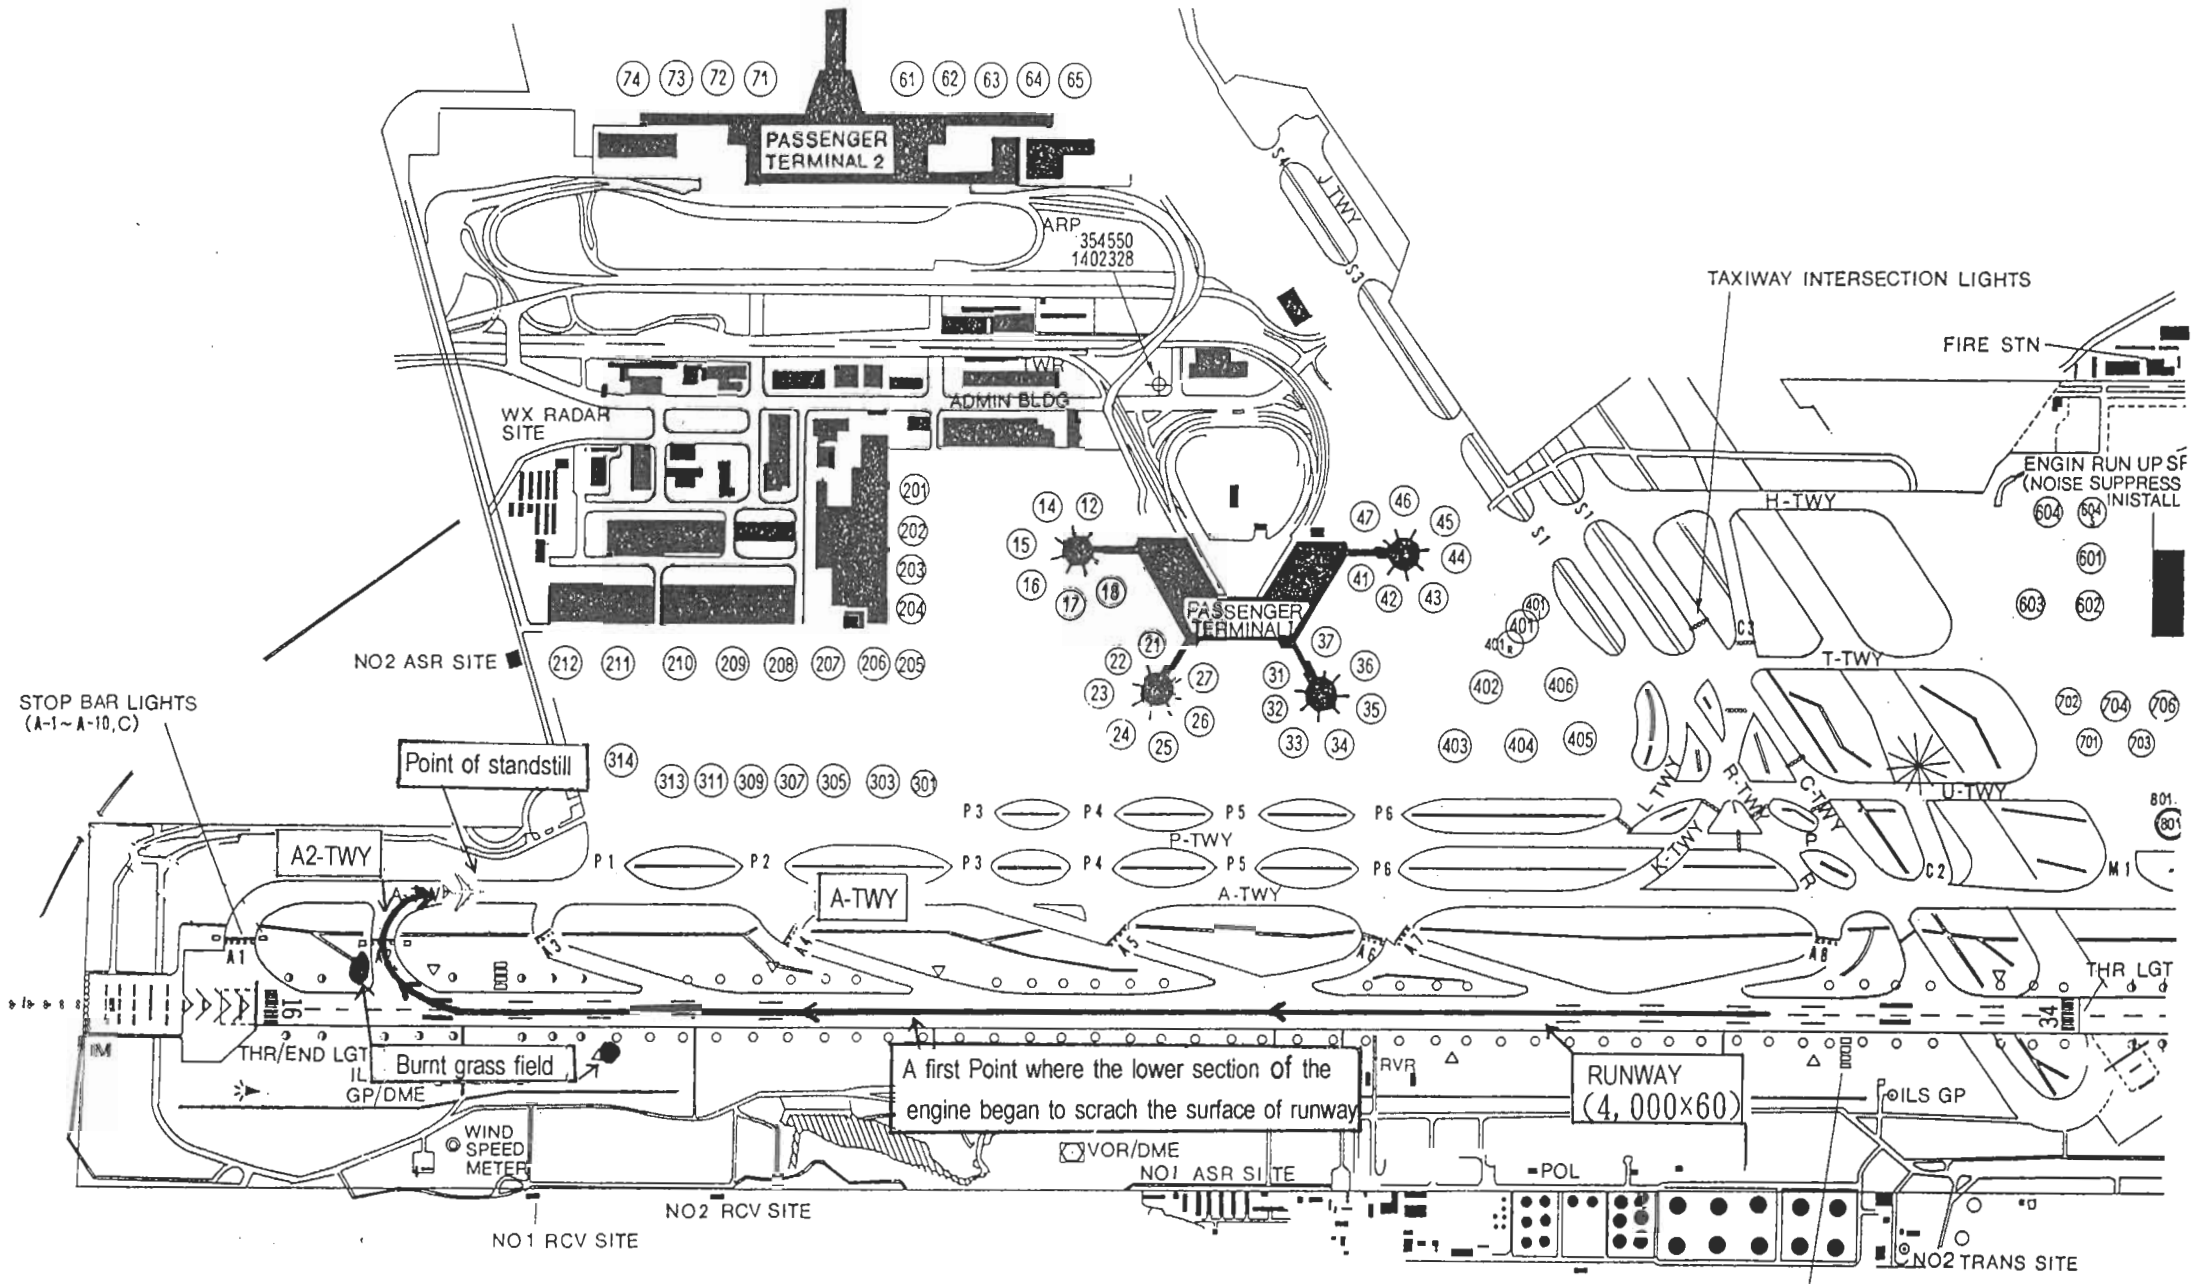
Figure 1 Ground Track of The Aircraft

On the runway were noted scratch marks approximately 2.5 m wide and approximately 1,060 m long reaching Taxiway A2 caused by dragging of the forward portion of No.1 engine cowling along the runway, and similar marks reaching the location where the aircraft sat were also found on Taxiway A2 and Taxiway A.

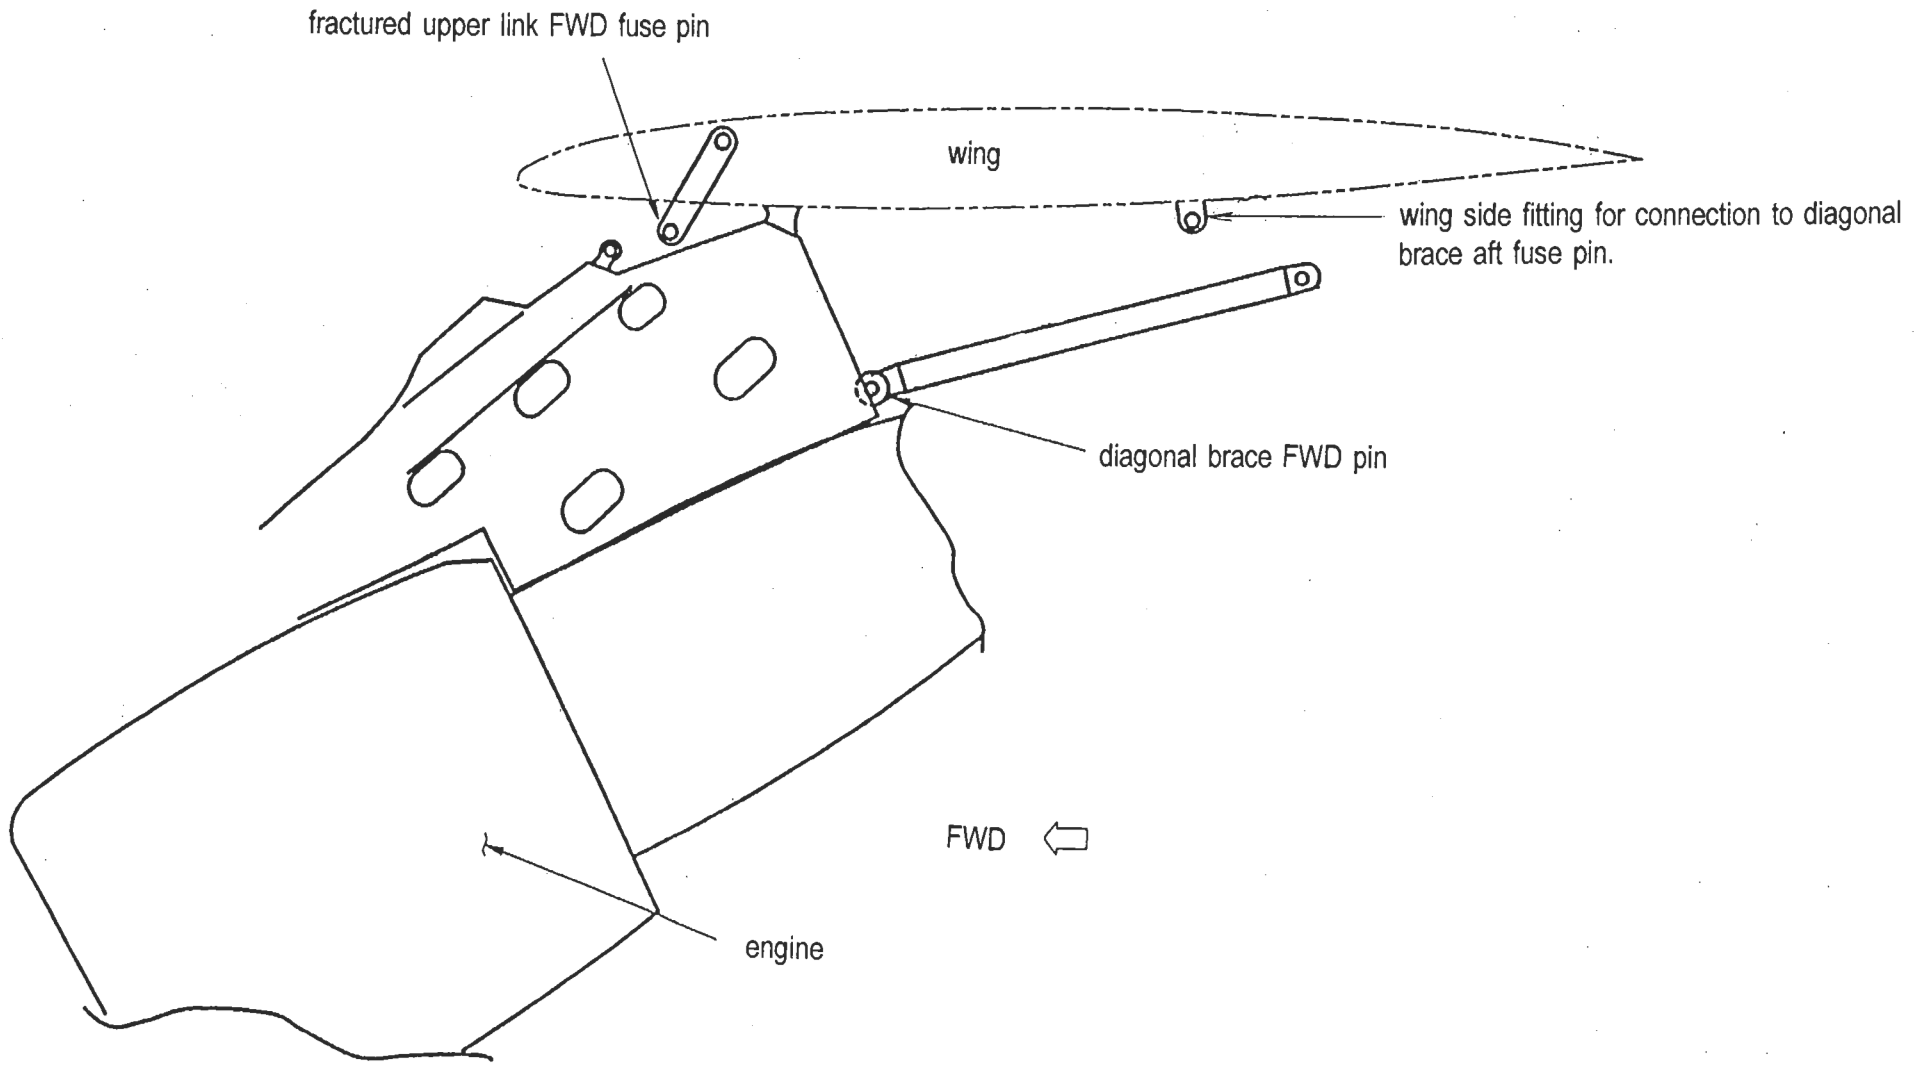
Figure 3 Schematic of No.1 Engine Nacelle Strut

It was noted that No.1 engine of the aircraft dangled with the mid-spar fitting as the fulcrum, touching the ground as the upper link which served as the attachment of the nacelle strut to the wing was disconnected at the forward joint due to the fracture of the forward fuse pin, and diagonal brace was disconnected at the aft joint as the aft fuse pin slipped out. (See Figure 3 and Photos 1, 2 and 3)

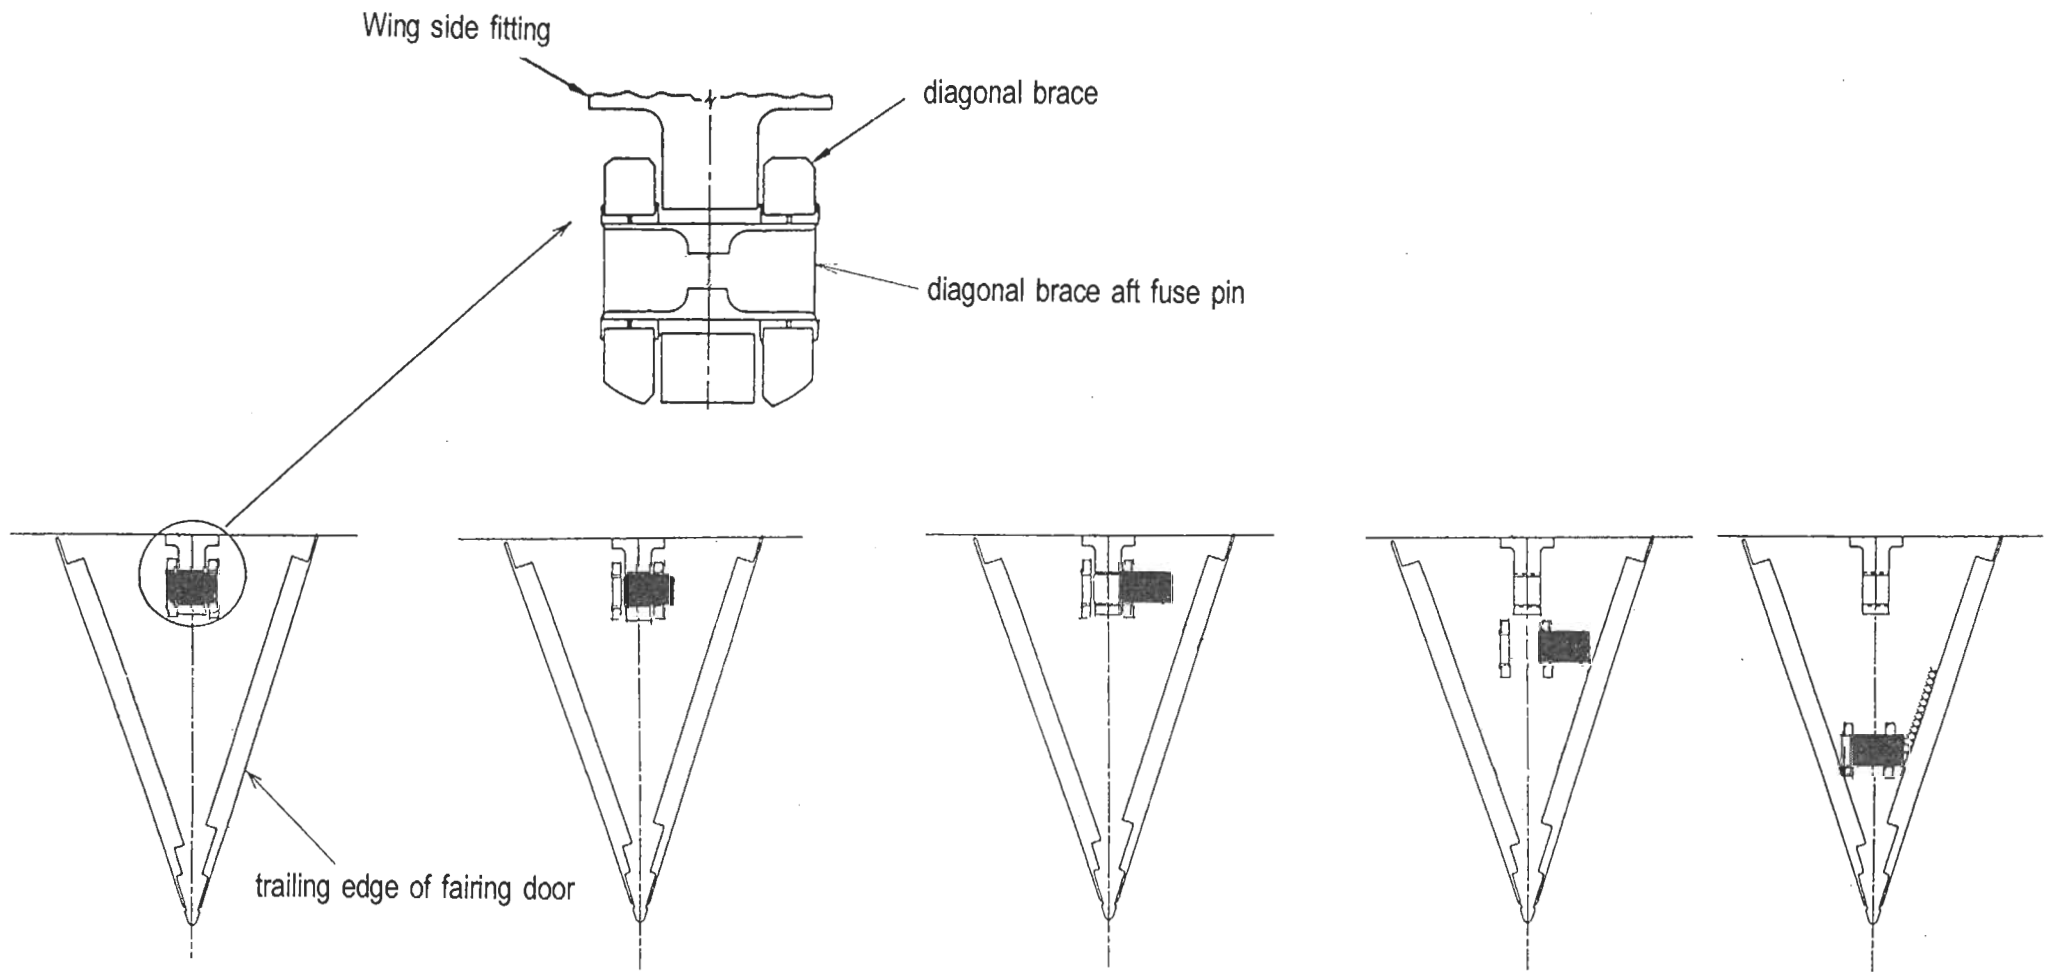
Figure 5 Sequence of Slipping of Diagonal Brace Aft Fuse Pin

The diagonal brace was found disconnected at the aft joint, and the aft portion was found in the trailing edge fairing. The aft joint fuse pin was found, inserted halfway into the brace lug. (See Figure 5 and Photo 4)

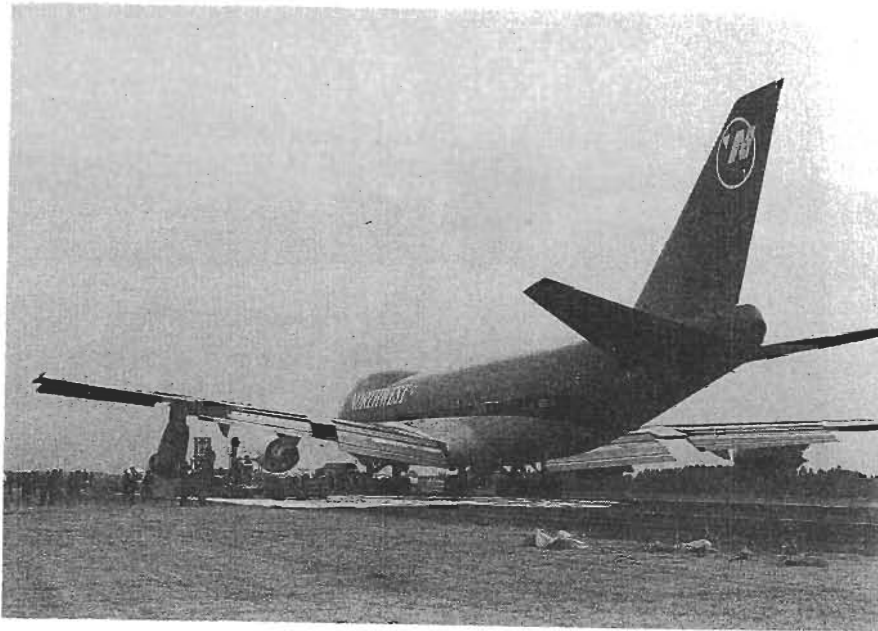
Photo.1. The Aircraft involved in The Accident

The damage to parts of the aircraft were as follows: (See Photos 1~6)

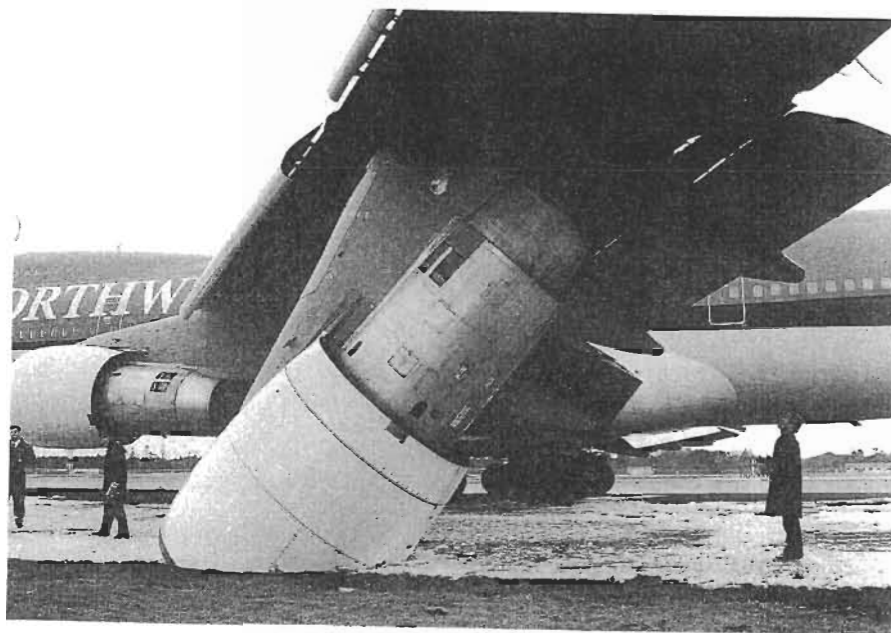
Photo.2 No.1 Engine of The Aircraft involved

Damage due to the dragging against the ground during the landing roll and the rollout after it, was noticed on the lower portion of the engine nose cowl and both left and right fan cowl panels.

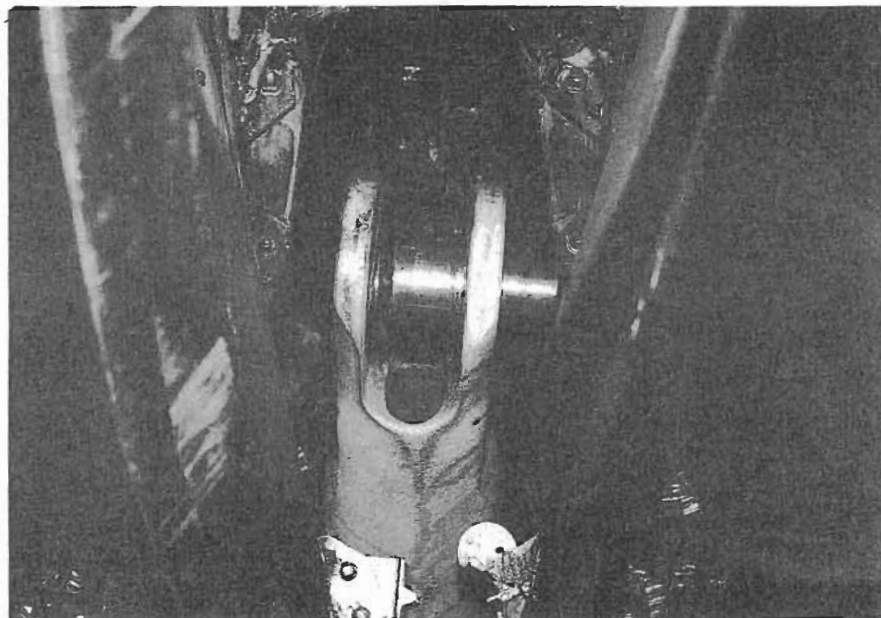
Photo.4 Aft Fuse Pin and Aft Portion of No.1 Nacelle Strut Diagonal Brace

Both primary retainer and secondary retainer were not found either in the aircraft or in its vicinity, and an extensive search of the runway, taxiway and grassy land also failed to find them.

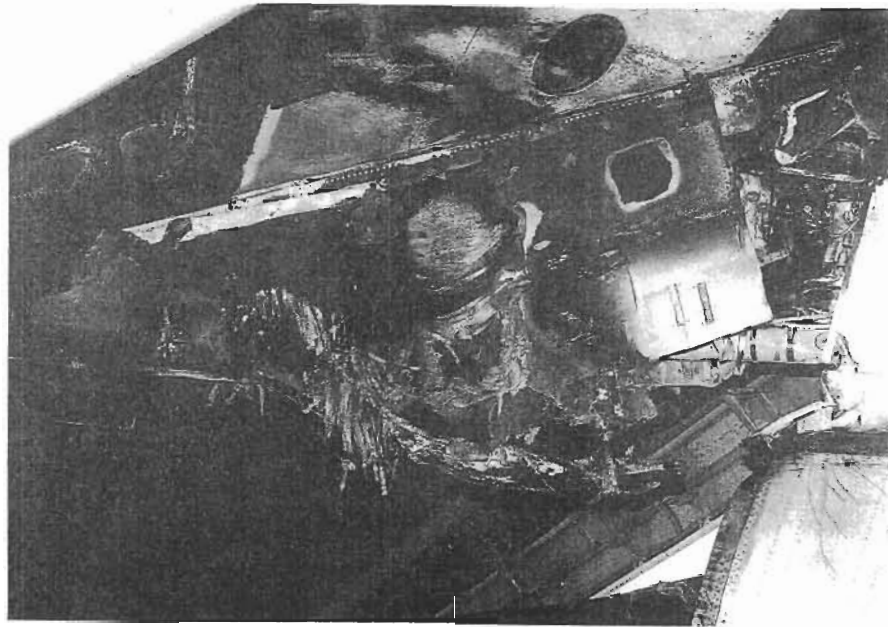
Photo.5 Burnt No.1 Nacelle Strut Trailing Edge Fairing

The primary retainer of the fuse pin is an assembly consisting of a cap, a bolt and a nut. As the fuse pin was fractured, the bolt was fractured into 3 parts. The cap and the broken bolt were found in the strut, still attached to the fuse pin. (See Figure 4 and Photos 5 and 6)

⑥ Damage to No.1 Nacelle Strut, its Vicinity and other Parts (See Photo 5)

★ The side brace was fractured at the strut side joint.

★ It was noted that the return line pipe located in the reservoir tank

of No.1 hydraulic system was broken, damaging the tank and resulting in the loss of all hydraulic oil. It is estimated that this damage was caused by the drooping of the forward portion of the nacelle strut. It was also found burnt.

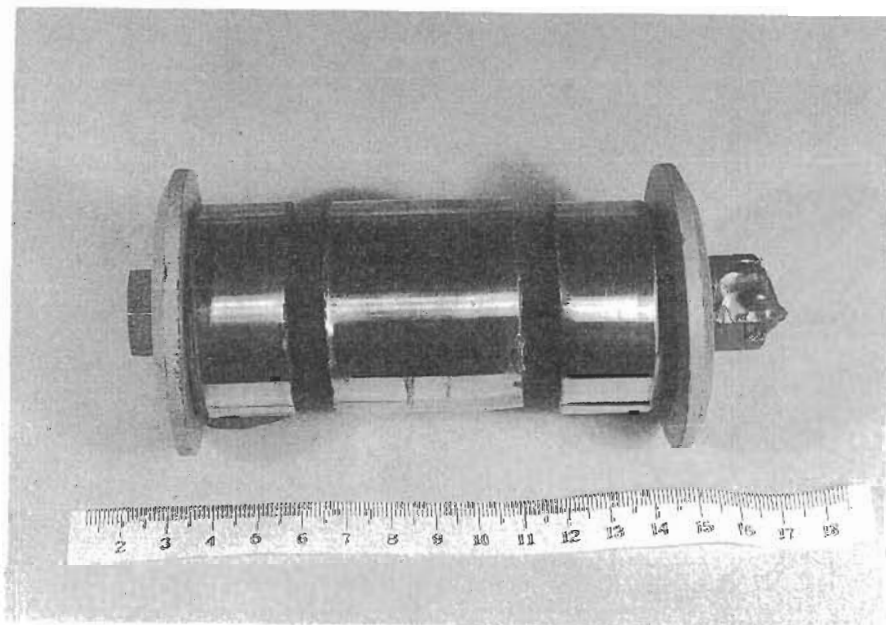
Photo.6 Fractured Upper Link Forward Fuse Pin

The forward fuse pin was fractured into 3 parts. The center part was found attached to the rear mount bulkhead fitting and 2 other parts, separated from the upper link, were found in the strut.

The center part of the bolt was missing and this fragment was not found since it was a small fragment with a diameter approximately 12 mm and 40 mm long in spite of a search of an extensive area of the runway, taxiway and grassy land.

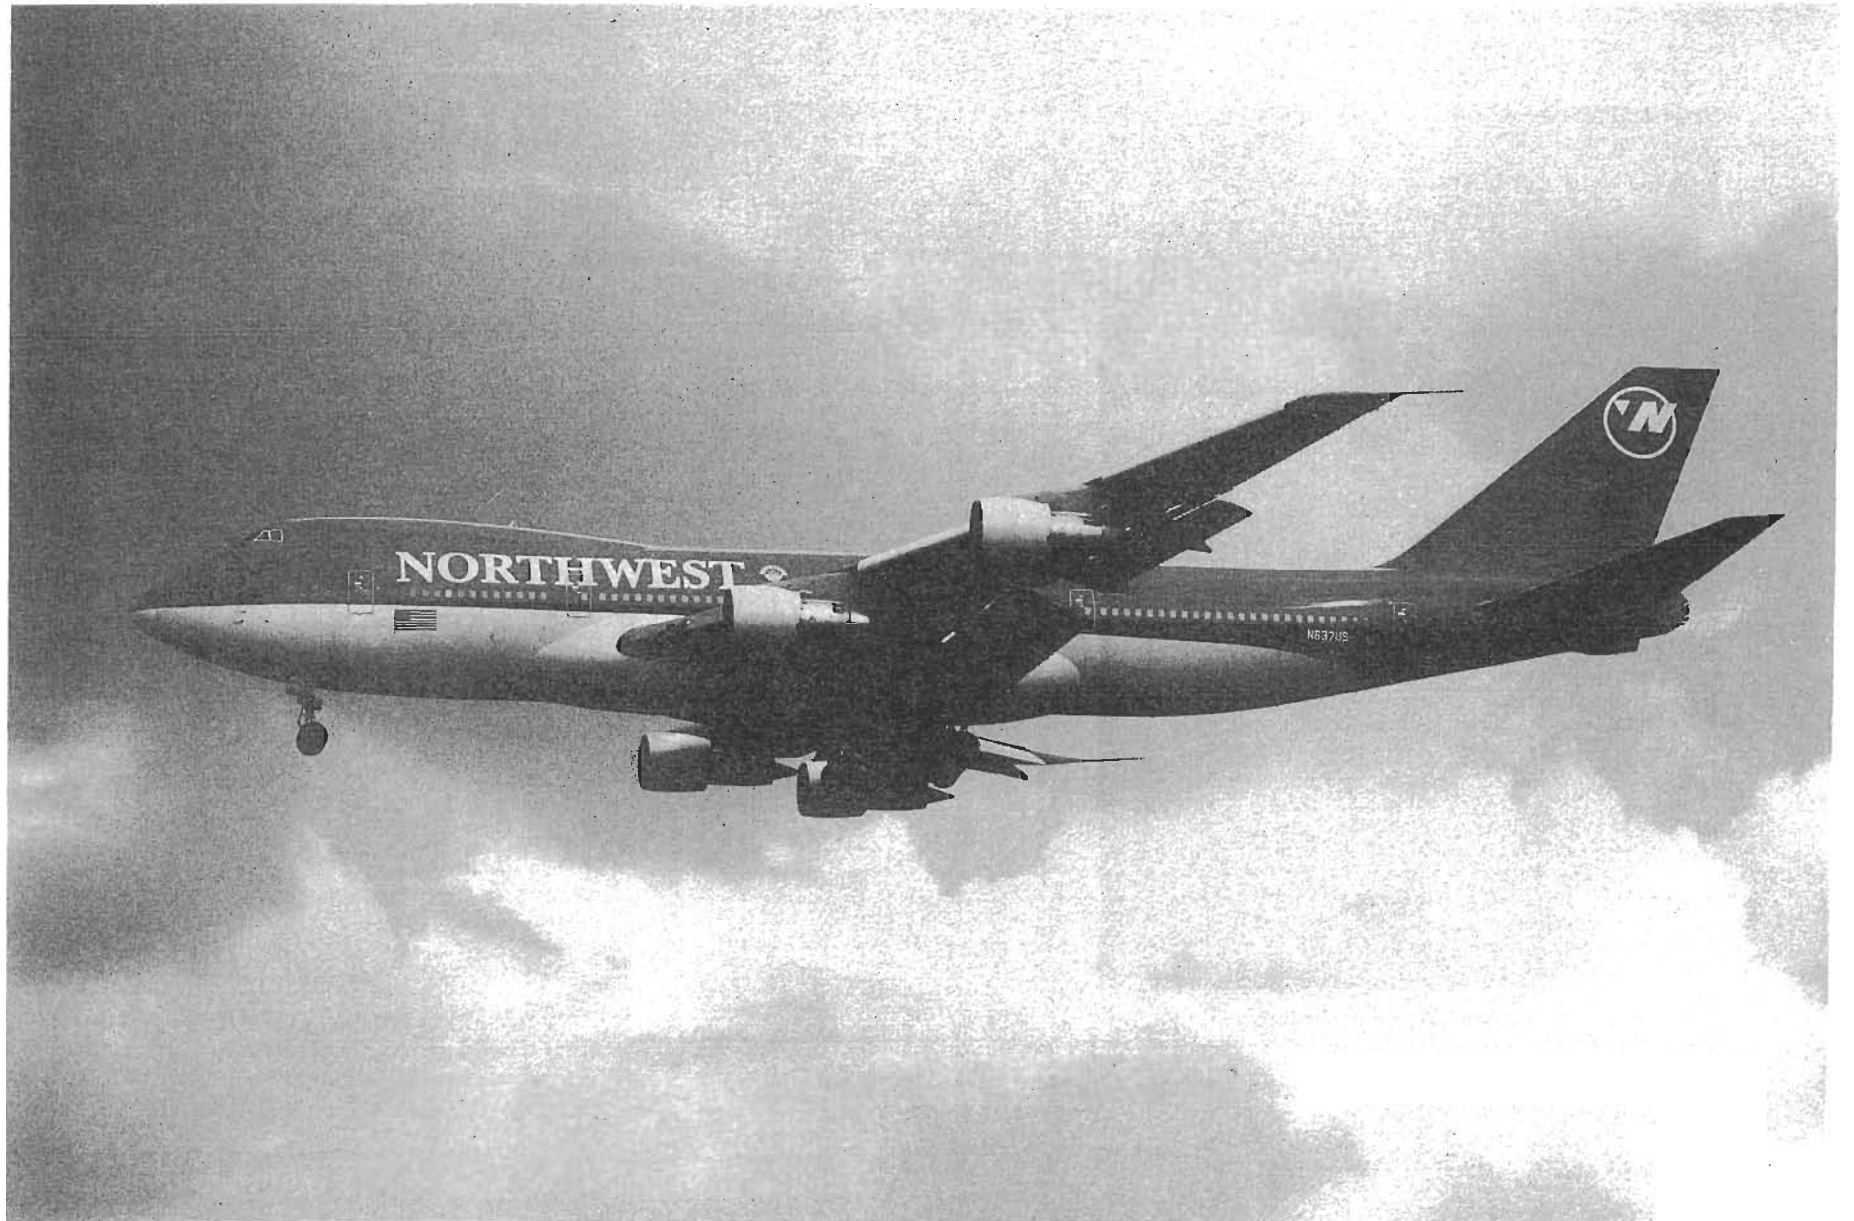
Photo.7 The Aircraft involved approaching New Tokyo International Airport

According to a person who saw the aircraft approaching for landing, the aircraft did not look abnormal outside, and a photo taken at that time also did not show unusual conditions around No.1 engine etc. (See Photo 7)

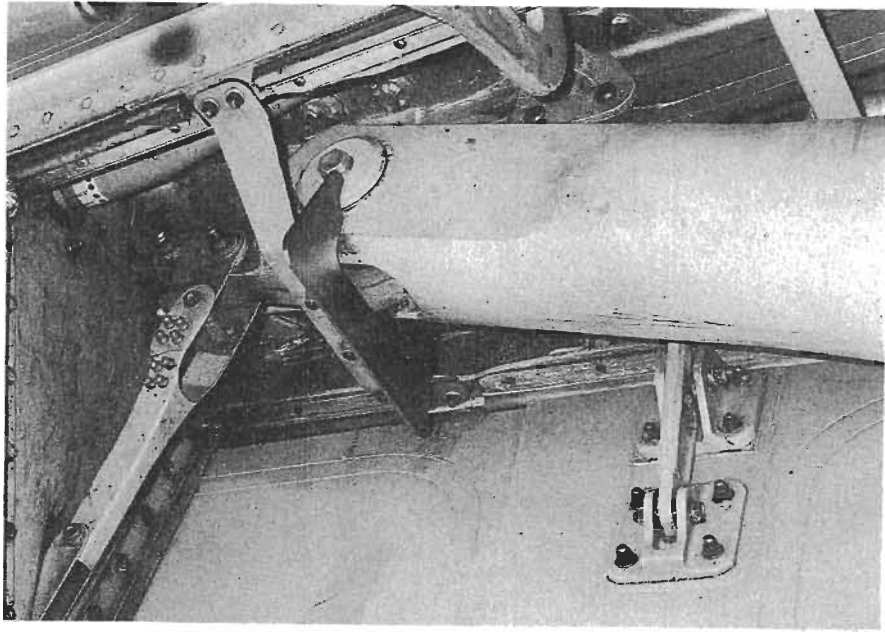
Photo.8 Secondary Retainer

At about 9 o'clock of March 1 (local time), one of the mechanics engaged in the maintenance found a white sack near a hand rail of the under-wing work stand in which was contained a primary retainer set and to which was tied the secondary retainer with wire.

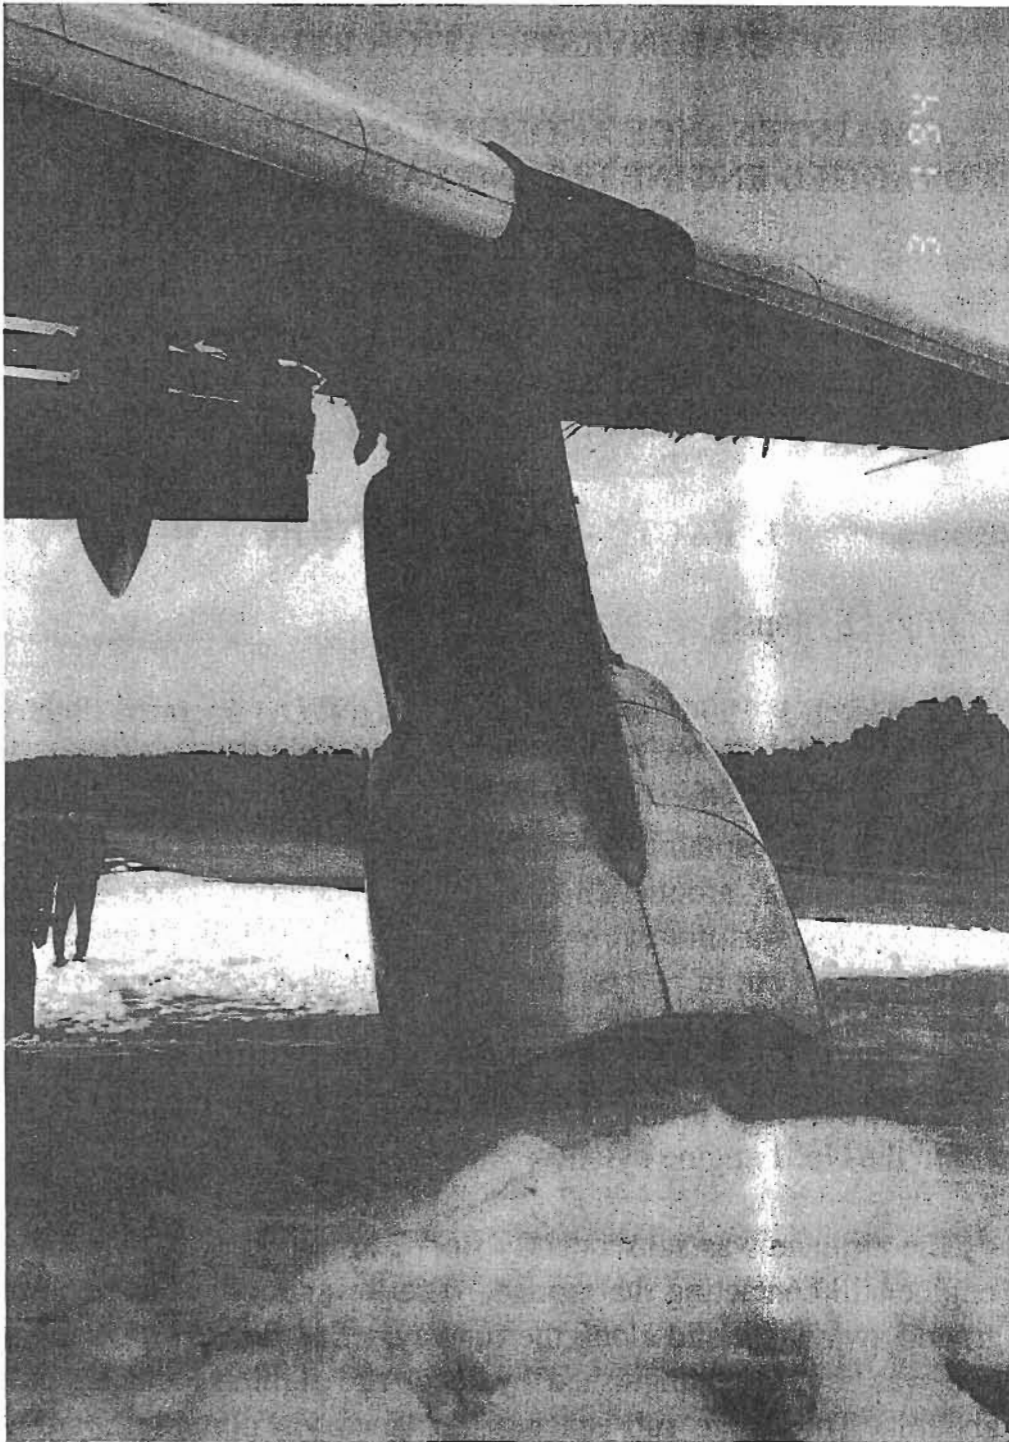
Figure 1.--No. 1 engine.

The airplane was subsequently stopped on a taxiway, with the front of the No. 1 engine still contacting the ground. The lower forward engine nose cowl had been ground away as it slid along the runway. (See figure 1). A fire near the No. 1 engine was rapidly extinguished by local fire fighters, and all passengers remained aboard. They were subsequently deplaned via portable boarding stairs about 30 minutes after the airplane was brought to a stop. There were no injuries.
