AA2011-12

**AIRCRAFT ACCIDENT  
INVESTIGATION REPORT**

**Japan Transport Safety Board**

**NORTHWEST AIRLINES INCORPORATED  
BOEING 747-400, N676NW (THE UNITED STATES OF AMERICA)  
IN THE AIR ABOUT 174 KM SOUTH-SOUTHWEST OF NARITA  
INTERNATIONAL AIRPORT  
AROUND 11:45 JST, FEBRUARY 20, 2009**

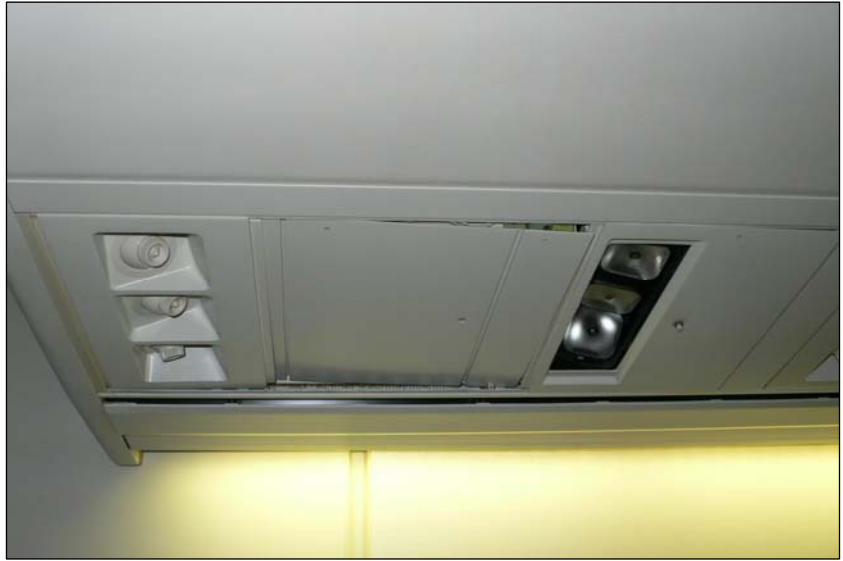
Cabin ceiling

(1) Damage to the cabin ceilings above the following seats.

Scratches: Seat 21B, Seat 59J

Wrinkles, dents: Seat 41B, Seat 62H

Detached panels, dents: Seat 51K, Seat 55J

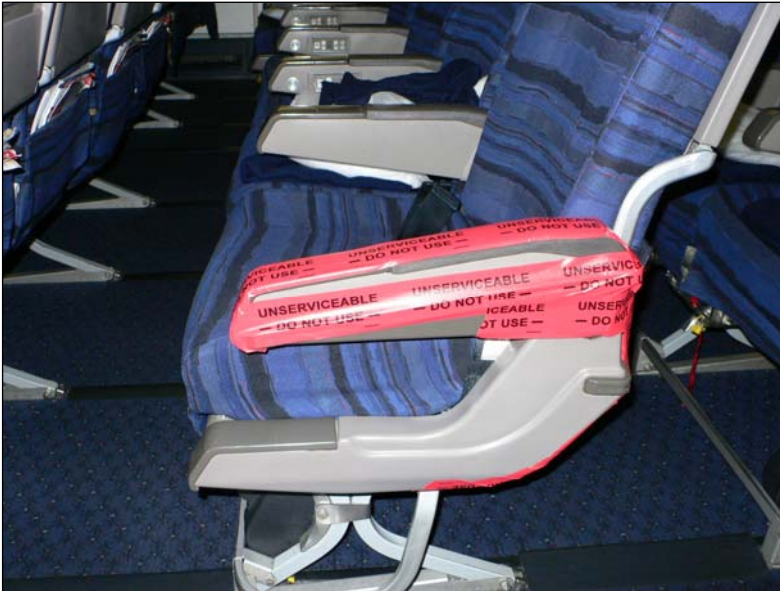
Armrest

(2) Damage to the seats

Armrests: Seat 40D, Seat 57B, Seat 58G, Seat 66G
