AIRCRAFT SERIOUS INCIDENT INVESTIGATION REPORT

KALITTA AIR (USA)
BOEING 747-200B, N714CK
APPROXIMATELY 3 km SOUTH OF NEW CHITOSE AIRPORT,
AT AN ALTITUDE OF APPROXIMATELY 1,300 ft
AROUND 10:52 JST, JULY 4, 2005

May 25, 2007

Aircraft and Railway Accidents Investigation Commission
Ministry of Land, Infrastructure and Transport

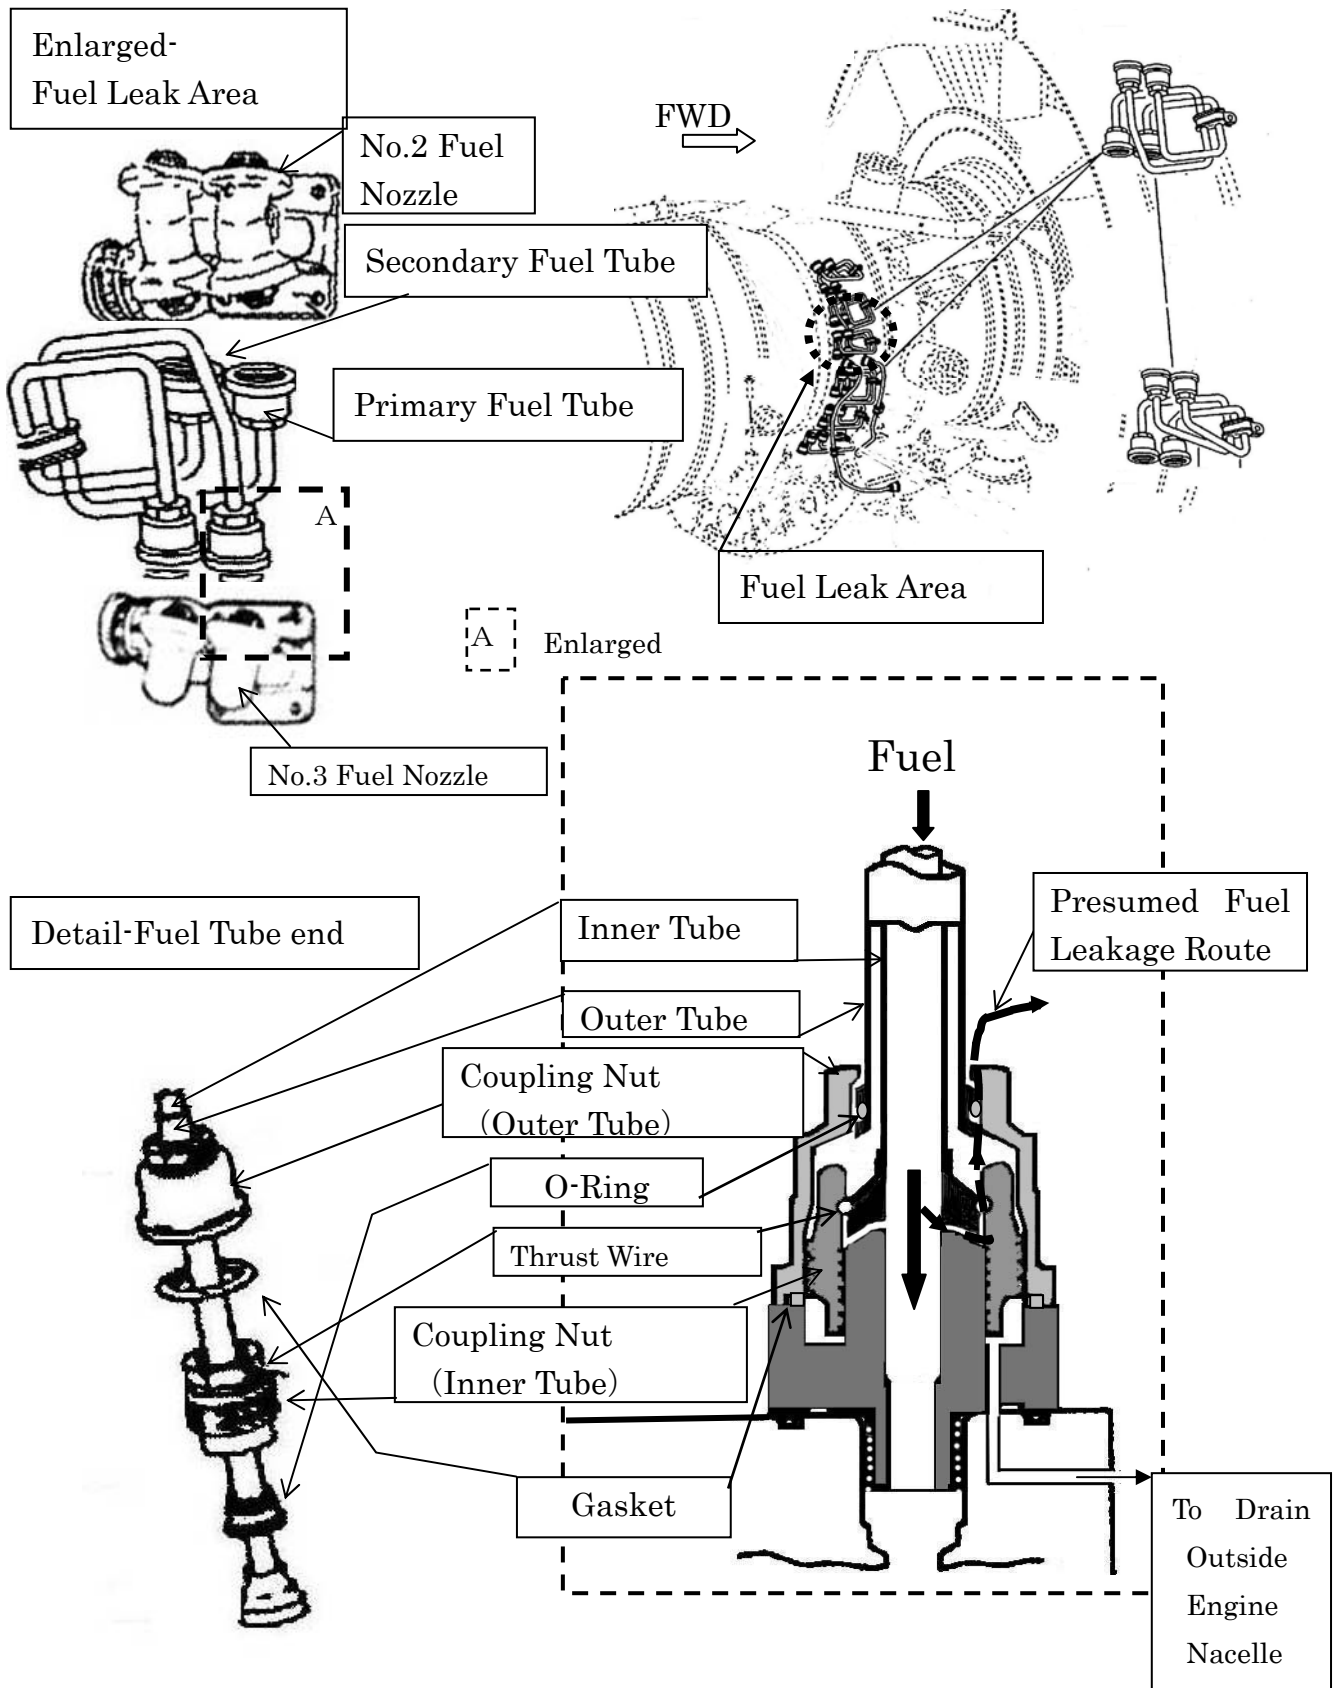
Figure 3 Fuel Tube Section View

A fit check of the event primary and secondary fuel tubes was performed. When the primary fuel tube was connected to the No. 2 nozzle a misalignment/gap at the opposite end of the tube was confirmed as 9 mm (0.35 in) between the No. 3 fuel nozzle and its mating primary tube end.

It is estimated that this caused fuel to leak past the conical seat interface of the inner tube to No. 3 fuel nozzle joint and then the leaked fuel was injected into the engine nacelle due to incomplete sealing between the O-ring attachment area and the coupling nut of the outer fuel tube, resulting in the ignition of fuel when it contacted the hot section of the engine case.

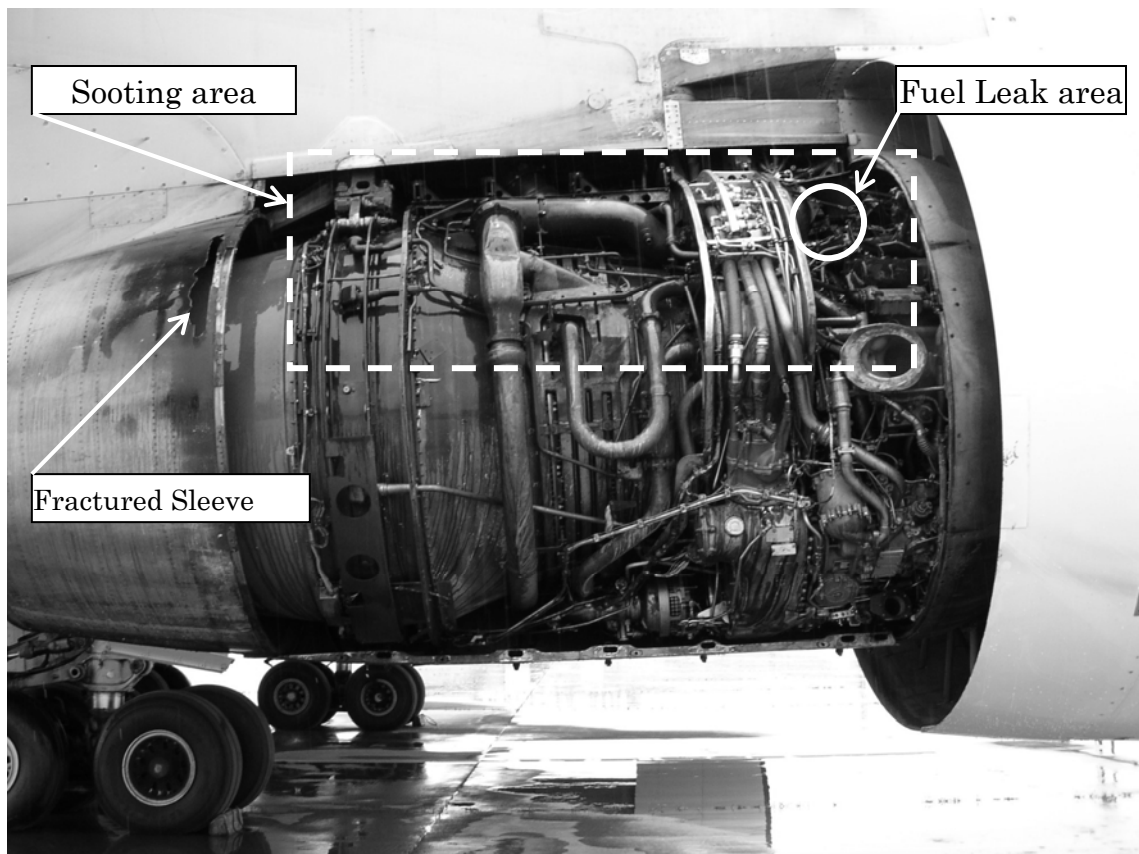
Photograph 2 No.3 Engine Right Hand Side

Deformed and broken areas were found on the engine cowling right side.

Part of the inside frame of the cowling and the hinge fittings attaching the cowling were found broken.

high-pressure turbine of the engine exhibited sooting. Damage was found on the electric cables, tubes, and other parts around the area. The turbine sleeve at the aft part of the engine had an open hole in its right upper portion, measuring approximately 75 cm in length and approximately 10 cm in width.

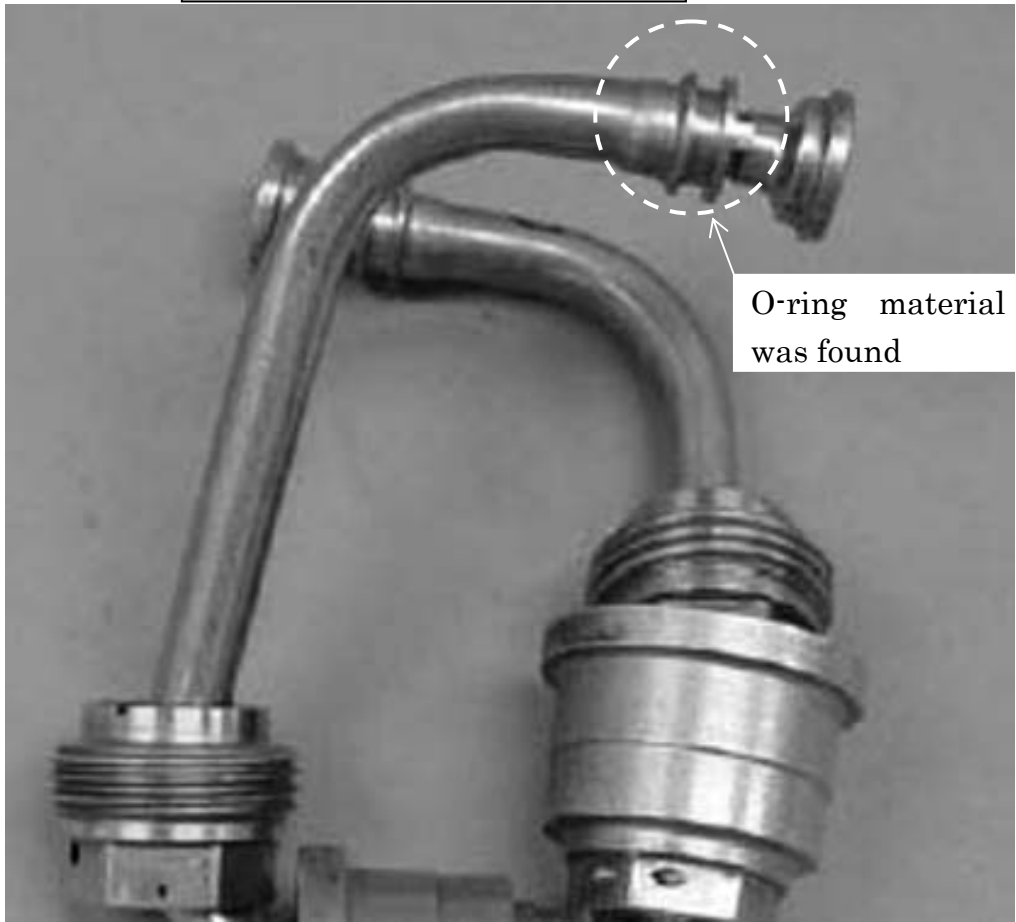
Photograph 3 Fuel Tube Ends connecting
to No.3 Fuel Nozzle

3) At the primary fuel tube end connecting to the No. 3 fuel nozzle, there existed a slight amount of flame-heat-affected material in the O-ring fitting area on the outer tube but there was no visible contamination around it. The material was found to be coincided with the O-ring material. The O-ring itself was not found. On the other hand, at the secondary fuel tube end adjacent to that, there was a burnt O-ring remaining in the O-ring fitting area of the outer tube.

Fuel Leaking Primary Tube

O-ring material
was found

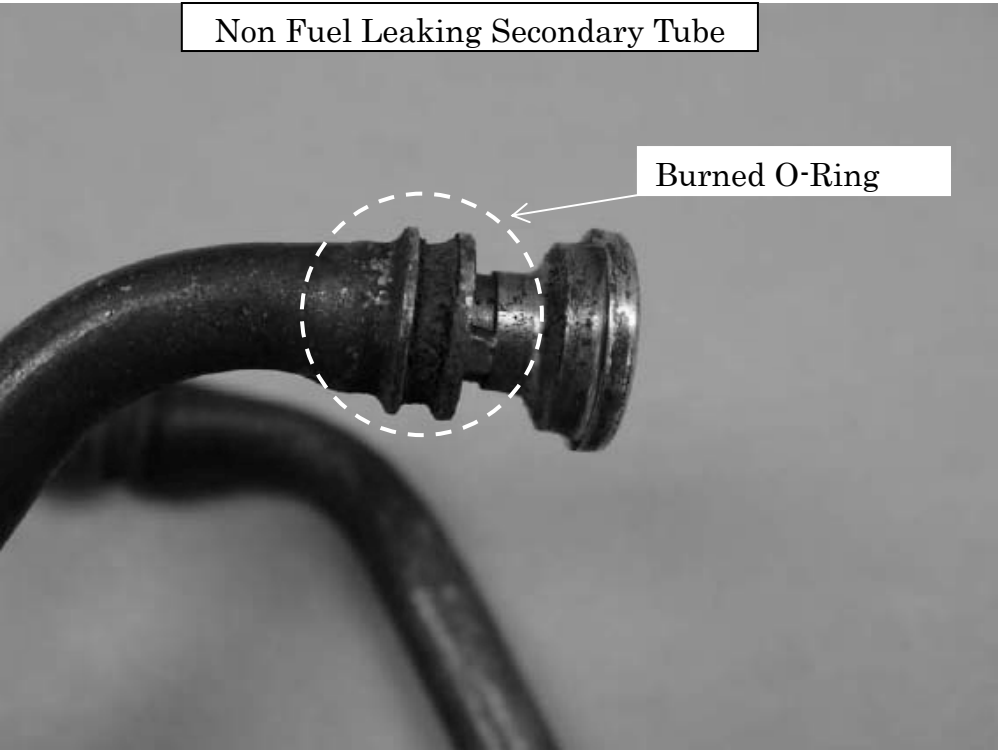
Non Fuel Leaking Secondary Tube

Burned O-Ring

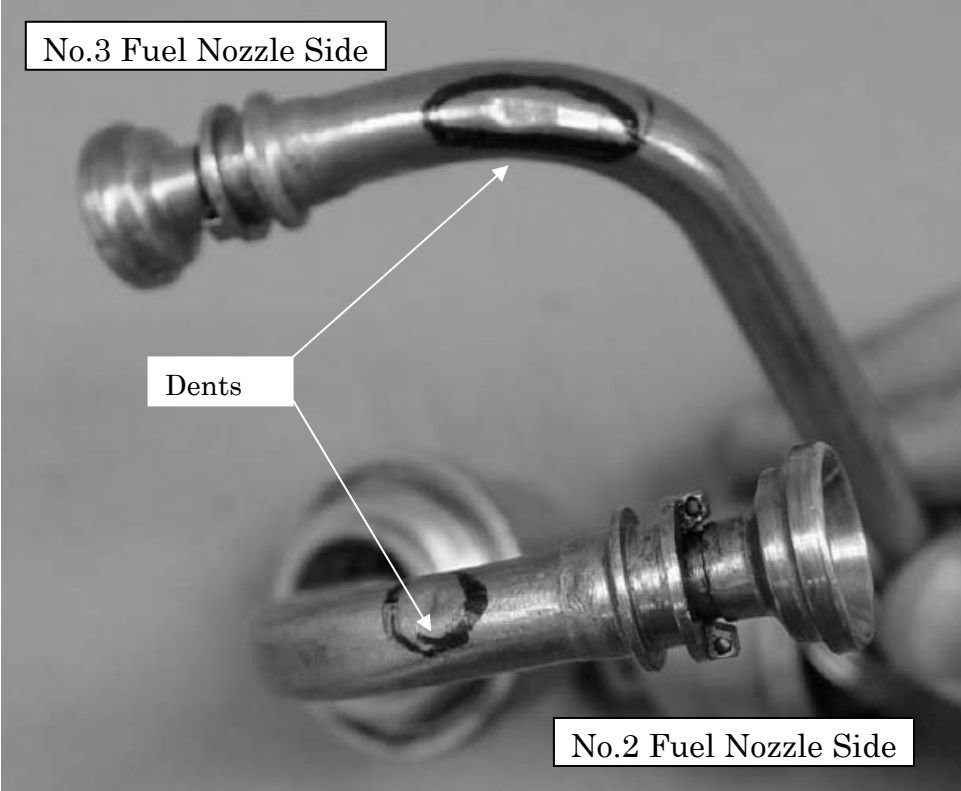
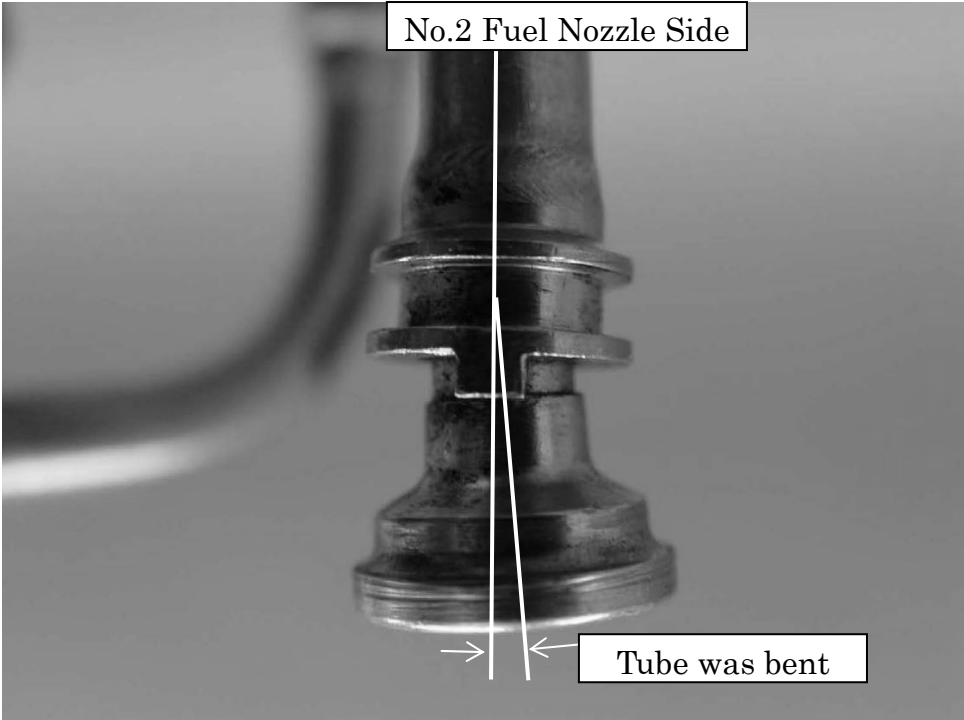
Photograph 4 Deformation of Primary Fuel Tube End

1) The primary tube coupling the No. 2 and No. 3 fuel nozzles exhibited dents on its external surface in the areas near both ends. At the primary fuel tube end connecting to the No. 2 fuel nozzle, tube was bent of the inner tube axis was confirmed to the reference of the outer tube axis. The end of the inner tube had no damage on either the inner or outer surfaces.

As described in 2.9.3, the dents on the fuel tube and the slant angle in the attachment area are not considered to have occurred after installation on the engine but it is considered possible to have occurred during the replacement work of the engine's fuel nozzles. However, it could not be determined when it occurred.

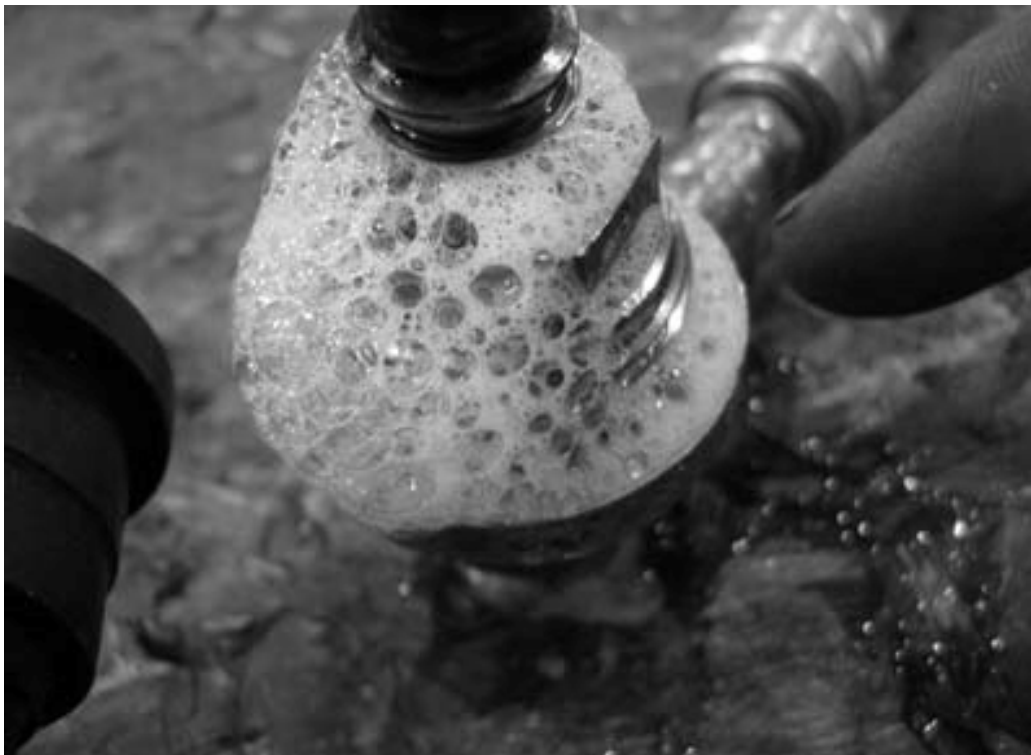
Photograph 6 Leak check at Primary Fuel Tube
attachment area connecting to No.3 Fuel Nozzle

Based on the check results mentioned in 2.9.1, an inspection was performed using compressed air and a soap and water solution on the primary and secondary fuel tubes that had been connected to the No. 2 and No. 3 fuel nozzles. This inspection confirmed an air leak near the No. 3 fuel nozzle and primary fuel tube interface.

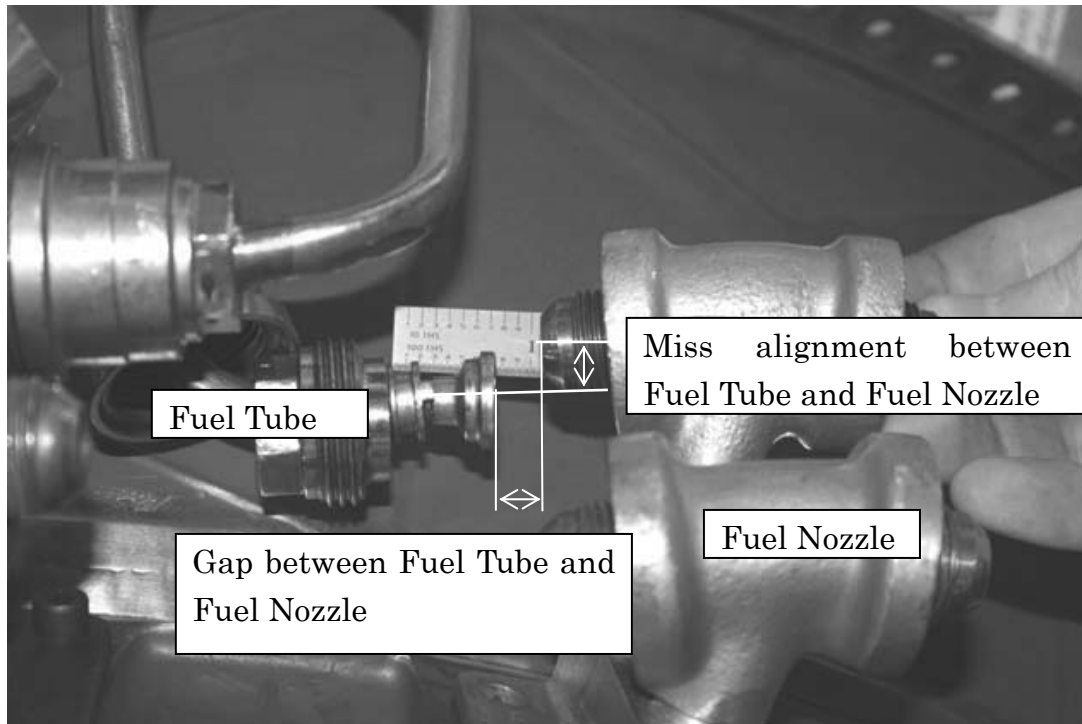
Photograph 7 Primary Fuel Tube alignment

As described in 2.9.3 (3), there was a gap of approximately 9 mm as well as significant misalignment between the No. 3 fuel nozzle and primary fuel tube. It is estimated that if the inner and outer coupling nuts were fastened under this condition with proper torque specified in the manual, the resistant force resulting from the gap and misalignment would have caused the effective fastening torque of the coupling nuts to lower, after passing of time the gap emerged in the attachment area between the inner fuel tube and No. 3 fuel nozzle at the time of the serious incident.
