**AIRCRAFT ACCIDENT
INVESTIGATION REPORT**

**American Airlines, Inc.
N 7 5 1 A N**

AMERICAN AIRLINES, INC., BOEING 777-200, N751AN
PASSENGER AND CABIN ATTENDANT INJURY
BY THE SHAKING OF THE AIRCRAFT
AT AN ALTITUDE OF APPROXIMATELY 27,000 FT
OVER NORTHERN KANTO, JAPAN
AT ABOUT 19:35 JST, DECEMBER 16, 2014

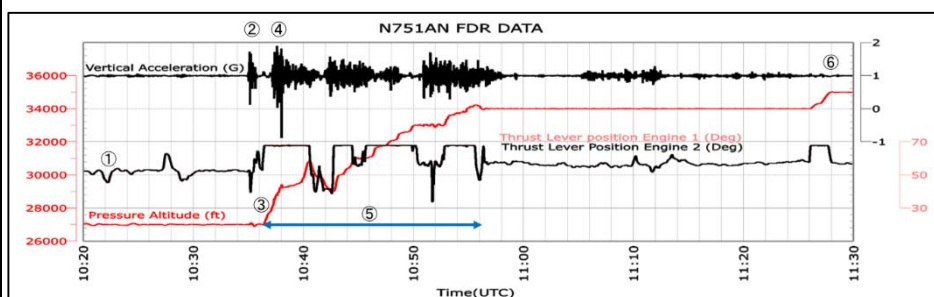
Fig. 1 Data of FDR

visually recognized that the thrust leveres moved back ward by auto-throttle (this is one of the representative premonitory phenomenon of shake) and thus turned on the seatbelt signs (Fig. 1 ①). This time, although it was dark and thin cloud were sometimes seen outside the windows of the cockpit, an airborne radar did not display clouds expected to cause a big shake and there was no actual shake, accordingly, the PIC did not give instructions such as calling for attention or seating instruction by P.A. announcements. In the cabin, the cabin attendants confirmed the wearing of seatbelts, and then continued in-flight service. The PIC continued to fly at an altitude of 27,000 ft due to stable conditions of the air current.

At about 10:35, the first big shake occurred, and the PIC made a P.A. announcement to all including the cabin attendants so as to take a seat and wear a seatbelt (Fig. 1 ②). It was still dark and thin clouds were sometimes seen outside the windows of the cockpit and an air borne radar did not display the clouds expected to cause the big shake. Passenger A stayed in the lavatory following the advice of a cabin attendant in an aisle. The cabin attendants dealt with the shake such as holding a service cart, taking a seat or holding on an armrest.

Although the PIC requested a ATC authority, and then he ascended to a higher altitude to avoid the shake (Fig. 1 ③), the second big shake occurred (Fig. 1 ④) during the ascending. Passenger A in the lavatory and the cabin attendant in an aisle to the somewhat rearward of the center of the cabin were seriously injured by being hit to the ceiling due to those big shakes of Fig. 1 ② and ④ (maximum +1.8G through -0.88G). After that, although the PIC continued to change the altitude where the shake is weakened (Fig. 1 ⑤) while contacting the ATC authority, the fierce shake continued for about 20 minutes after Fig. 1 ④. About one hour later since the first big shake, the shake of the aircraft subsided at the altitude of 35,000 ft (Fig. 1 ⑥).

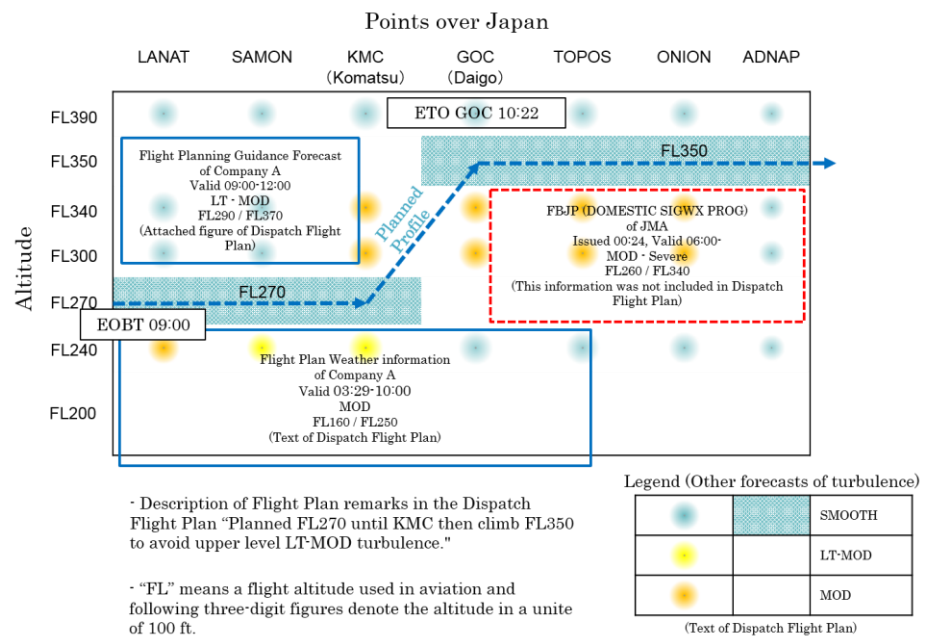
Fig. 3 Forecast related to turbulence (until PIC's signature)

The PIC did not forecast any turbulence along the planned profile (blue dashed line in Fig. 3) from the given weather information. In addition, neither the dispatcher nor the PIC grasped the forecast of turbulence which was able to be read from the FBJP of JMA (it was a range enclosed with a red dashed line, and details in FBJP were shown in 2.6(4)).

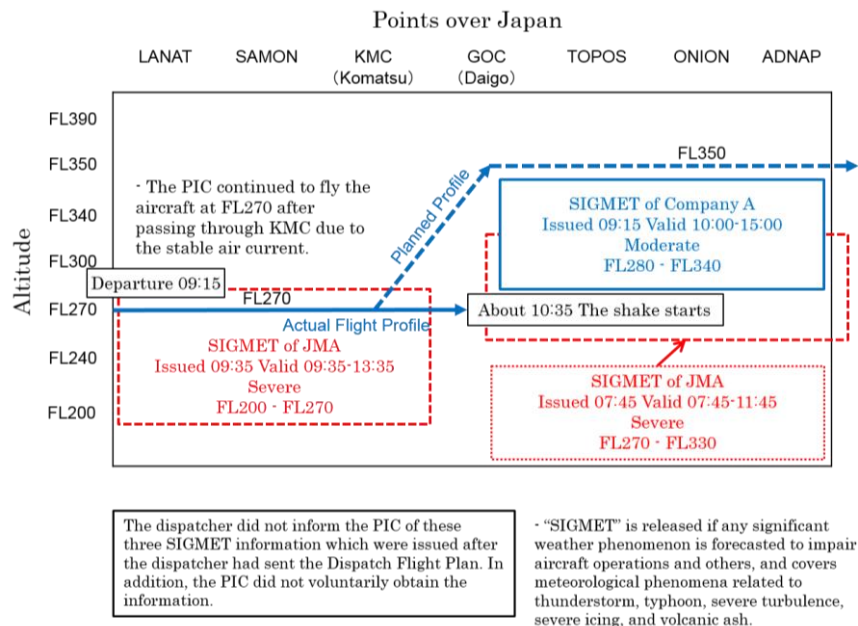
Fig. 4 Forecast related to turbulence (by the time from take-off to shaking, after flight planning)

The PIC continued to fly at FL270 (blue solid line of Fig. 4) after passing through KMC (Komatsu at 10:17) because the air current at FL270 through which the aircraft had flown according to the planned profile was stable and the PIC did not grasp the forecast of turbulence which was able to be read from FBJP of JMA shown in Fig. 3. Although the forecast of turbulence related to the planned profile and the actual flight profile had issued from Company A (the range enclosed by blue solid line) and JMA (the range enclosed by red dashed line), the PIC did not grasp these three SIGMET.

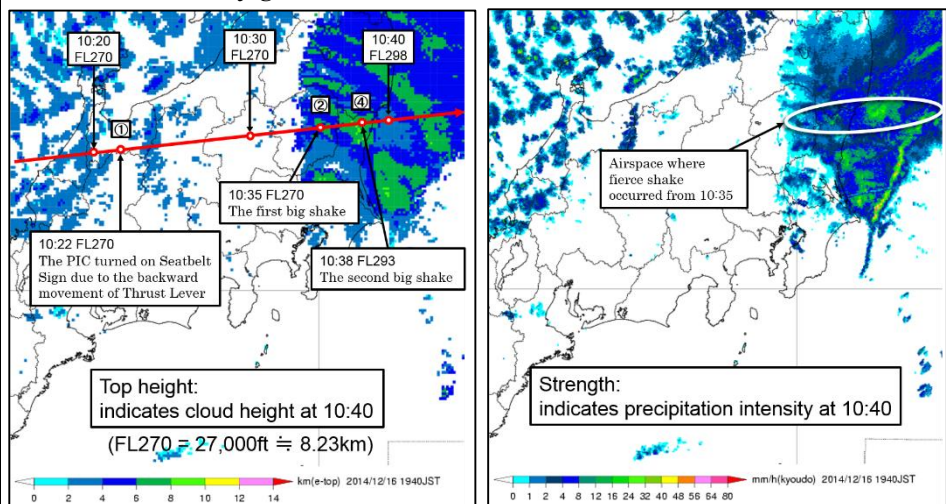
Fig. 5 Observation information by ground weather radar (when encountering the fierce shake)

Focusing on the cloud height (Top height) and rainfall intensity (Strength) at the point of the first big shake (②) and near the point of second big shake (④) in the actual flight profile (red bold solid line of Fig. 5), the rainfall intensity was weakly observed in the airspace where the cloud reached the altitude almost equivalent to the actual flight profile.

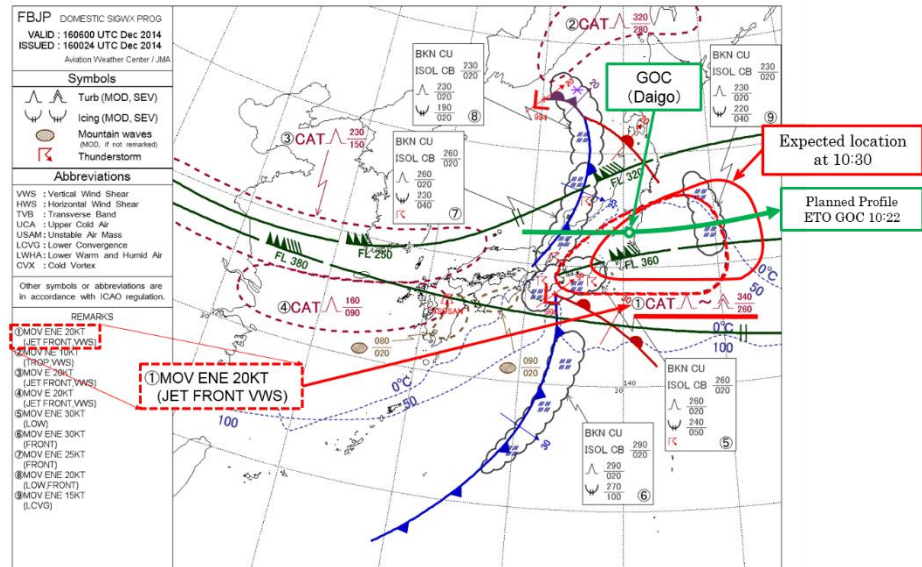
Fig. 6 Effective FBJP when the aircraft passed over Japan (partly added)

The weather information related to planned profile and the actual flight profile of the aircraft is the one enclosed by red dashed line in the left REMARKS column of Fig. 6, and in the figure of the right chart part, moderate to severe CAT (clear air turbulence) was expected as ①CAT Δ ~ Δ 340/260 in the airspace enclosed by red dashed line. The location of this airspace expected at 10:30 was added as "Expected location at 10:30" to the figure of the right chart part by red solid line. In the planned profile (added by green bold solid line) in which the aircraft was scheduled to pass through GOC (Daigo) at 10:22 (ETO GOC at 10:22), the aircraft was scheduled to fly across the airspace of CAT shown in "Expected location at 10:30" during the same time period.
