AIRCRAFT ACCIDENT
INVESTIGATION REPORT

GARUDA INDONESIA
DOUGLAS DC-10-30, PK-GIE
FUKUOKA AIRPORT
June 13, 1996

November 20, 1997

AIRCRAFT ACCIDENT INVESTIGATION COMMISSION

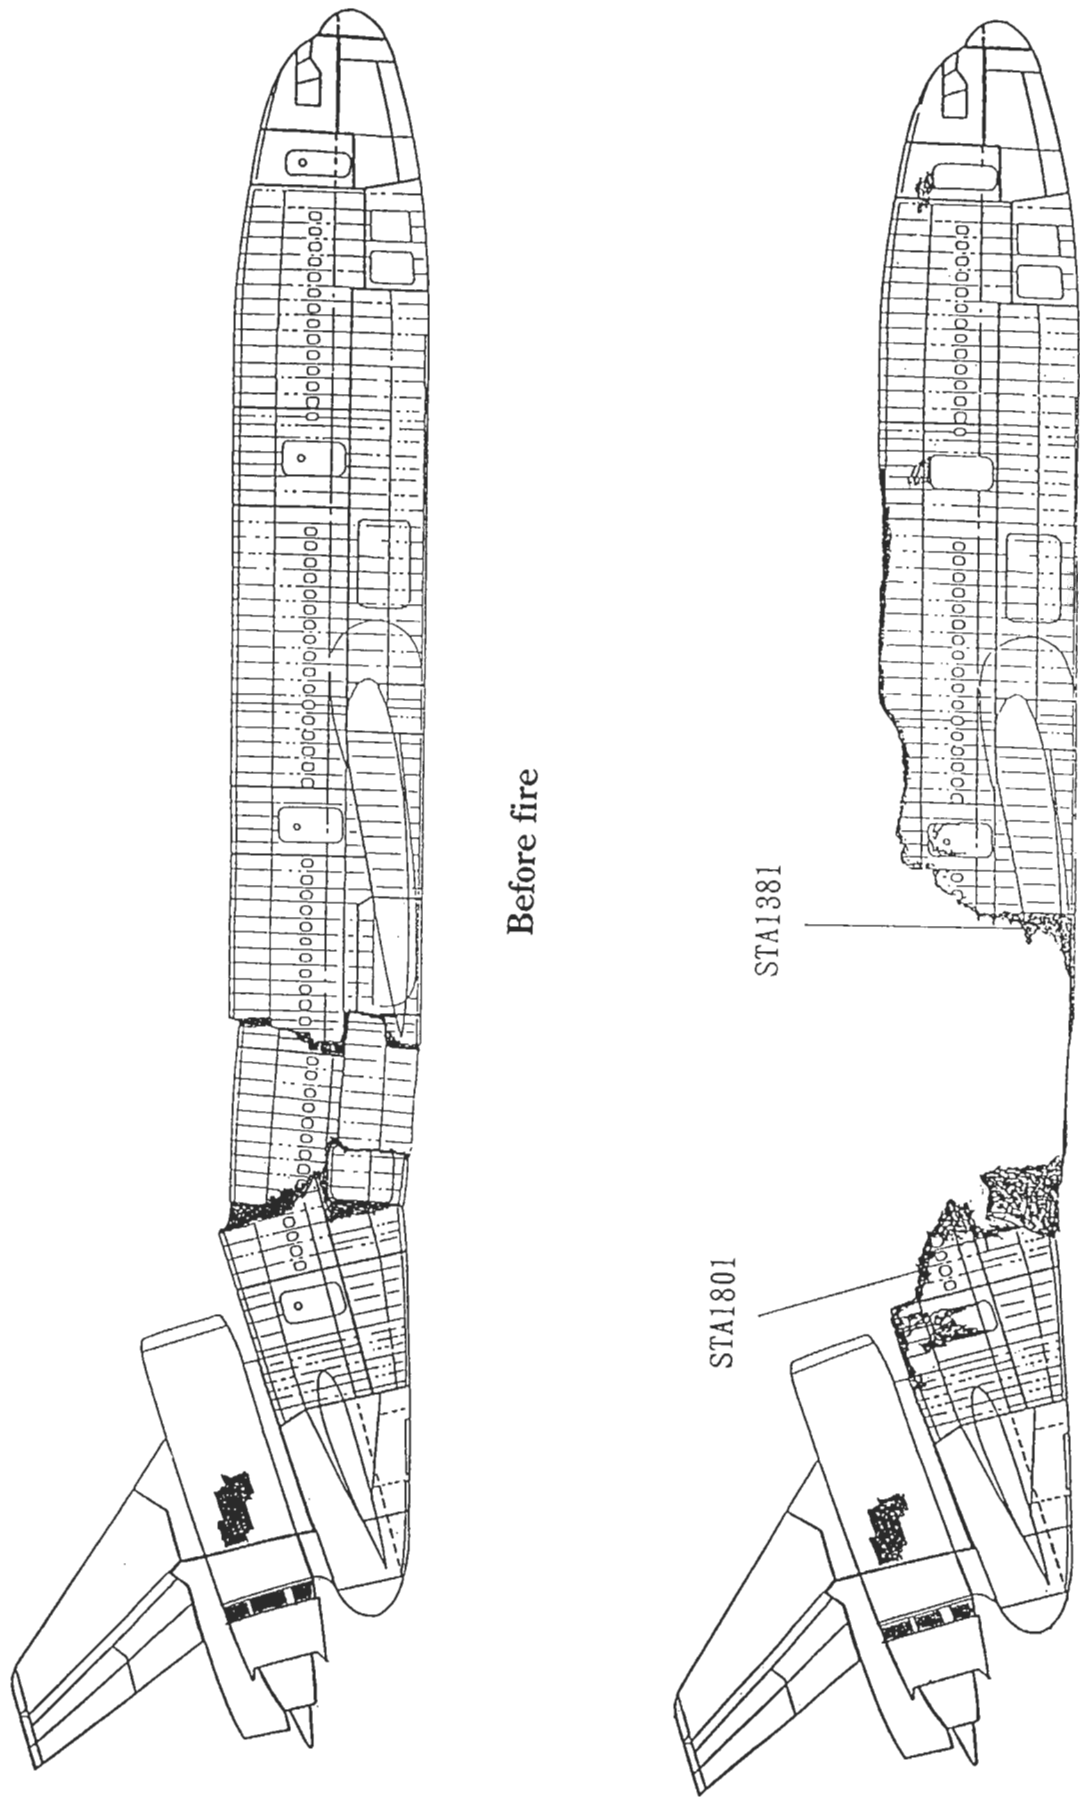
Figure 3-1 Airframe Damage (right side view)

Dents and rubs were found on the fuselage right-side skin above the 3rd-from-aftmost cabin window, and score marks (in upward, slantwise and aft directions) and cracks were noted on the fuselage right-side skin under the 6th-from-aftmost cabin window.

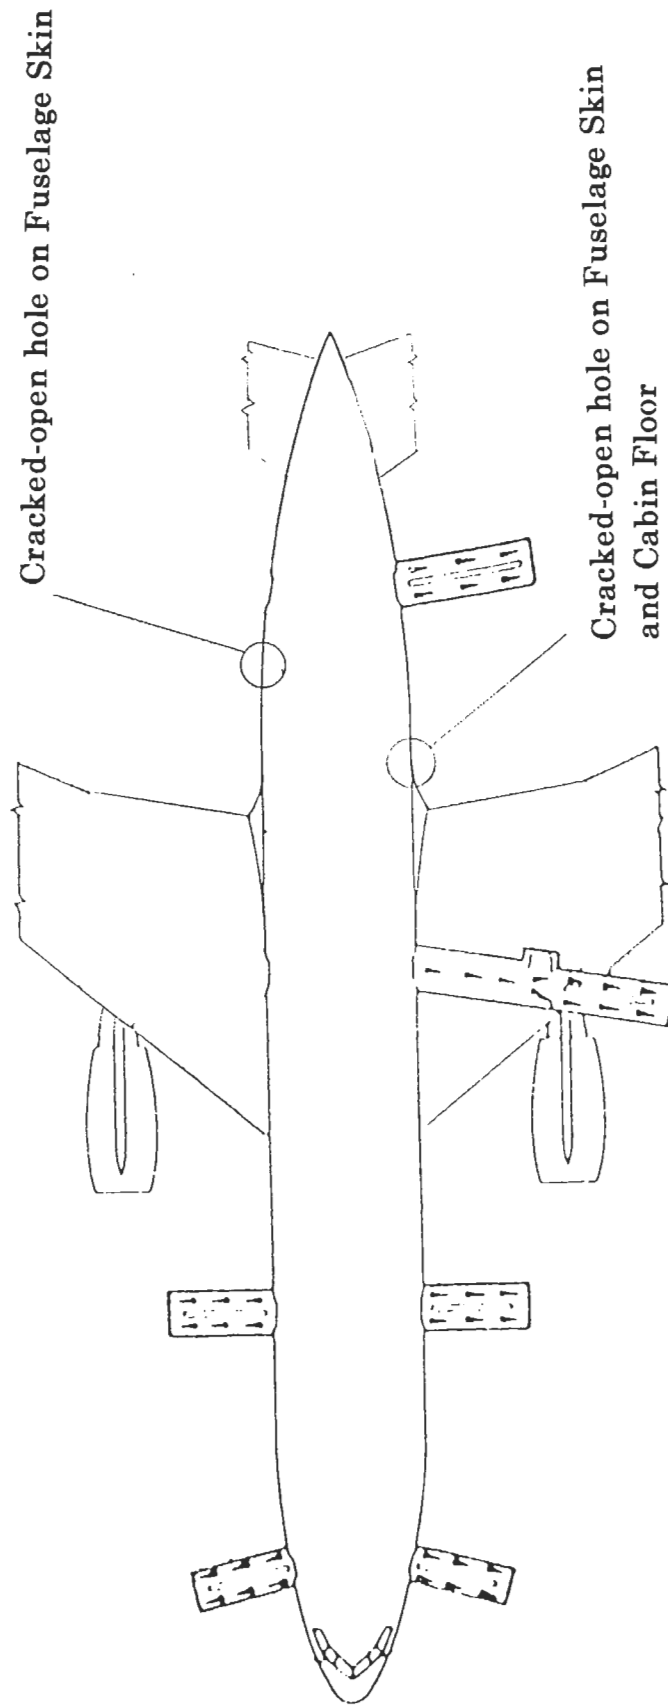
Figure 6 Deployment of Slides/Rafts and Cracked-open Holes on Fuselage Skin and Cabin Floor

Passengers evacuated through eight places; all except two of the six doors (3R and 4R), a crack in the floor near a seat (row 30) at the left side of the cabin and a crack at the rear of a seat (row 35) at the right side of the aft cabin. The number of passengers who evacuated from these places was as follows. The points from which 8 persons exited could not be determined.

1R door :	2,	1L door :	4,	2R door :	19,	2L door :	64,
3L door :	117,	4L door :	27,				
Crack near the seat (row 30) at the left side of the cabin:							2
Crack at the rear of the seat (row 35) at the right side of the cabin:							14

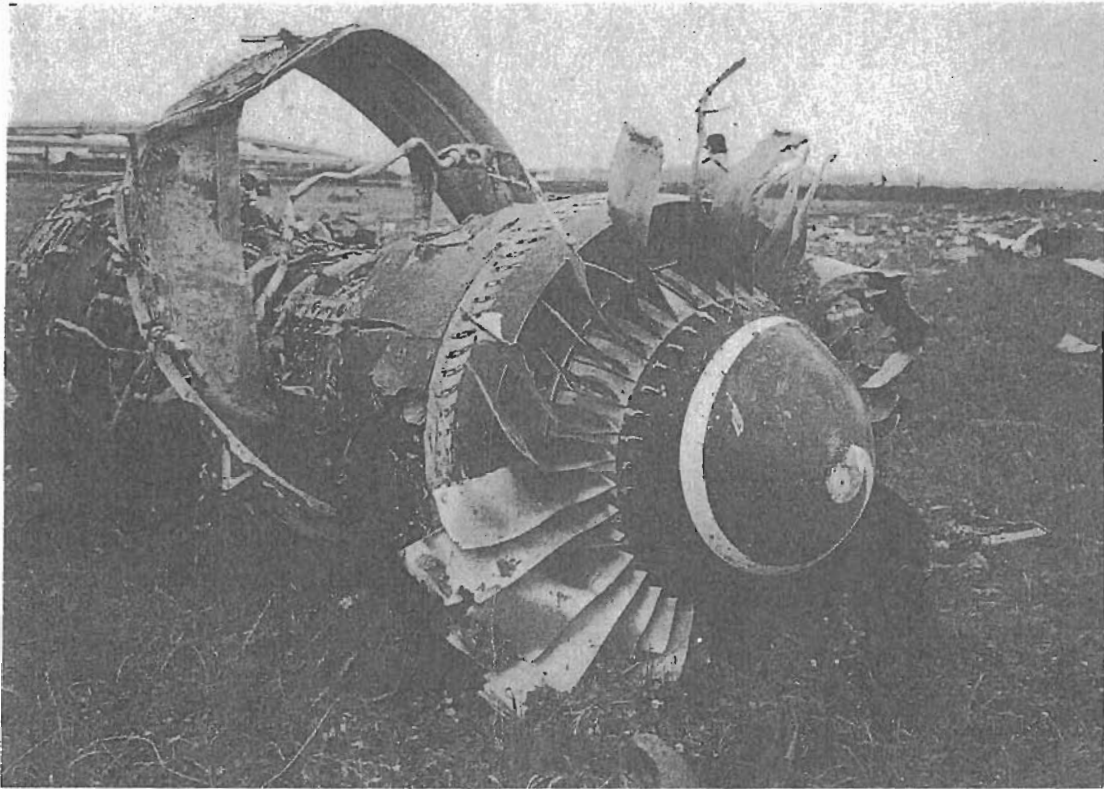
Photograph 2 No. 1 Engine

- ① The engine itself had separated from the pylon.
- ② All of the engine fan cases, including the cowlings, were torn off and detached.
- ③ The tips of most of the fan blades were fractured and curled.
- ④ The accessory gearbox was fractured into small pieces.

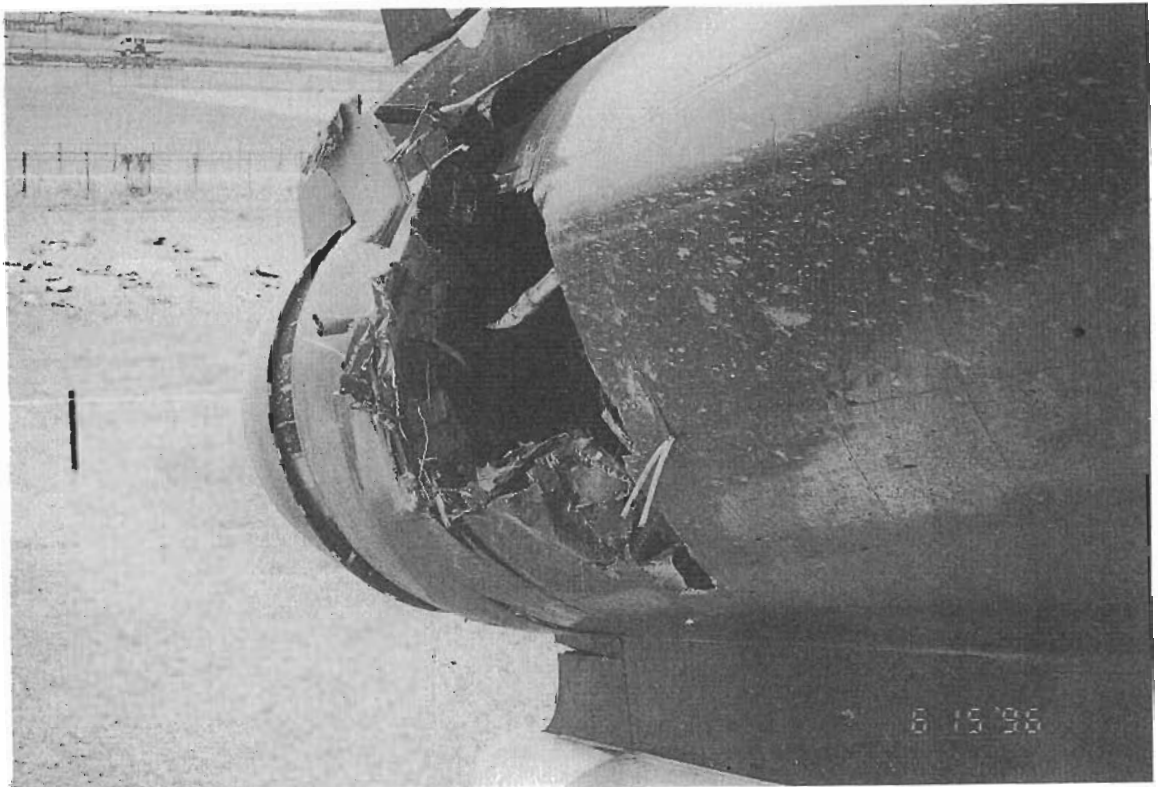
- ① There was a hole measuring approximately 2 metres by 3 metres in the right side of the inlet duct. The edges of the opening were partially flared inward and aft.
- ② One fan blade had separated at just below the midspan. A piece of the liberated blade was wedged into a narrow crack between the fan case and the fan blade. All other fan blades were missing their tips and leading edges.
- ③ A piece of the outer skin of the right wing was wedged into the fan blades.
- ④ The inside of the fan case was worn in many places in the direction of fan rotation.

Photograph 3-2 No. 2 Engine (open hole on the air inlet duct)

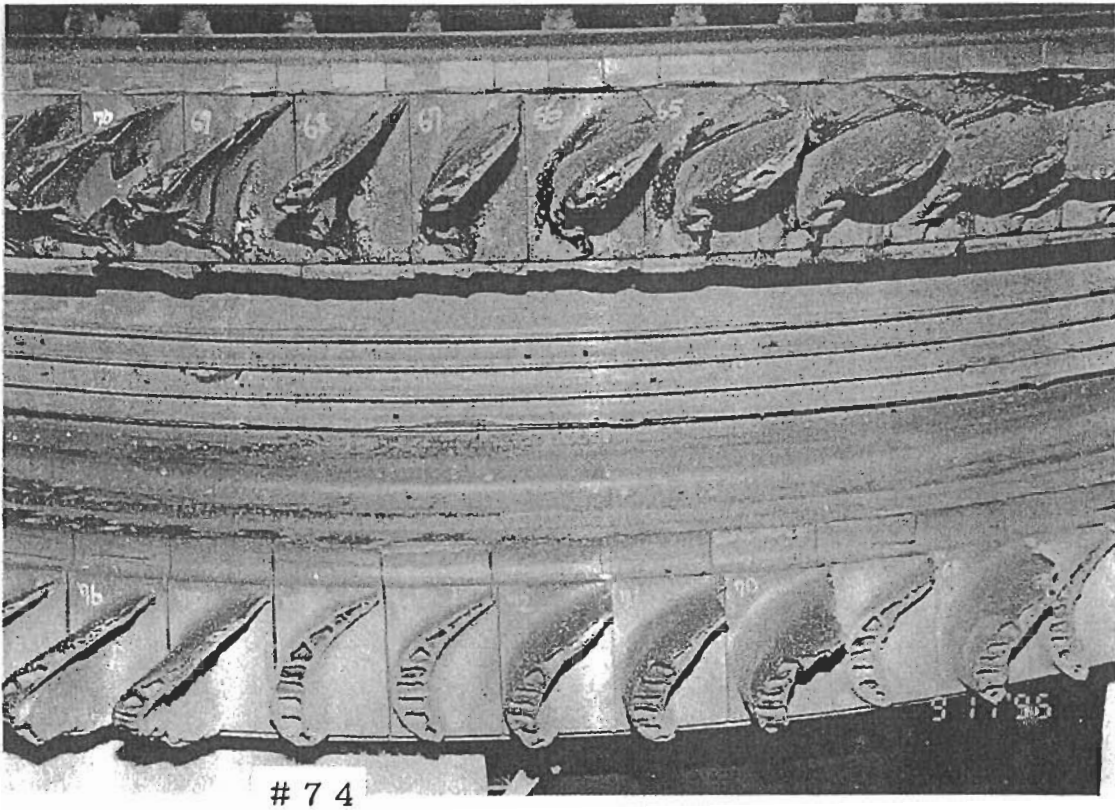
Photograph 4-5 No.3 Engine (state of damage to HPT blades assembled to disk)

- ④ Sooting was noted on the left side of the combustor inner wall, which had no noticeable damage.
- ⑤ Fine metal splatter were noted adhering to all of the HPT stage 1 nozzle guide vanes, which were missing their trailing edges. All 80 of the HPT stage 1 blade airfoils were fractured at the root or at the midchord of the airfoils and severely blackened. The extent of the damage to the HPT module was the greatest among the three engines.

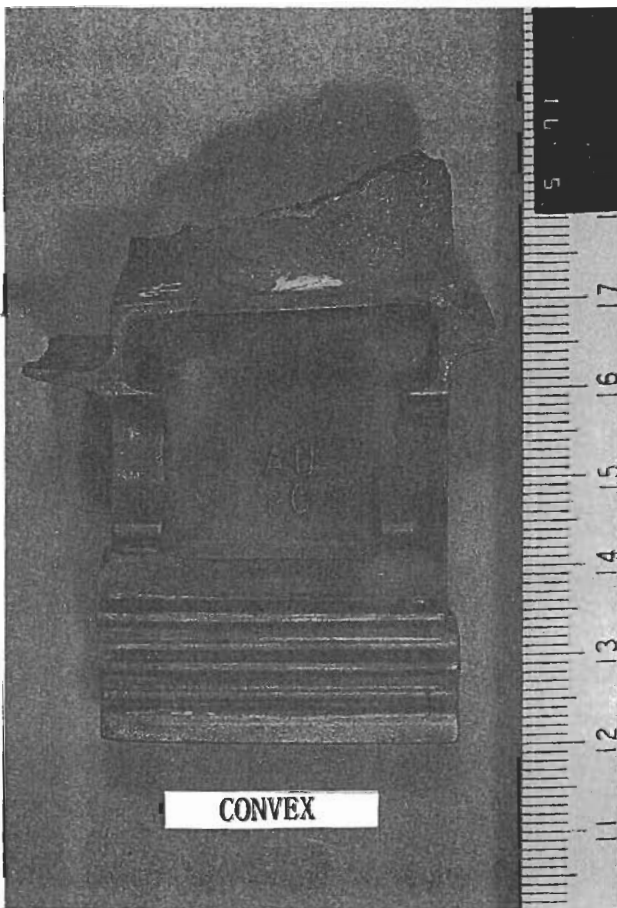
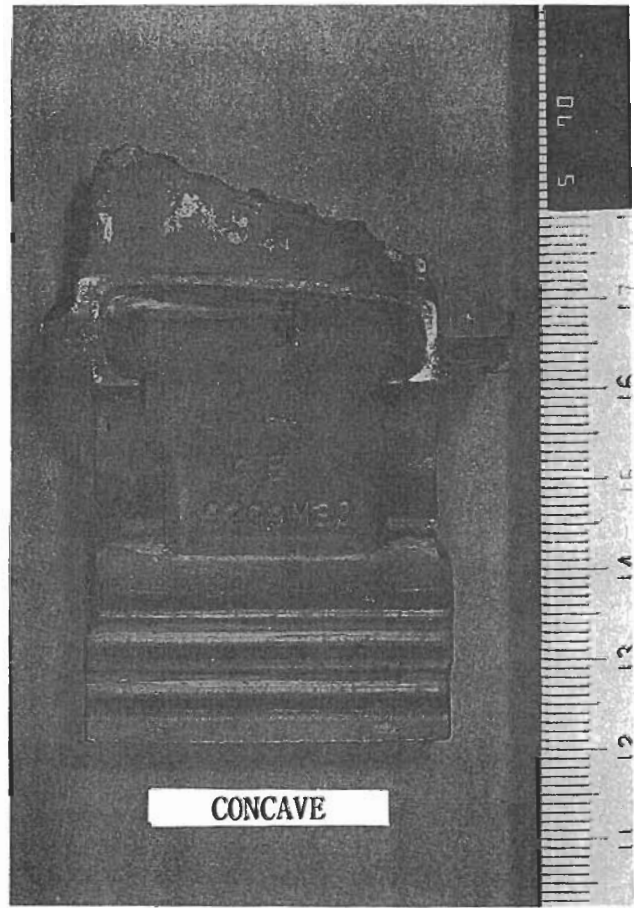
Photograph 4-6 No. 3 Engine (damage to the HPT stage 1 No.74 blade)

- ⑥ Evidence of metal fatigue was found on the fracture surface of one of the HPT stage 1 blade airfoils. Further details are given in section 2.14.4.

- (1) The airfoil of one of the No.3 engine HPT stage 1 blades, blade No.74 (P/N: 9299M30G05, S/N: KTWJ0073), had separated outboard of the blade platform, in a plane 12 millimeters above the platform at the leading edge and 5 millimeters above the platform at the trailing edge. Close inspection of the fracture surface revealed intergranular oxidation (IGO) along crystalline metal grain boundaries in the walls of airfoil trailing edge (No. 8) internal cooling air passage.

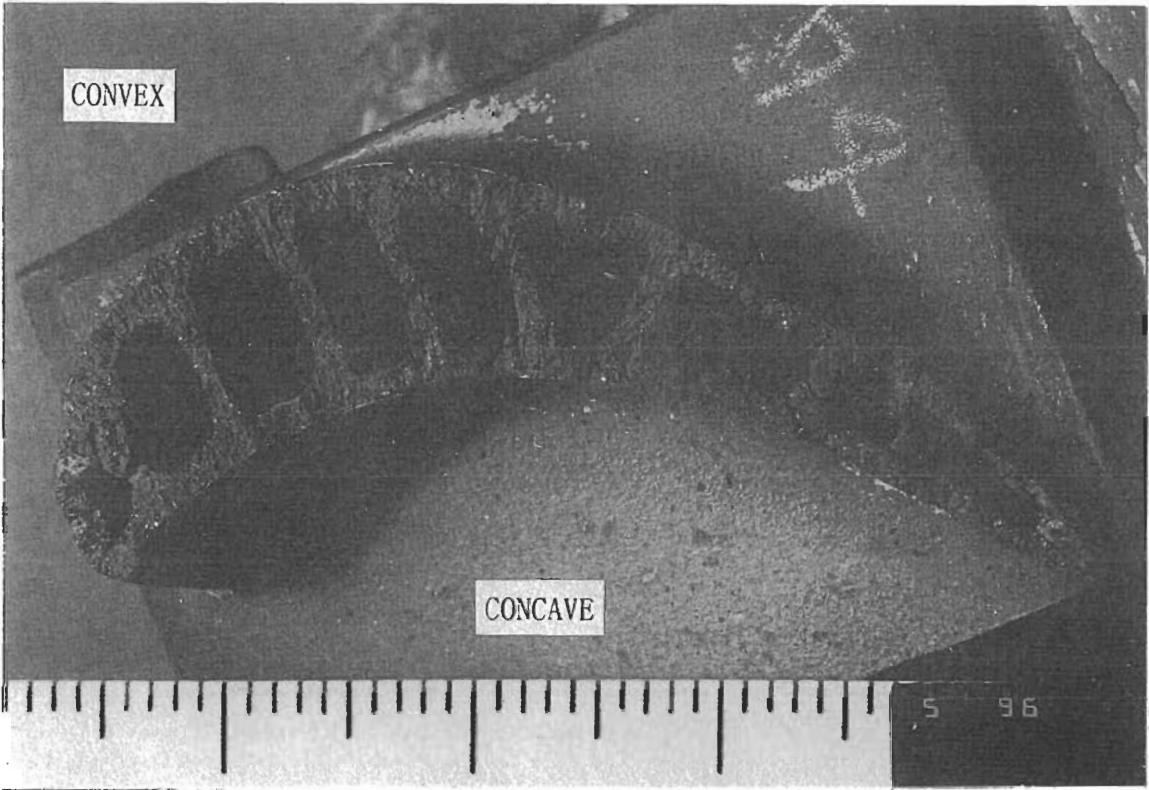
Photograph 4-7 No. 3 Engine (fracture surface of the HPT stage 1 No. 74 blade)

A fatigue crack caused by IGO-related corrosion, approximately 15 millimeters long, propagated from one of the internal wall origins, through the airfoil wall, and along the concave side of the airfoil.

- (1) GE issued service bulletin SB72-1007 on December 14, 1992, which released an advanced blade (P/N 9229M30G11) with an oxide coating applied to the internal cooling air passages in order to improve the lifespan of the HPT stage 1 blades.
- (2) In November, 1993, GE disseminated a "CF6 Fleet Highlites" article to advise operators of specific information on blade airfoil separation. While noting the availability of the improved HPT blade (P/N 9299M30G11), the article recommended operators to implement a management system to replace HPT blades on the basis of total cycles in service since new.
- (3) On June 16, 1994, GE disseminated AOW (all operators wire) 94-50-07 advising operators of the following:
