**AIRCRAFT SERIOUS INCIDENT  
INVESTIGATION REPORT**

**JETSTAR AIRWAYS PTY LTD.  
V H V K J**

## CASE EQUIVALENT TO CONTINUED LOSS OF THRUST OF ENGINES IN FLIGHT JETSTAR AIRWAYS PTY LTD.

BOEING 787-8, VHVKJ

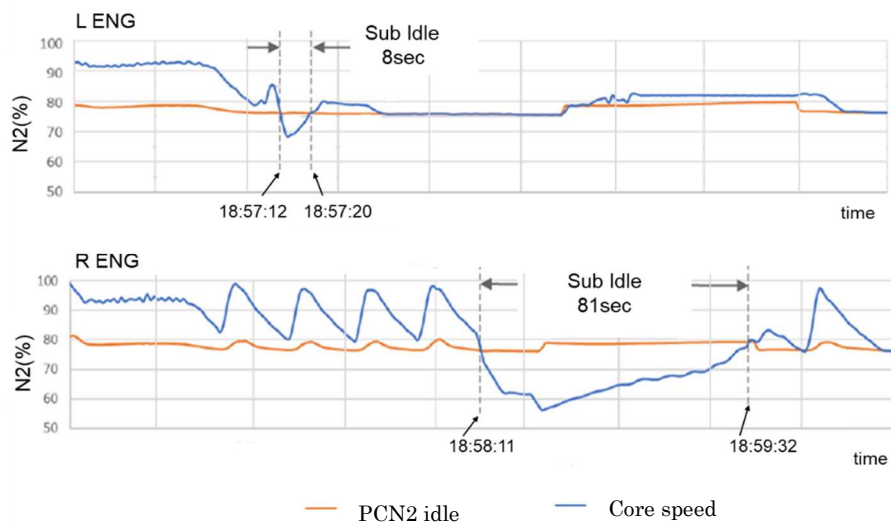
Figure 6: Engine RPM and Oscillation

Oscillation refers to the status that actual engine rpm does not stabilize repeating fluctuations up and down against required value of engine rpm calculated by EEC. CPL recorded the occurrence of rpm oscillation of both engines. The oscillation occurred during the first flight after biocide treatment conducted on March 27, and also during engines start and cruising on event flight. However, amplitude of the oscillation was so small as not to be noticed by the PIC or the FO and there was no record of EICAS message appearing either. The oscillation became remarkable enough to be recognized by the PIC and the FO during the descent to Kansai International Airport, and “ENG FAIL L” and “ENG FAIL R” EICAS messages appeared immediately

thereafter. The oscillation status of engine rpm at that time was as follows. (See Figure 6)

(4) It is highly probable from CPL record that engine rpm oscillations was caused by the condition that FMV spool and FSV spool had restricted freedom of movement when fuel pressure was low, and moved more freely when fuel pressure was high. Besides, it is highly probable that engine rpm temporarily fell below idle due to fuel flow that was significantly reduced by movement of FSV spool when engine rpm was reduced to near idle during the descent for landing. It is highly probable that EICAS messages of “ENG FAIL L” and “ENG FAIL R” appeared because the engines temporarily fell below idle.

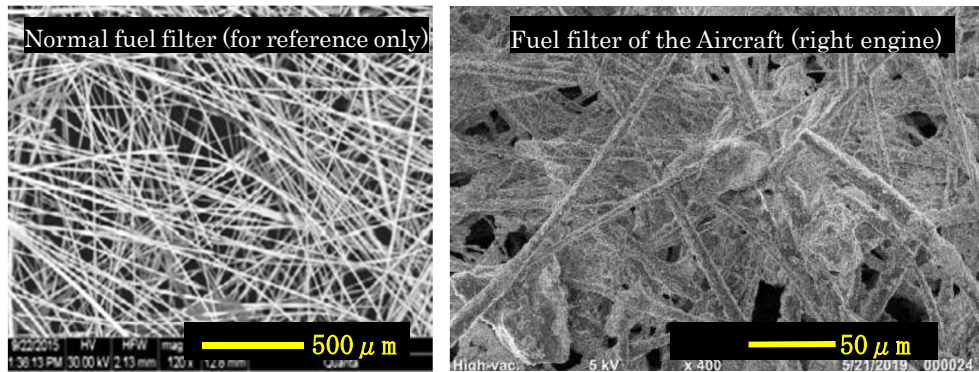
Figure 7: Fuel Filter

- i) Residue was detected from fuel filter of both engines. Composition of the detected residue were similar to the ones of biocide (Kathon FP1.5).

Note: It is possible to find some Kathon FP1.5 residue in the fuel filter after biocide treatment.

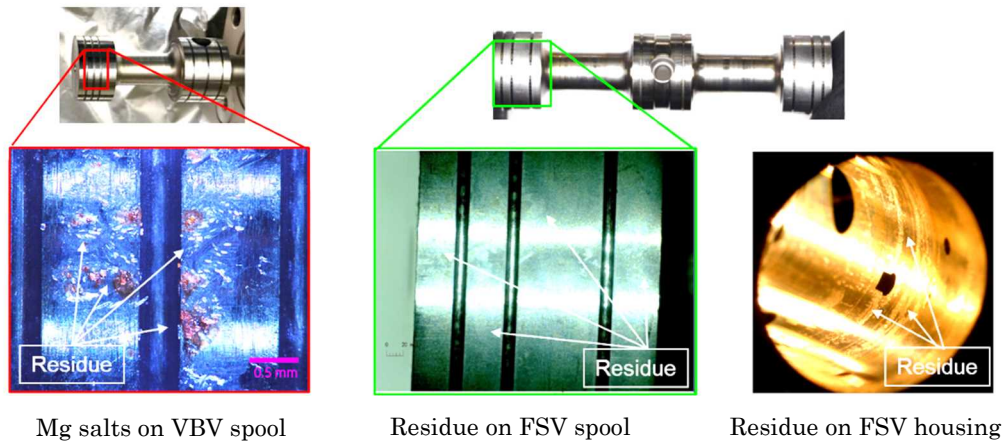
Figure 8: Residue primarily composed of Mg salts

- ii) FSV spool and VBV spool of both engines did not move with Residue primarily composed of Magnesium salts being detected. Composition of the detected Residue primarily composed of Magnesium salts were similar to the ones of biocide (Kathon FP1.5). FSV spool, if it is under normal condition, moves on a test stand by the force of 0.5 lbs\*<sup>5</sup>; however, the spool did not move even by applying the force of 160 lbs. Magnesium salts and residue were detected from FMV spool, HPT ACC spool and VSV spool of the left engine.

(3) It is highly probable that Residue primarily composed of magnesium salts accumulated in FMV spool and FSV spool, which meter engine combustion fuel, restricted movement of spools, caused inadequate fuel metering, thereby led to engine rpm oscillation that occurred from the first flight after conducting biocide treatment.

- (1) The Operator suspended biocide treatment using Kathon FP1.5 inside fuel tanks of the same type of aircraft. The Operator is reviewing maintenance procedures that occur infrequently, to identify task- specific training opportunities for maintenance personnel based on AMM.

- (2) The design and manufacturer of the engine issued service bulletin (SB) for aircraft equipped with GEnx engine to notify operators to suspend biocide treatment using Kathon FP1.5. (SB 73-0086 R00 ENGINE FUEL AND CONTROL – GENERAL (73-00-00) – SUSPENSION OF THE USE OF KATHON FP 1.5 BIOCIDES TREATMENT ISSUED SEP/30/2019)

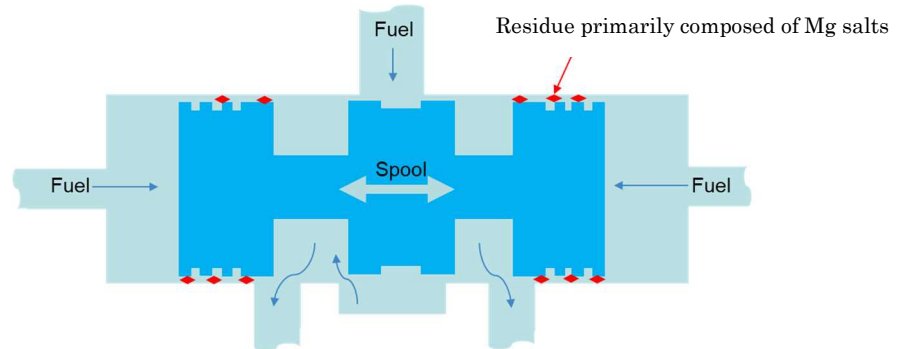
Figure 9: Portions where the residues were detected

two days before the serious incident was involved in the accumulation of Residue primarily composed of magnesium salts because the composition of the residue were similar to the Kathon FP1.5.
