**AIRCRAFT SERIOUS INCIDENT
INVESTIGATION REPORT**

VIETNAM AIRLINES

V N – A 1 4 6

**VIETNAM AIRLINES
BOEING 777-200, VN-A146 (VIET NAM)
ON B TAXIWAY AT NARITA INTERNATIONAL AIRPORT
AT ABOUT 07:44 JST, JULY 30, 2008**

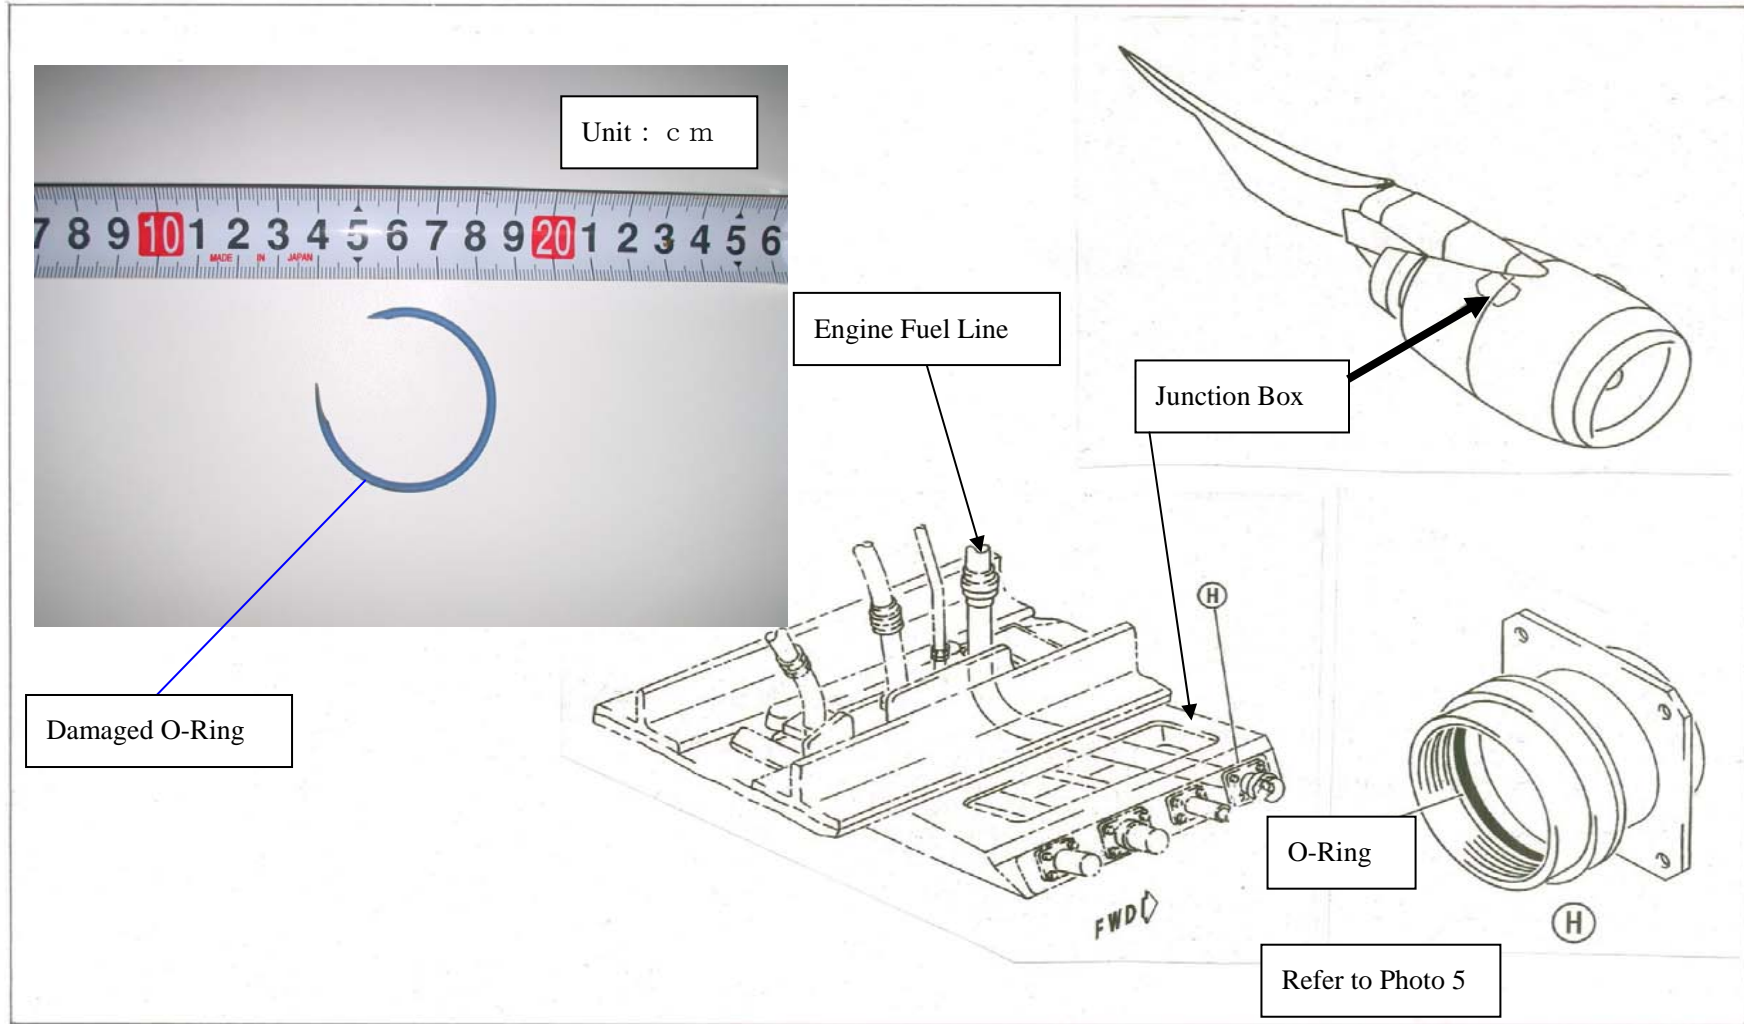
Figure 4 Fuel Supply Hose Coupling

- (1) Inside the engine cowl
 - ① Burn damage was found on the hydraulic pressure hose, hydraulic supply hose and case drain tube.
 - ② The fuel supply hose was burned. Disconnecting the quick disconnect coupling, the O-ring *⁵ was found severed with the ends showing sharply cut surfaces and 25% of its length was missing.
 - ③ Conducting a hardness test on the structural members inside the pylon, reduced hardness was found in almost all of the members.
 - ④ The electrical wiring harnesses were burned.
- (2) The outer surface of the engine case was burned and covered with soot.

- (3) The fractured surfaces of the damaged O-ring showed a sharply cut surface. It is therefore considered probable that the O-ring was pinched and became damaged when the fuel supply hose was connected.

It is considered possible that fuel leaked due to a gap in the O-ring that was created when the O-ring was pinched and severed during installation of the fuel supply hose.

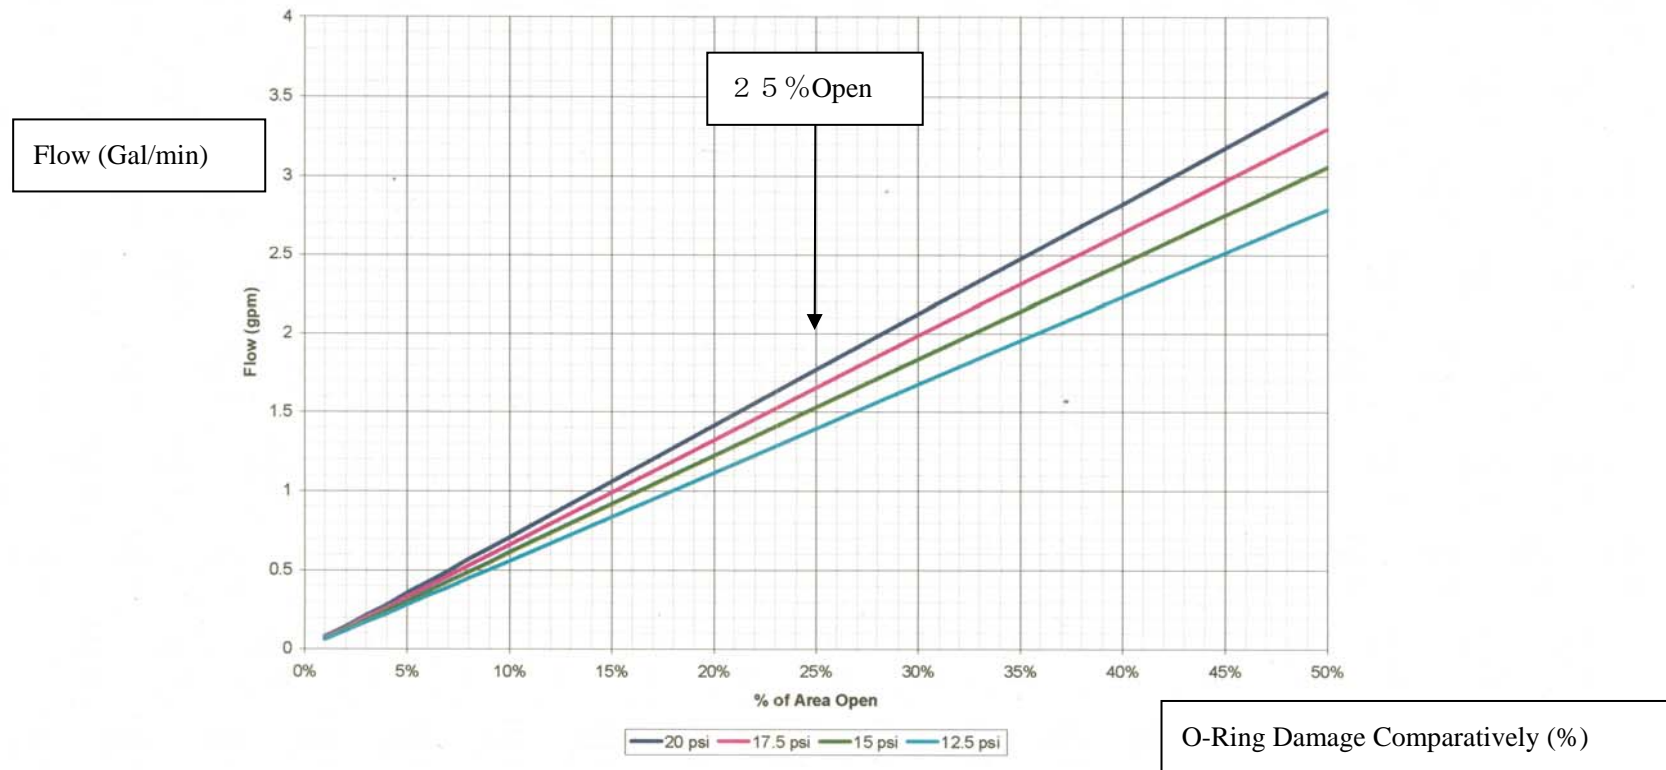
Figure 6 Fuel Leak Rate with the Damaged O-Ring

Using a fuel system tester, a fuel pressurization leak test was conducted using the O-ring removed from the Aircraft. Fuel leakage from the fuel supply hose coupling was detected.

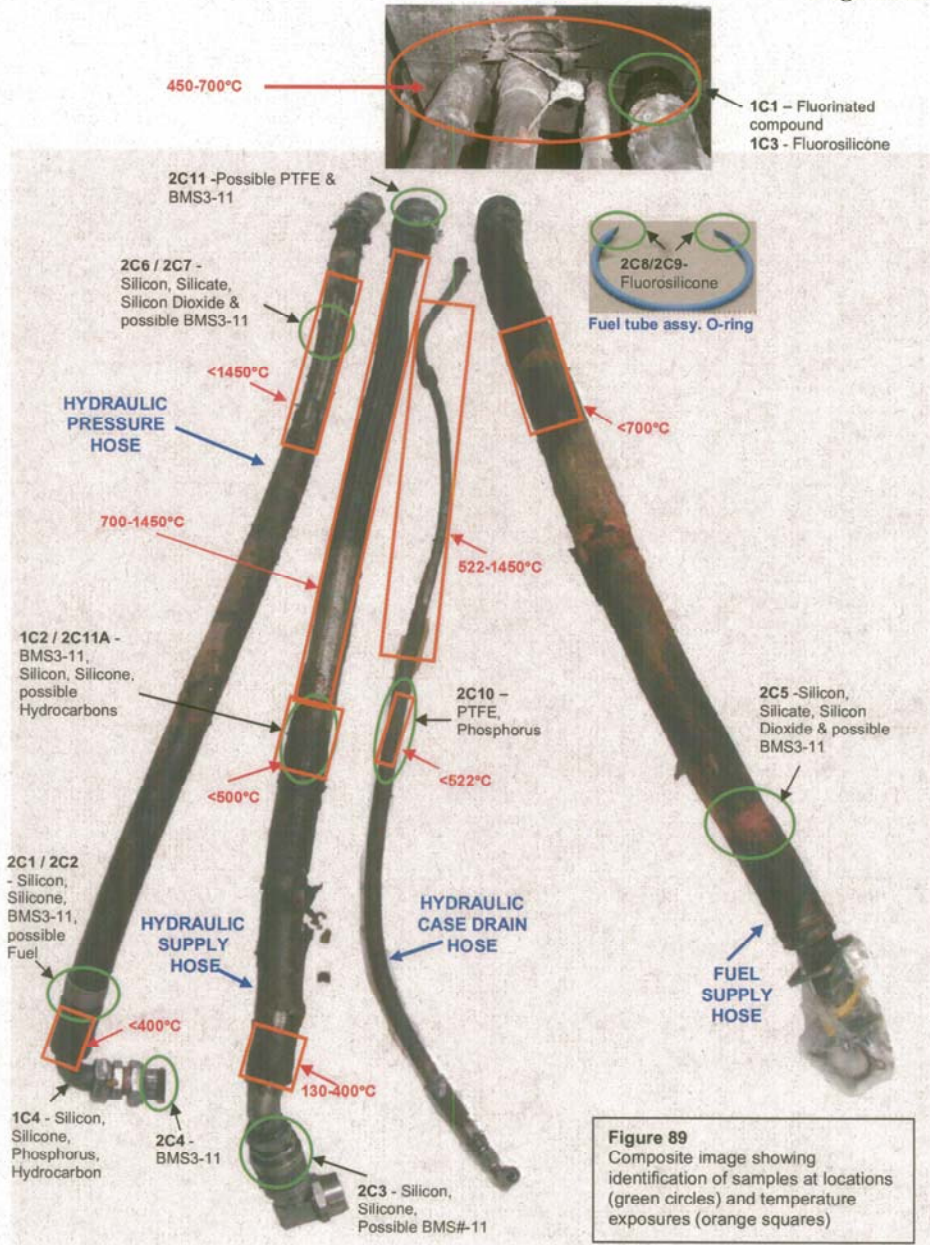
Figure 7 The Examination Results of Burning Temperature, etc.

(3) Hoses and other components near the junction box for the right engine of the Aircraft
The extent of burn damage suggested that the temperatures prevailing around the right engine junction box had been between 450°C and 1,450°C.

- ① Hydraulic hoses: Burned (hydraulic pressure hose <1,450°C and hydraulic supply hose 700–1,450°C); fuel components were detected on the surface of these hoses.
- ② Fuel supply hose: Burned (<700°C)
- ③ Other hoses: Burned (case drain tube 522–1,450°C)
- ④ Engine fire and overheat detection system: Partially burned
- ⑤ Engine fire detection card: In good condition

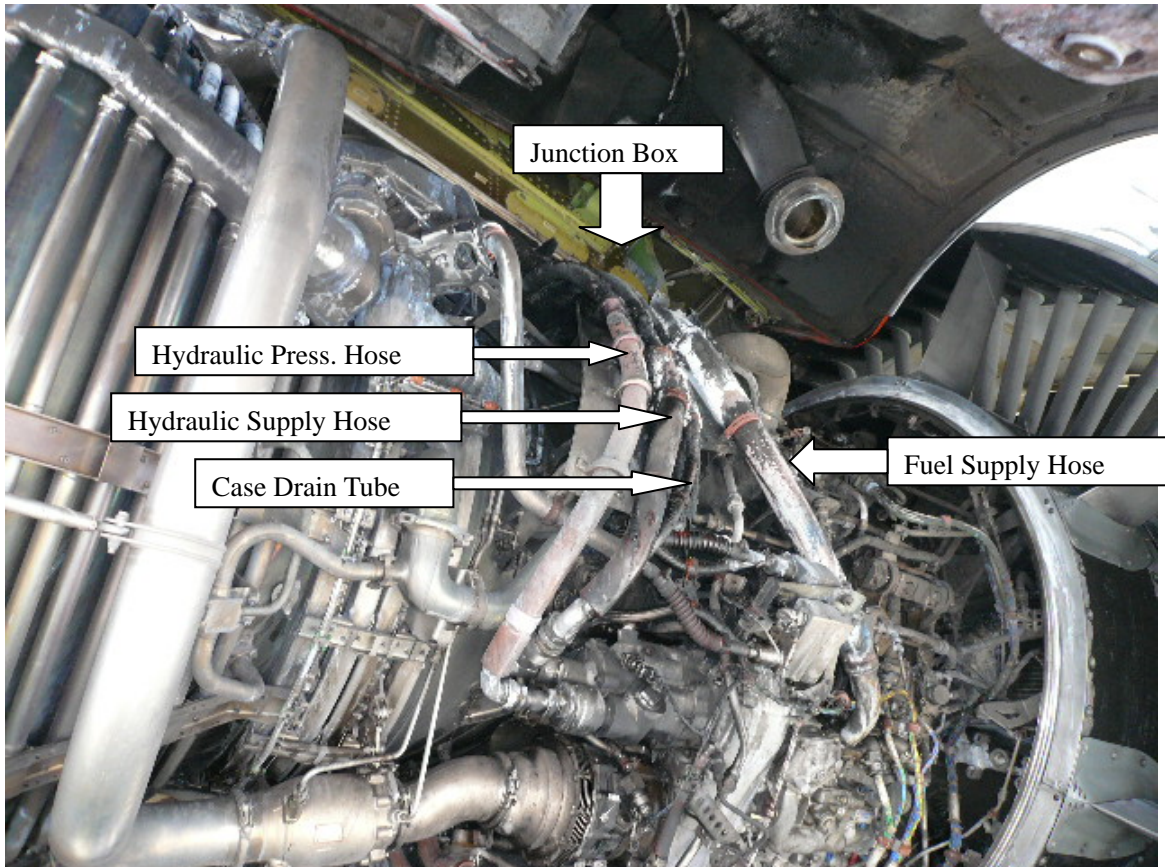
Photo 3 Engine Cowling Interior

When I started opening the aft cowling next, the heat shield fell down in shatters. It was so heavily burned that I was relieved that no one had been injured.
