AIRCRAFT ACCIDENT INVESTIGATION REPORT

**Cathay Pacific Airways
Lockheed L 1011-385-1, VR-HOC
New Tokyo International Airport
March 24, 1990**

**Aircraft Accident Investigation Commission
Ministry of Transport**

March 27, 1992

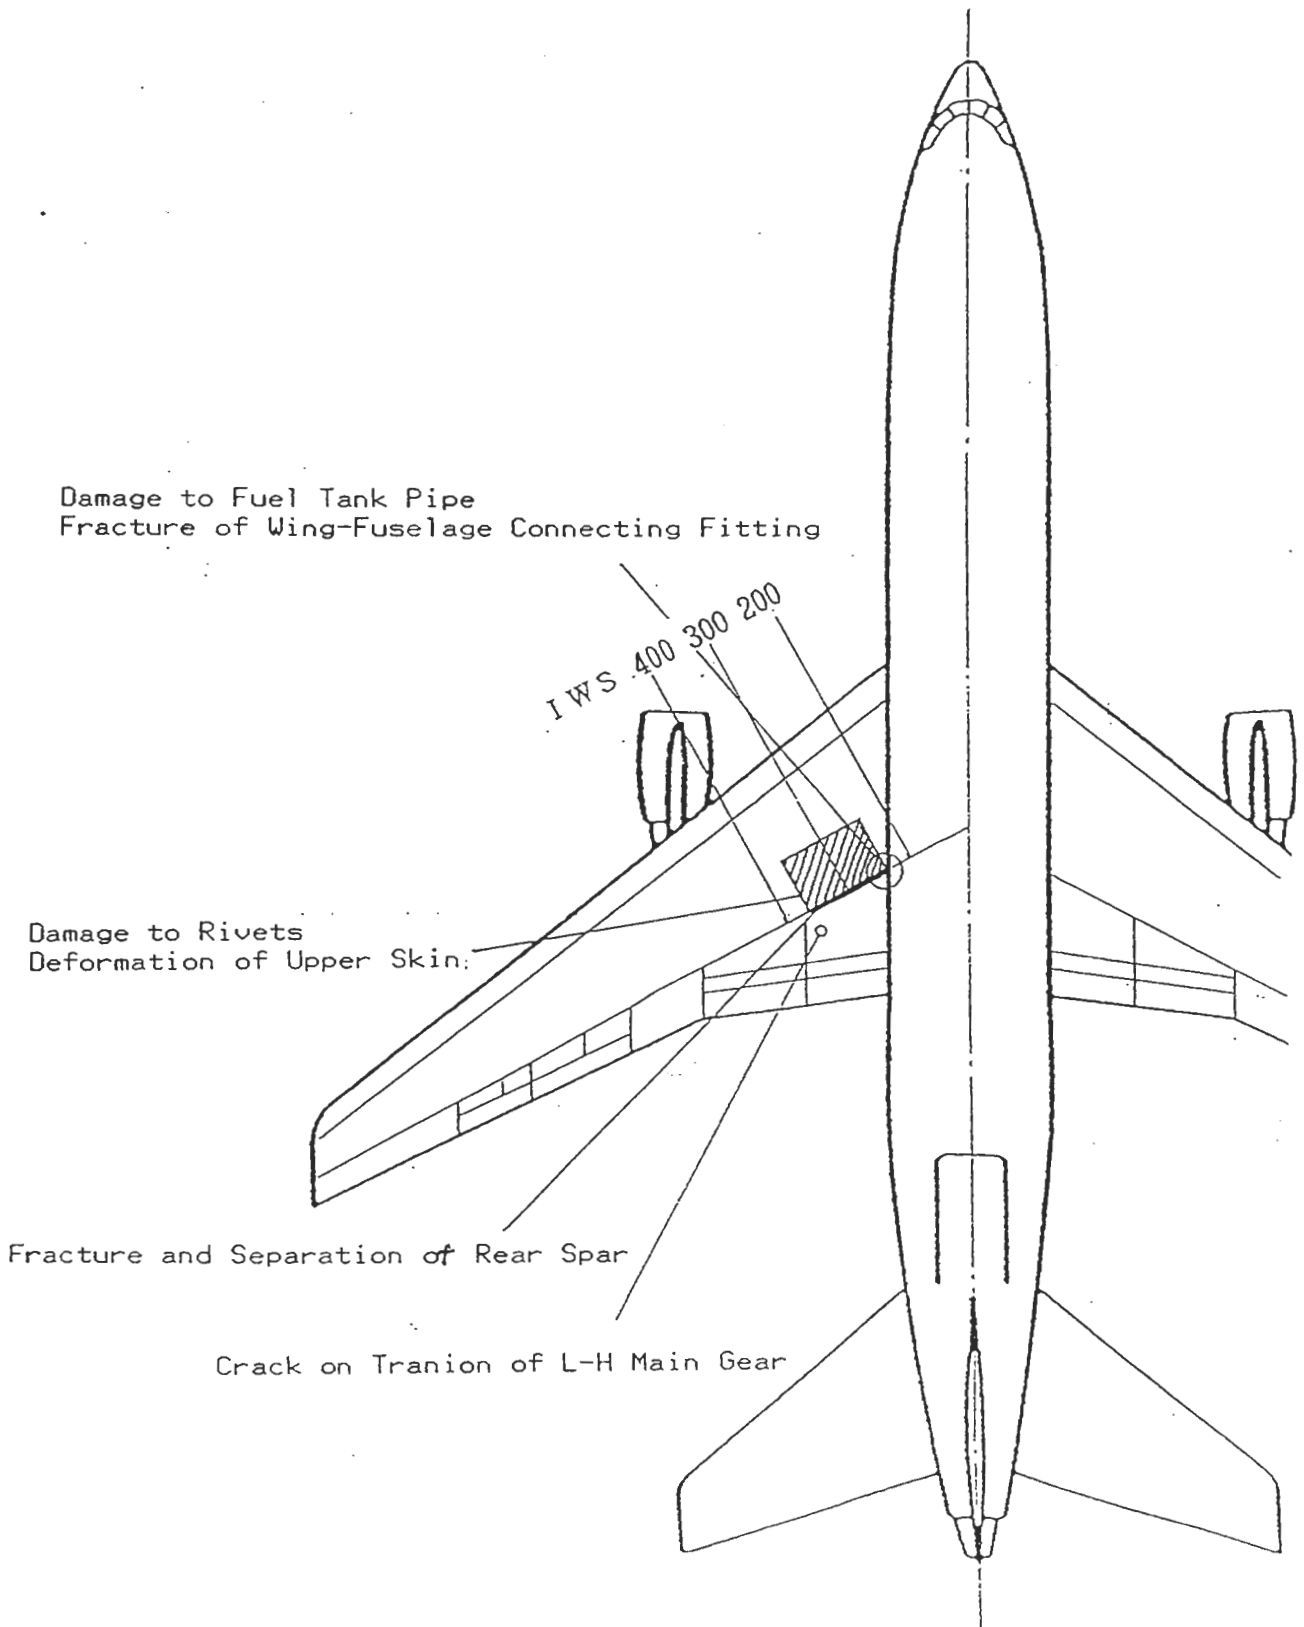
Attached Fig. 4 Damage to Airframe

The rear spar of the left wing root and its vicinity were fractured and fuel leaked out from No.1 fuel tank. (see Attached Figs. 4 and 5, Photos. 1 and 2)

(1) Fracture of the left wing rear spar web at IWS (Inner Wing Station) 241
The left wing rear spar web was shear-fractured vertically along rivet holes of the stiffener attached to IWS 241. By this fracture the upper spar cap was fractured at the tip of the upper outboard fitting located slightly nearer to the wing tip, causing a deformation of the upper skin in the vicinity. The lower spar cap was buckled upward at the tip of the lower outboard fitting.

(3) Damage to the joint of the spar cap with the rear spar web
Rivets connecting the upper and the lower spar cap with the rear spar web were shear-fractured between the buckled portion of the rear spar web (refer to (2) above) and the shear-fractured portion near the root portion (refer (1) above)

(4) Damage to the fittings connecting wing and fuselage
Cracks were observed on the upper forward inboard fitting as well as on upper outboard fitting of the left wing rear spar.

(5) Damage to rivets on the upper skin of the left wing
Rivets were damaged, with their head coming off or floated, on the upper skin of the left wing between the rear spar and the front spar with a range from the wing root to IWS 346.

Fuel within the tank leaked out from the cracks at the aft rear spar which constitutes part of No.1 fuel tank. The estimated leakage is approximately 7,000 pounds.

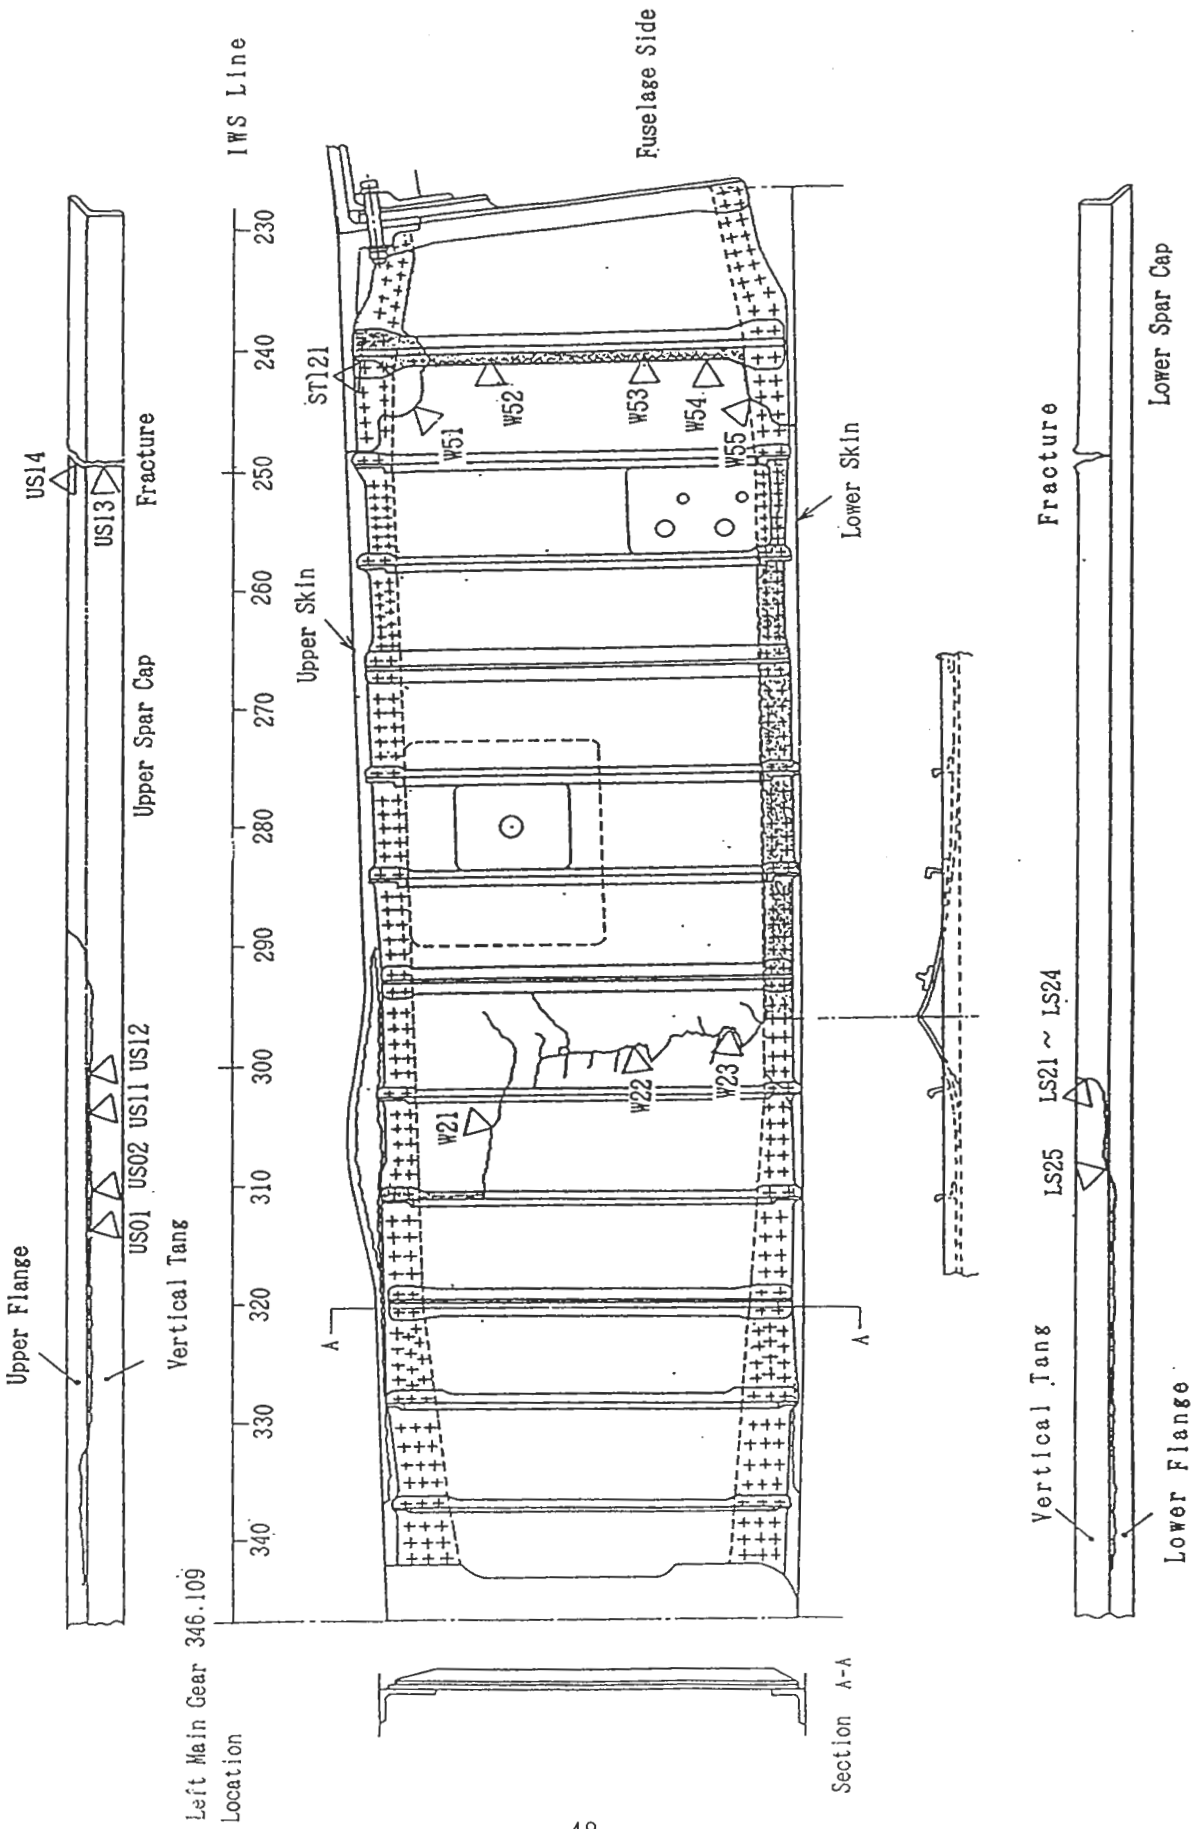
Attached Fig. 5
 Damage to Neighborhood of Root of L-H Wing Rear Spar

The left wing rear spar web was buckled making its center at IWS 300, projecting backward, and a crack was found propagated and branched from its lower tip upward to its 70 % height. On the wing tip side, about 15 cm from the crack at the lower tip of the web, another crack was also initiated on the vertical tang of the lower spar cap, from where the crack extended up to IWS 346 along the corner of the lower spar cap. As to the upper spar cap, a crack was initiated at the vicinity of IWS 290, somewhat nearer to the fuselage side than the crack of the spar web, up to IWS 346 along the corner of the spar cap, and the upper flange side was heaved about 7 cm upward together with the upper skin.

As to the rear spar web, the fracture surfaces would have been formed along rivet holes by a static failure due to shear and tension load. Surfaces with a dimple pattern, peculiar to the static failure, were prevailing, except for a fracture surface having a fan-like pattern caused by fatigue about 2 mm in diameter on the edge of a rivet hole. It was recognized that this fatigue failure surface was not the origin from which the static failure started.

In the vicinity of IWS 300, the rear spar web was fractured by buckling in such a manner as to be projected rearward and deformed. On each forked cracked surface was found the dimple pattern. All these surfaces would have been formed by a static failure due to shear and tension load.

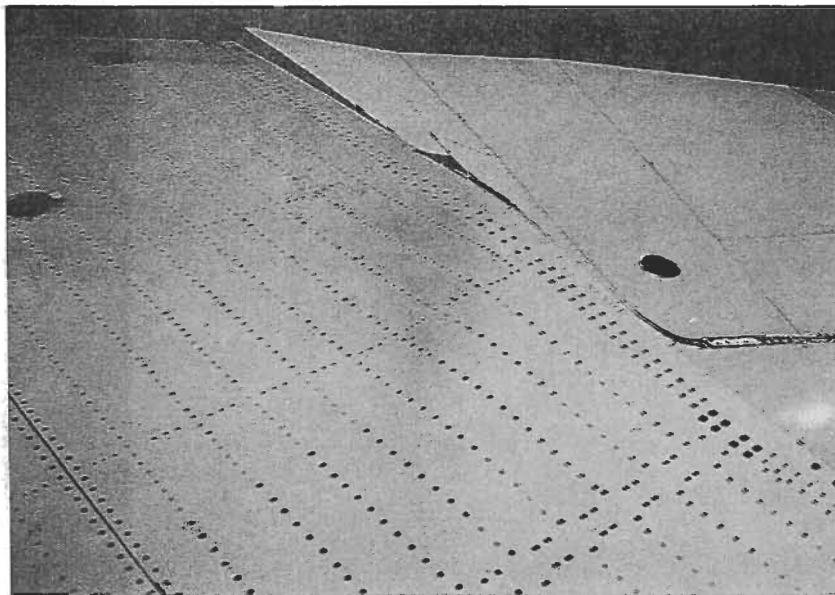
Photograph 1

Damage: Wing Upper Surface (L/H)

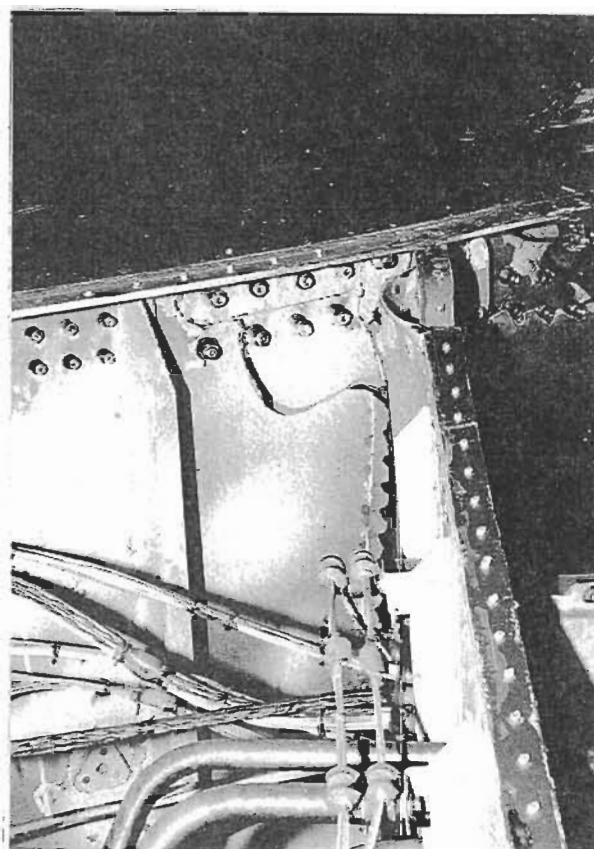
Photograph 2

Damage: Wing Rear Spar (L/H) (near IWS241)
