(AIRCRAFT ACCIDENT INVESTIGATION INTERIM REPORT)

BOMBARDIER DHC-8-315, JA722A

AIRBUS A350-941, JA13XJ

December 25, 2024

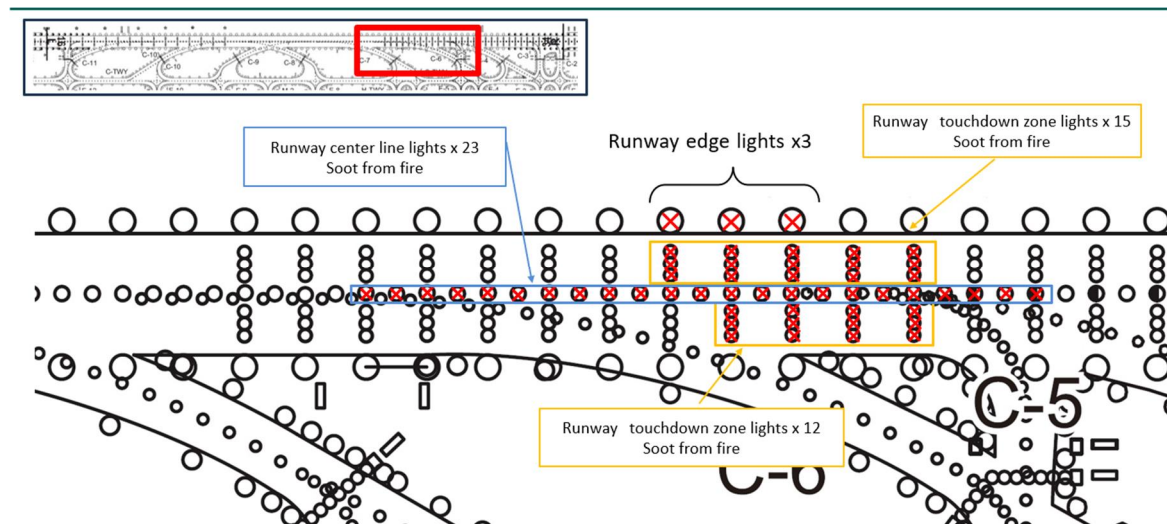
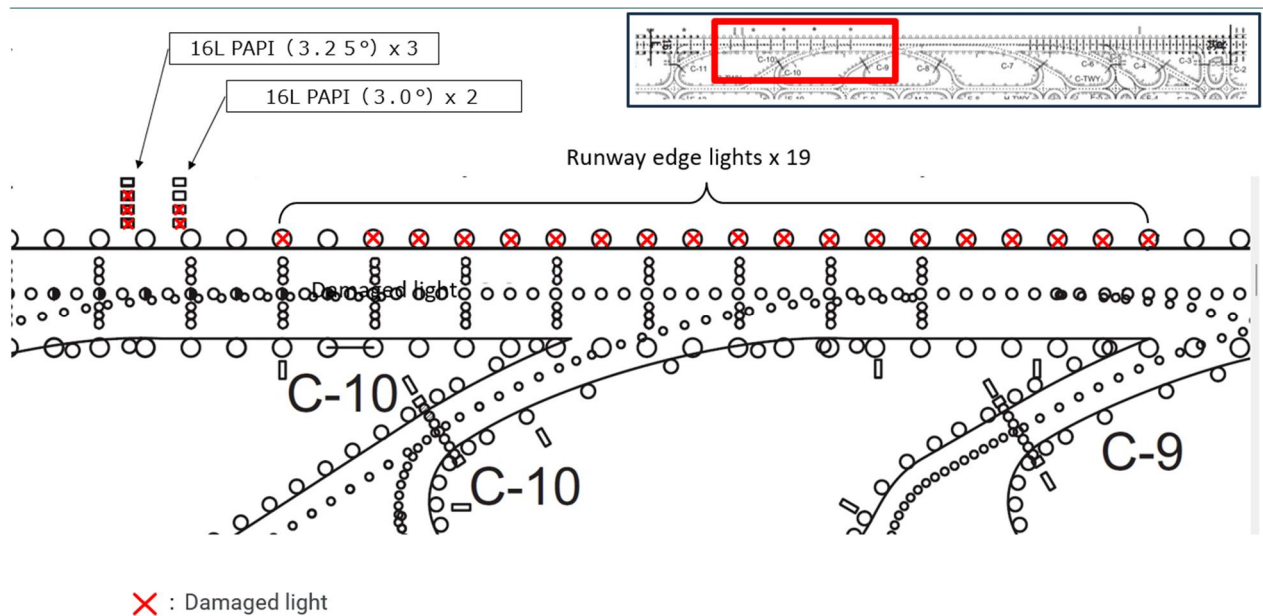
Figures 10-1 Damage to aerodrome lighting aids
(Near the collision site)

The aerodrome lighting aids damaged because of this accident are as follows (see Figures 10-1 and 10-2):

| • Runway edge lights: | 22 lights (damaged and covered in soot from fire) |
| • PAPI for Runway 16L (3.0degrees): | 2 lights (missing and displacement) |
| • PAPI for Runway 16L (3.25degrees): | 3 lights (destroyed and missing) |
| • Taxiway centerline lights | 4 lights (covered in soot from fire) |

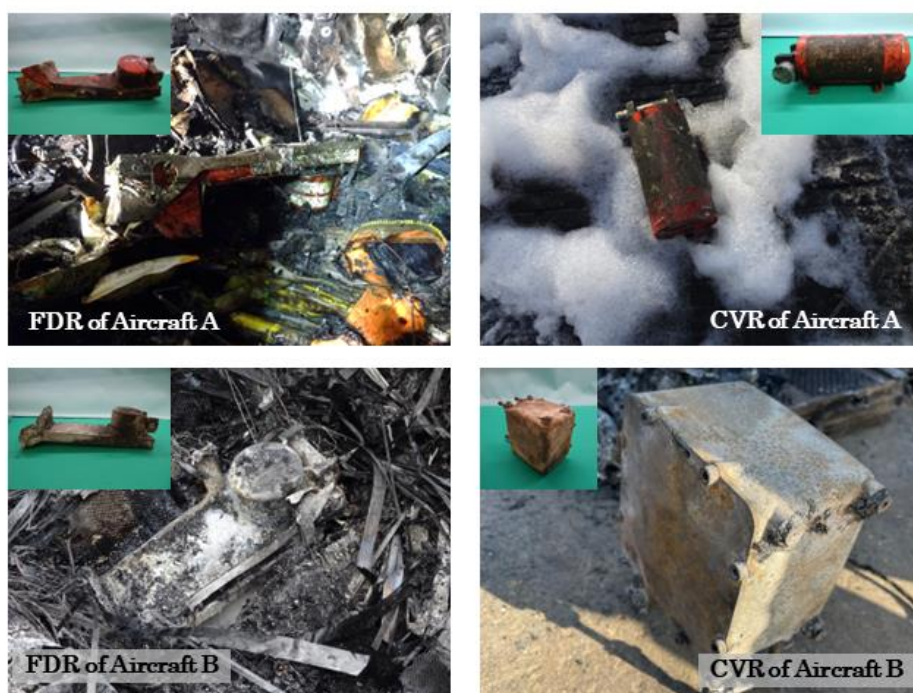
Figure 27 : The condition of the flight recorders

The FDR was recovered with its outer case and internal electronic boards damaged, but the part containing the recording medium that recorded the FDR data (hereinafter referred to as the "CSMU") was not damaged.

The CVR was recovered with the CSMU that recorded the audio separated from the other parts. The outer case and the internal electronic board were damaged. The recording medium that recorded the audio had a burnt signal line, which was repaired, and the recording data was retrieved.

The FDR was recovered with its outer case and internal electronic boards burned. The recording medium that recorded the FDR data had a damaged connector to which the signal line was connected, so this was repaired, and the records were retrieved.

The CVR was severely burned around the area, so the outer case was burned along with the storage rack, and only the CSMU, which recorded the audio, was recovered. No internal electronic board other than the CSMU could be found. The recording medium that recorded the audio was not damaged.

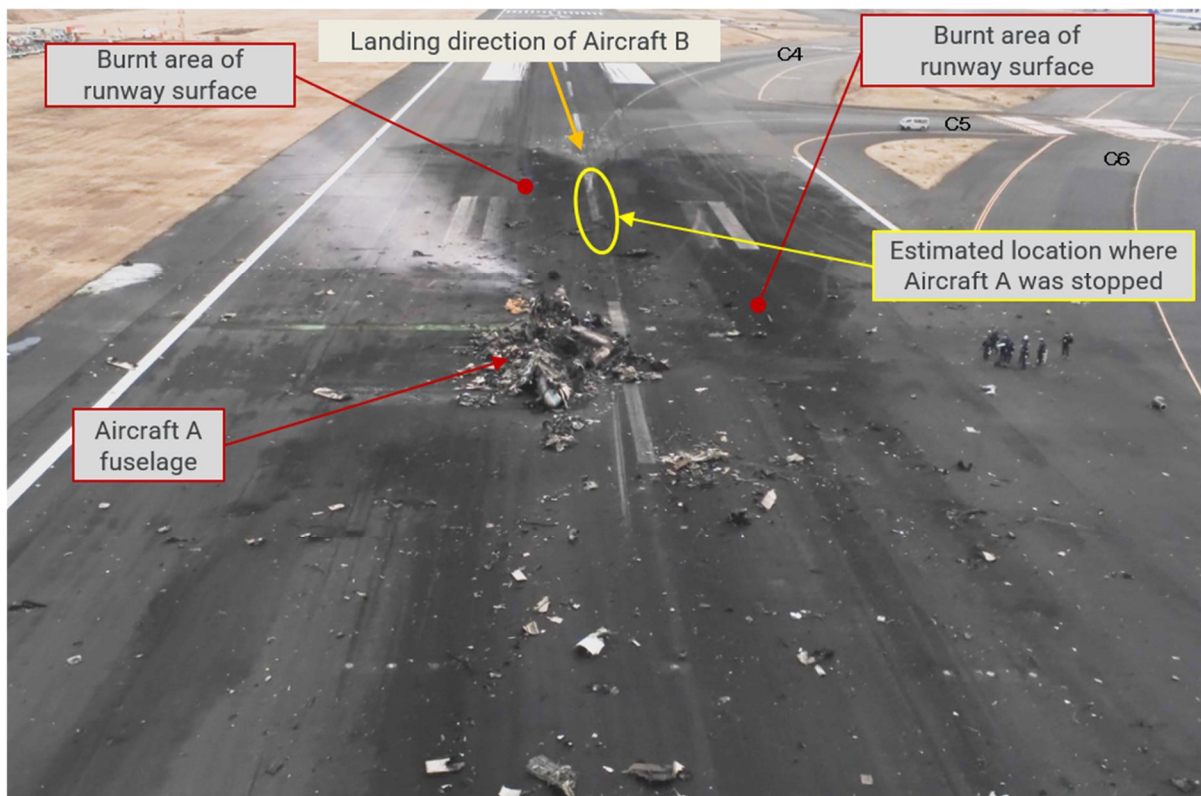
Figure 28: The Scene where Aircraft A and B Collided

The runway surface was scorched from the area where Aircraft A and B collided to where the remains of Aircraft A's fuselage were found (see Figure 28).

A line of abrasion marks remained on the runway from the collision point to where Aircraft B had stopped. The abrasion marks were connected to tracks made by the nose landing gear strut of Aircraft B in the grass beside the runway. In the grass where Aircraft B had run off the runway, there were tracks made by the nose and main landing gear, as well as abrasions caused when both engines came into contact with the grass (see Figure 29).

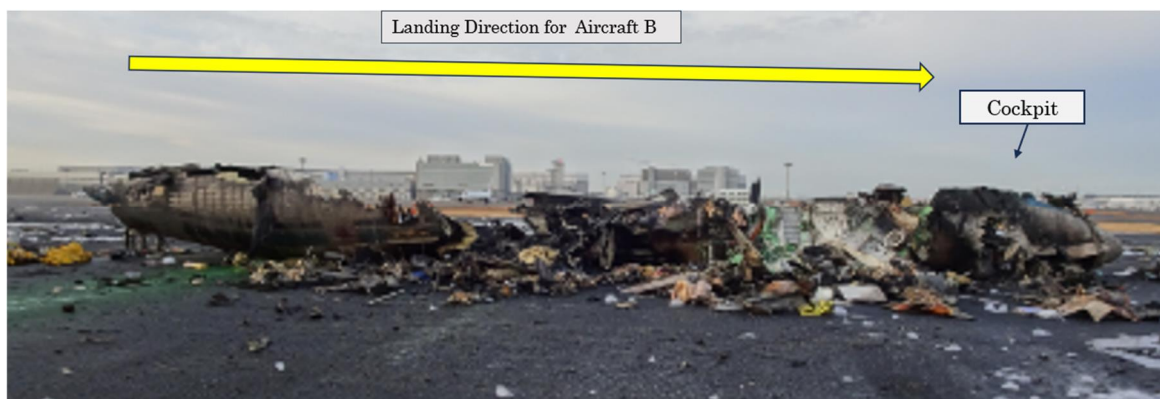
Figure 30-2 Fuselage of aircraft A (right side)

The fuselage was crushed by pressure from the upper rear, and the upper surface, including the wing structure, was completely damaged and disintegrated, and part of the tail fuselage was separated, along with the horizontal and vertical stabilizers and scattered forward and around. There was also fire damage throughout the fuselage (see Figure 30-2).

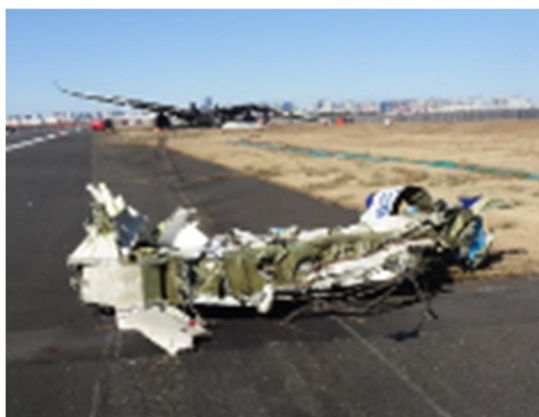
Figure 31-1 Aircraft A Vertical Stabilizer

The tail, which was separated from the tail access door on the underside of the fuselage as a result of the collision, along with the vertical and horizontal stabilizers, and was found in several pieces that were heavily damaged and broken. Part of the rudder was found compressed and buckled from the rear and was found inside the nose structure of Aircraft B.

The main structure of the vertical stabilizer was found close to Aircraft B (see Figures 31-1 and 31-2).

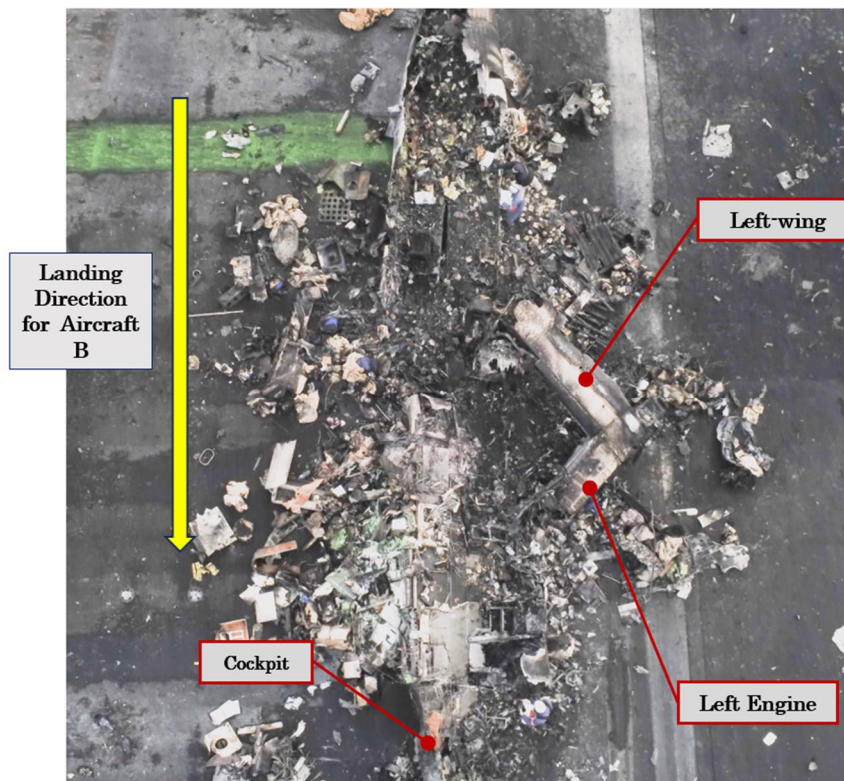
Figure 32: Condition of the Left Wing and Left Engine of Aircraft A

The left wing broke off near the base of the fuselage and was bent 90 degrees forward along with the engine. The center and right main wings were separated from the fuselage and scattered about 50 m forward in an inverted state. The trailing edges of both wings had been severely buckled and deformed by pressure from behind, and most of the outer parts of the wings from the engines were broken. They had also sustained significant damage from the fire that broke out after the collision (see Figure 32).

The left engine was found attached to the left wing along with the propeller and the reduction gear box (hereinafter referred to as RGB) that drives it, but it was severely damaged, with one propeller blade flying off and the remaining three severely damaged and deformed. The right engine had fallen out of the nacelle and was found about 400 m from the wreckage of Aircraft A. All of the propeller blades had flown off, and the RGB, including the propeller hub, had fallen into the grassy area next to the runway near the engine. Both were severely damaged and had been damaged by the fire.

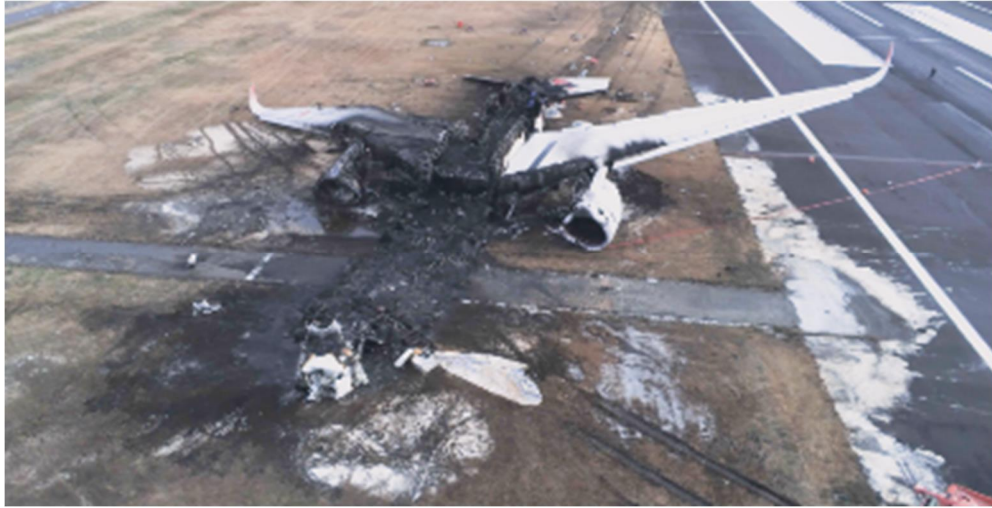
Figure 33: Overall View of Aircraft B

Aircraft B' was sitting in a forward-leaning position with its's nose landing gear buried in the grassy area beside the runway, The radome, forward bulkhead, and intakes of both engines had damaged caused by the collision with Aircraft A.

In addition, a fire broke out, which destroyed most of Aircraft B, except for part of the nose, both wings, both main landing gears, the lower fuselage, and part of the tail of the fuselage (see Figure 33).

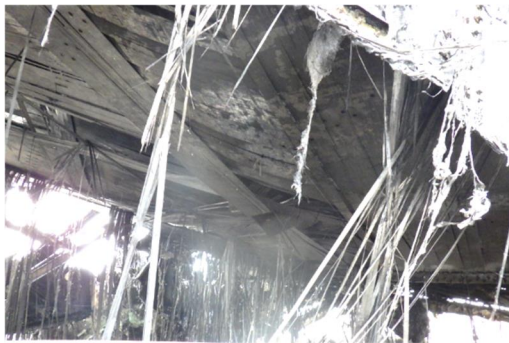
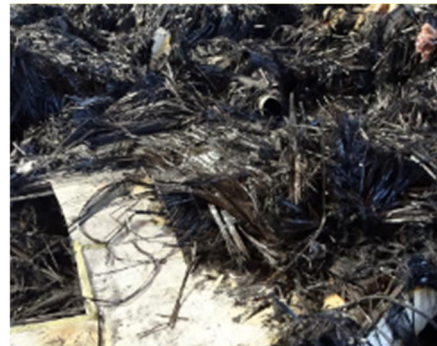
In addition, large amounts of resin ash and fiber dust were flying around the site every time the wreckage was moved (see Figures 34-1 and 34-2).

Figure 34-1: Burnout of the CFRP of Aircraft B
(Left: underside of the right main wing, Right: fuselage)

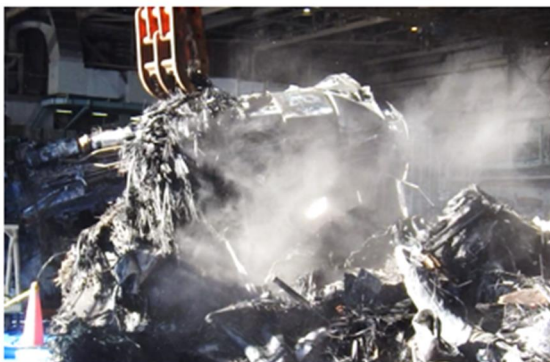
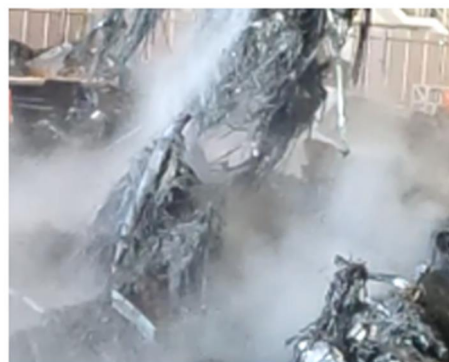
Figure 34-2 Dust after CFRP Burnout

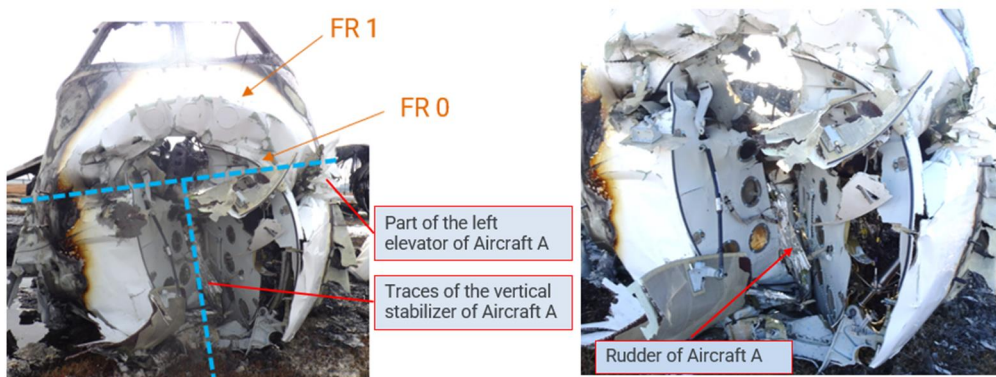
Figure 34-3 Nose Section of Aircraft B (external)

The nose was burned, except for the windshield frame and its surroundings, and the forward frame. The radome was completely destroyed except for the framework, and the inner frames (hereinafter referred to as "FR0" or "FR1, with frame numbers), of which FR 0 in the forwardmost part was cracked vertically in the center (see Figure 34-3). Inside, part of the crushed rudder (140 cm x 115 cm) (see Figure 34-4) of Aircraft A was embedded, as it penetrated FR1, the pressure bulkhead behind it, and its front protective shield (made of aluminum alloy) (See Figures 34-3, 34-5, and 34-6). In addition, on the extension line, a horizontal crack had appeared in FR0 slightly above the center, and part of Aircraft A's left elevator had pierced the left nose skin FR1 (see Figures 34-3 and 34-4).

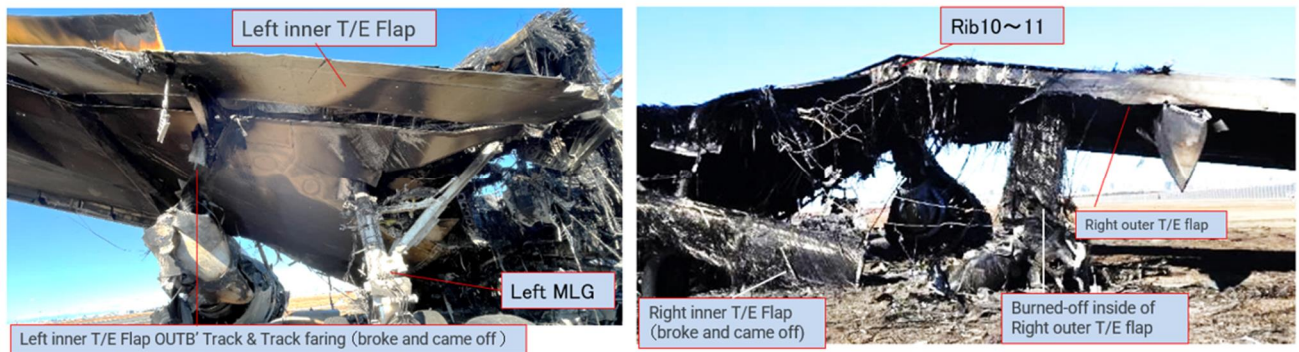
Figure 35: Condition of the Main Wing (from rear)

Both wings were exposed to fires that broke out in the engines and fuselage due to the impact, and the surrounding areas were burned.

The left wing maintained its shape, but the area from the left engine attachment point to the fuselage side had been burned by fire, and the leading edge had been burned off by fire. As for the trailing edge, the outer track fairing of the inner trailing edge flap had fallen off, and there were signs of liquid leaking from near the base. At the time of landing, the aircraft had been carrying approximately 7,000 lb (approximately 3,900 L) of fuel, but when the aircraft was dismantled, very little fuel remained inside the wings (see Figure 35).

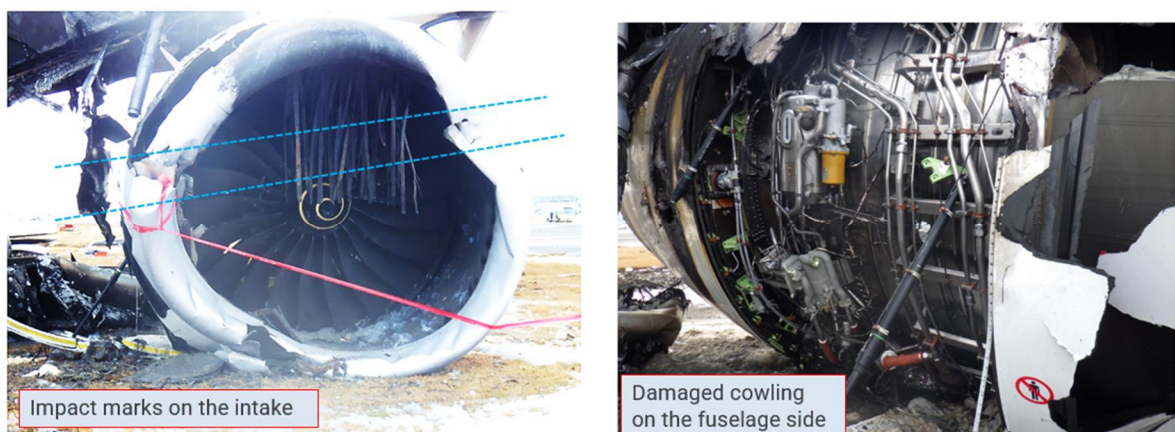
Figure 36-1 Damage to the Left Engine

There were impact marks at the 2 o'clock and 10 o'clock directions toward the front of the intake, and the intake barrel at 2 o'clock (fuselage side) was torn and had a hole. The right side (fuselage side) of the fan cowl was largely damaged, and fragments were scattered on the runway. (see Figure 36-1) Inside the damaged right cowling, the one of the two suction lines to the engine-driven pump of the hydraulic system had been ruptured by the collision, and numerous other damages were found. The thrust reverser was in the stowed position, but its locked position status is unknown because it cannot be structurally determined from the outside.

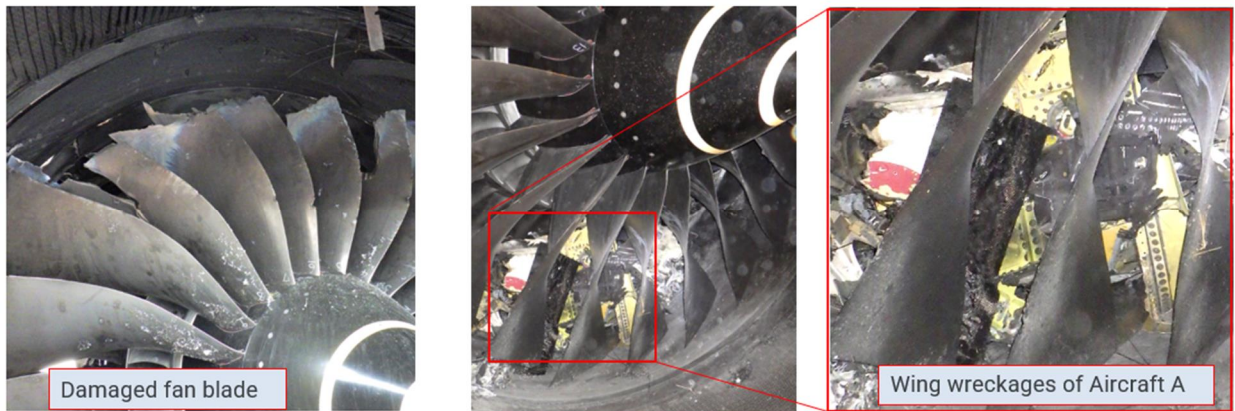
Figure 36-2 Wreckage of Aircraft A Found inside the Left Engine

Seven of the 22 fan blades in total had large tip damages, and a number of other blades were also damaged. Part of the shattered wing structure of Aircraft A was also found on the downstream the fan blades (see Figure 36-2). The rear of the fan duct was exposed to intense fire, and the inside of the duct was also severely damaged by fire.

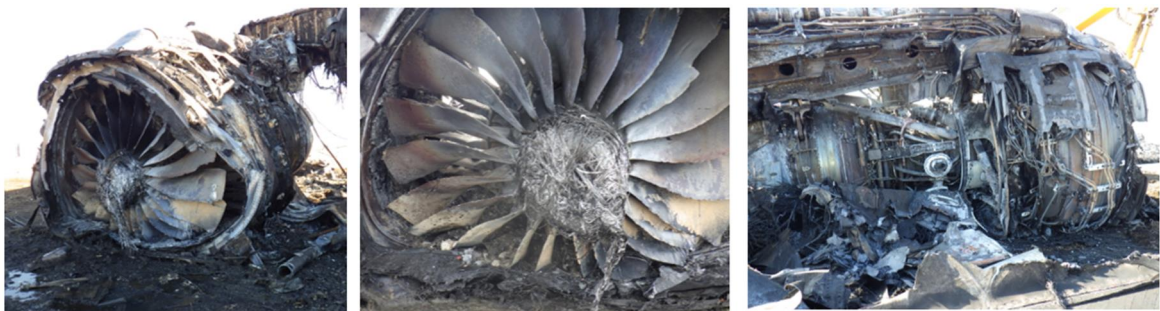
Figure 37 Damage to the Right Engine

Overall the damage from the fire was severe, and the intake was completely destroyed. The fan section was deformed and sunk into the ground, and several fan blades had lost their tips and were deformed along with the fan case. The spinner was also damaged by the fire. In the downstream a blade, there was part of Aircraft A's main wing, which had been shattered, as was the left engine. The entire engine sustained significant damage from the fire, and both the fan cowl and the reverse cowl were severely burned, and other equipment in the vicinity, such as EEC was also completely destroyed by the fire. (See Figure 37)

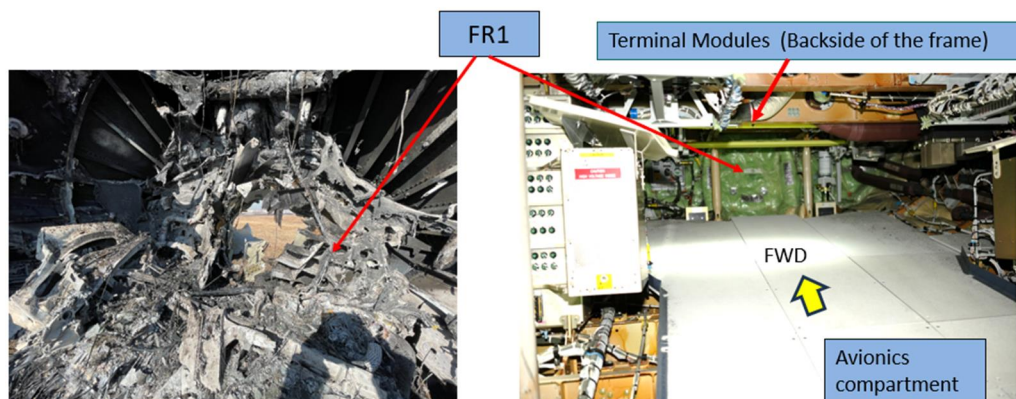
Figure 40-4 Damage to the Nose

- Rudder pedal position sensor and its input mechanism
- Brake pedal position sensor (BPTU) and its input mechanism
- Electrical wiring consolidation point (terminal module) behind the central panel of the cockpit
- Surrounding circuit breaker panels and EPDC (Electric Power Distribution Center), surrounding electrical wiring, and others.

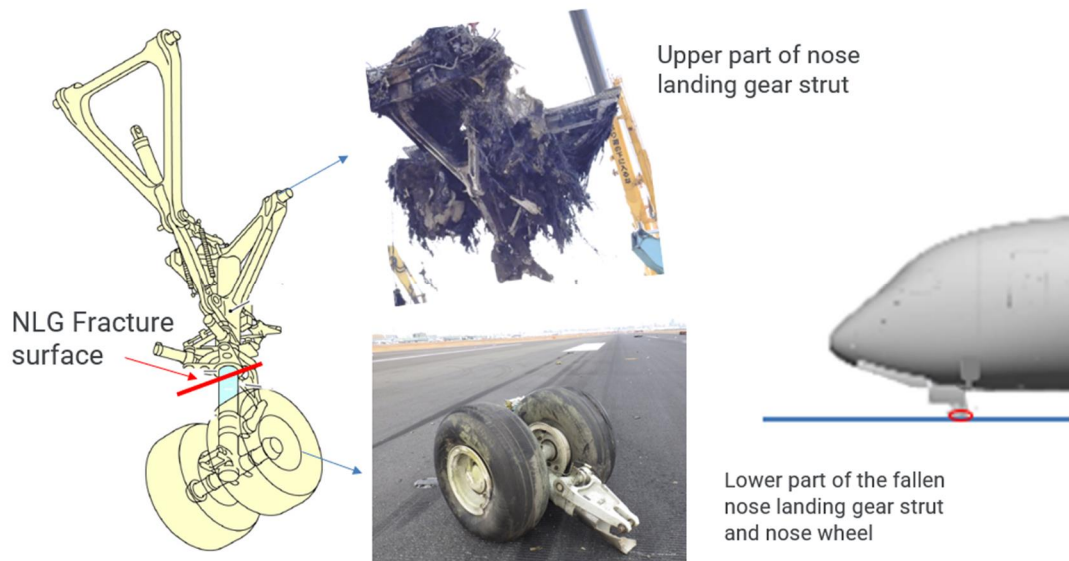
Figure 40-6: Broken Nose Gear (added to the diagram provided by Airbus)

The nose landing gear broke off in the middle of the strut and separated from the aircraft. The separated parts, including the nose tire, fell onto the runway 480 m from the impact point. The struts remaining in the aircraft did not collapse, so the underside of the nose fuselage avoided contact with the ground during the roll (see Figure 40-6).

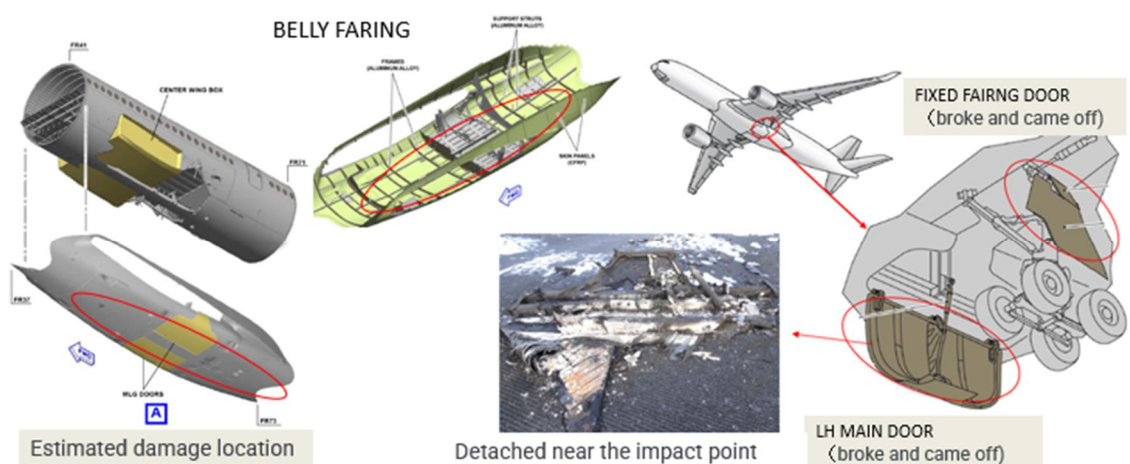
Figure 41-1 Damage to Lower Fuselage, Belly Fairing
(additions to the diagram provided by Airbus)

The fuselage of Aircraft A, which collided with Aircraft B, caused damage to the lower fuselage of Aircraft B when Aircraft B climbed over and it passed Aircraft A. Most of the air conditioning-related equipment inside the wing belly fairing was broken and detached by the impact from below, and an intense fire (could be categorized as an explosion) broke out from aircraft A, causing the left main landing gear well door and left main landing gear door to fall off. These were found in a severely burned condition near the point of impact. (See Figure 41-1 and Figure 41-2).

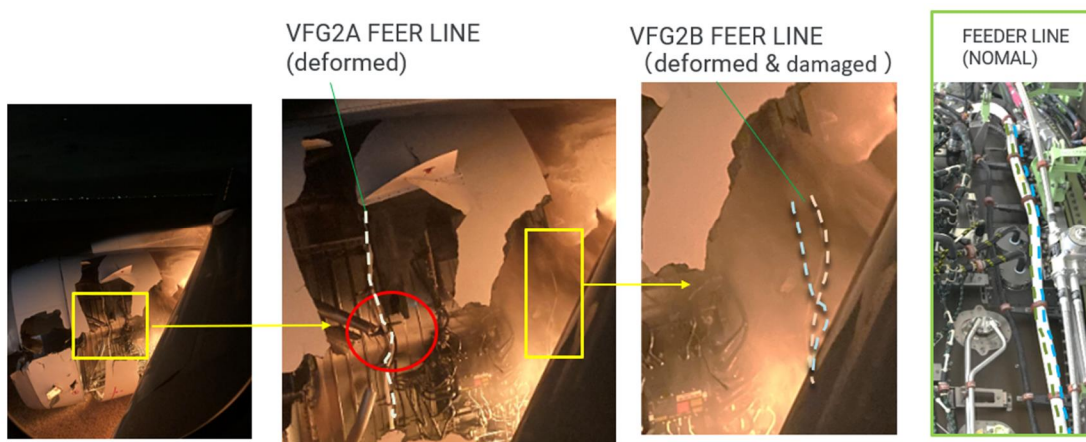
Figure 43 Damage to the Right Engine Power Feeder Line
(pictures provided by passenger)

The FDR recorded that 0.8 second after the impact, 230V EMER AC BUS1 and 115V EMER AC BUS1 were lost. In addition, images taken from outside Aircraft B- and from inside the cabin showed that the power feeder lines and wiring of the two generators (VFGs) on the right engine had been damaged (see Figure 43).

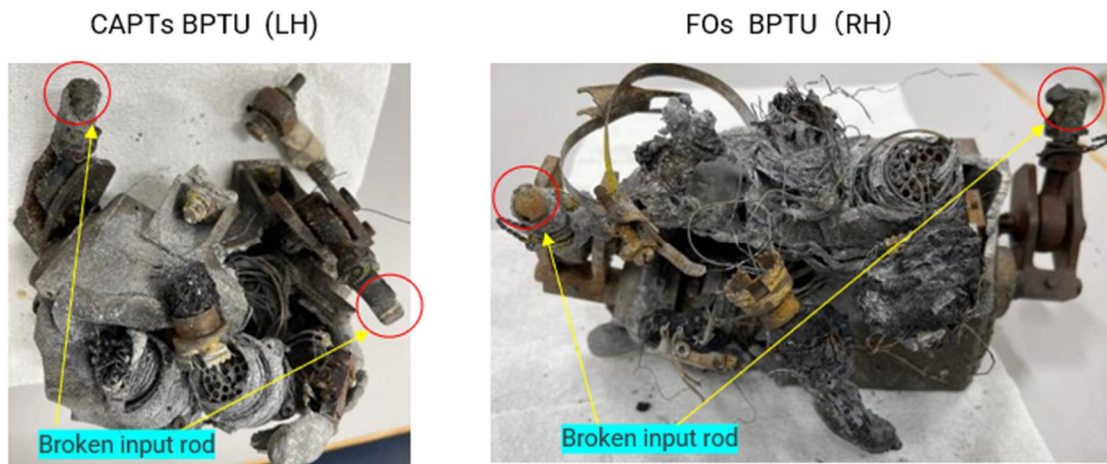
Figure 45-2 Damaged BPTU and Broken Input Rod

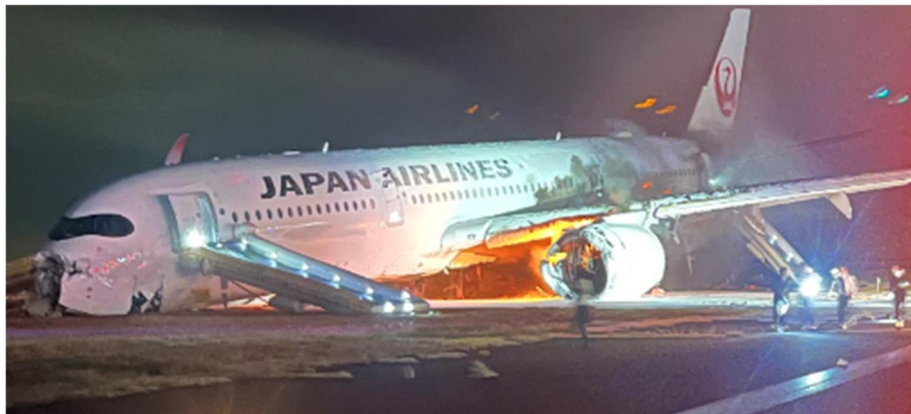
Figure 47: Collapsed Aircraft B
(provided by a passenger)

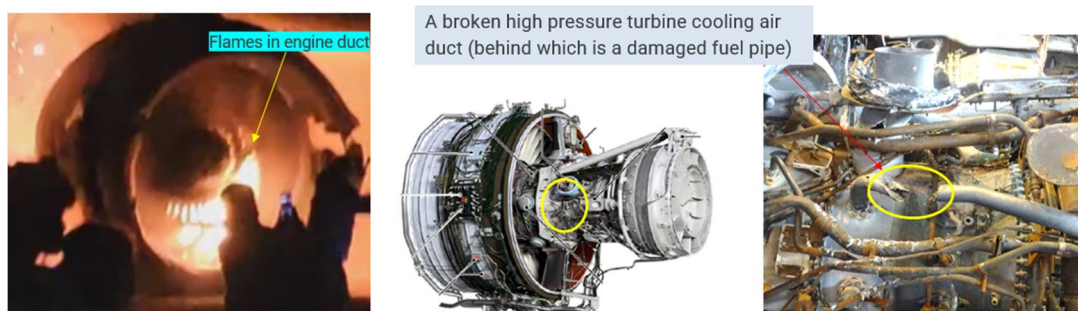
Figure 49-2 : Damage to the Right Engine at 9 o'clock
(added to Airbus diagram)

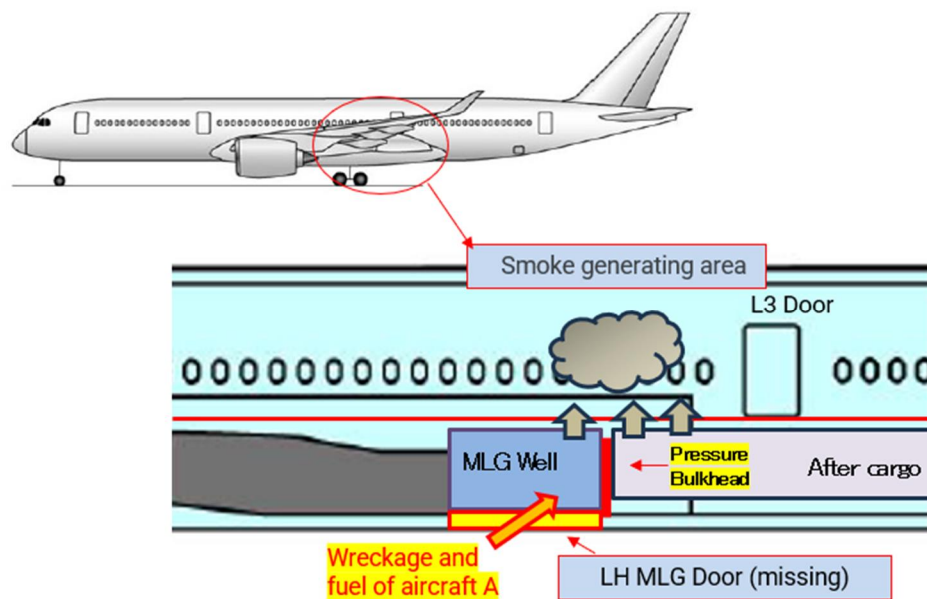
Figure 51-1 Damage to the Lower Fuselage of Aircraft B
(additions to the diagram provided by Airbus)
