**(AIRCRAFT ACCIDENT INVESTIGATION:
THE SECOND INTERIM REPORT)**

**JAPAN COAST GUARD
BOMBARDIER DHC-8-315, JA722A
and
JAPAN AIRLINES CO., LTD.
AIRBUS A350-941, JA13XJ**

December 25, 2025
By the Japan Transport Safety Board

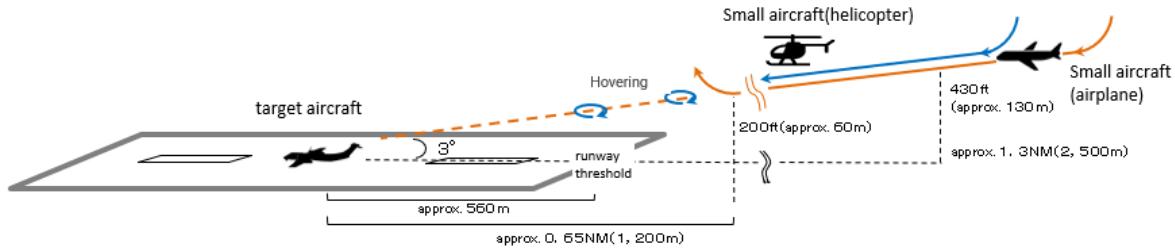
In addition to this verification experiment, to collect data necessary for analyzing Aircraft A's visibility from the approach path, a verification experiment was conducted by positioning an aircraft of the same type as Aircraft A (DHC-8-315) on the runway at Chubu Centrair International Airport at night from March 26 to 27, 2025, under conditions with no moonlight, similar to the day of the accident, and taking photographs from aircraft on final approach. For this verification experiment, the same exterior lights as at the time of the accident were turned on, and the airport lighting was set to the same brightness as at the time of the accident. Aerial photography was also conducted using a small fixed-wing aircraft and a helicopter (see Figure 1).

Figure 1: Verification experiment on the visibility of an Aircraft of the same type as Aircraft A on the runway at night (Image)

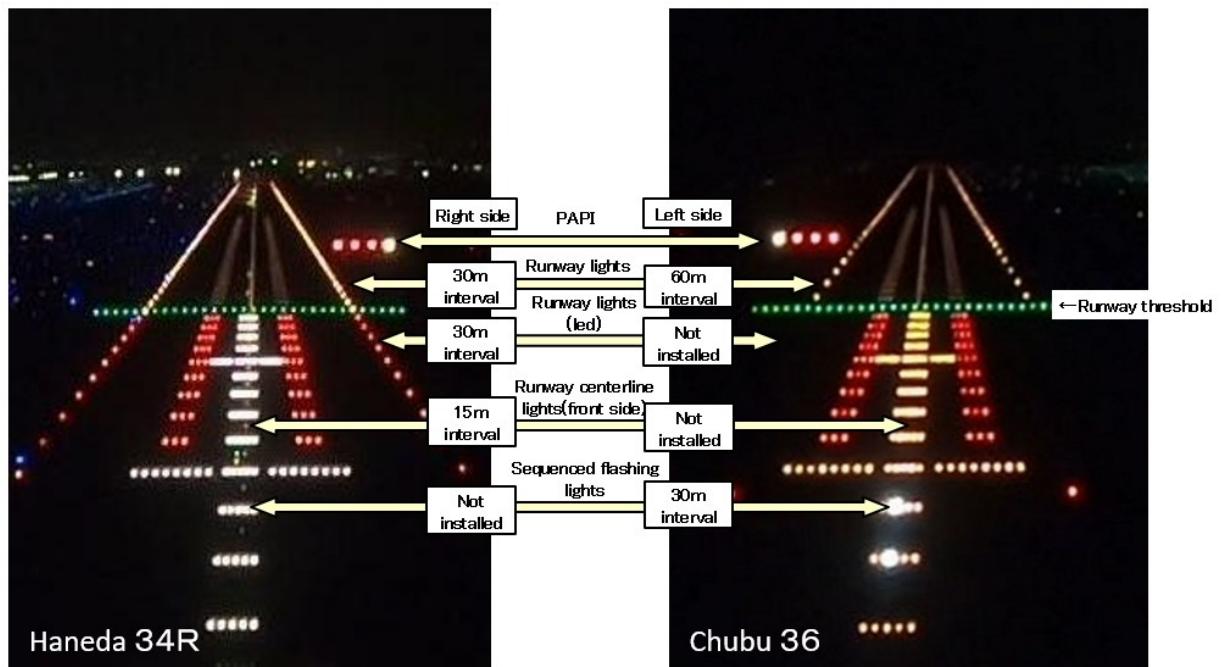
Chubu Centrair International Airport, where this verification experiment was conducted, has a Category III precision approach runway capable of landing even in low visibility conditions, similar to Runway 34R at Haneda Airport. Therefore, while there are differences in the sequenced flashing lights and runway centerline lights on front side of the runway threshold, the area beyond the runway threshold where the same type of aircraft as Aircraft A was positioned which is important for conducting the verification experiment, uses the same airport lighting manufacturer and layout as Haneda Airport's Runway 34R, except for the difference in runway light interval (see Table 1, Figure 2).

Figure 2: Comparison of Airport Lighting Images (Haneda Airport Runway 34R and Chubu Centrair International Airport Runway 36)

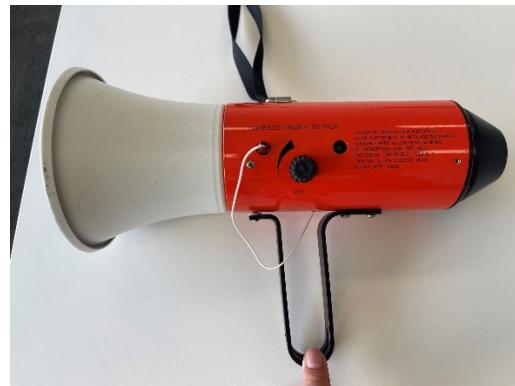
On board aircraft, portable megaphones are carried for use in emergency and abnormal situations to facilitate communication among crew members and to provide instructions and guidance to passengers both within the cabin and following evacuation, outside the aircraft (see Figure 3). Four portable megaphones were carried in the cabin of Aircraft B, and some of the cabin crew used them after the emergency evacuation began. However, some of these crew members stopped using the megaphones because they did not seem to be effective. The results of interviews regarding the transmission of emergency evacuation instructions are shown in Figure 4.

Figure 3: Portable megaphone of the same type as that carried on Aircraft B (output: 2W)

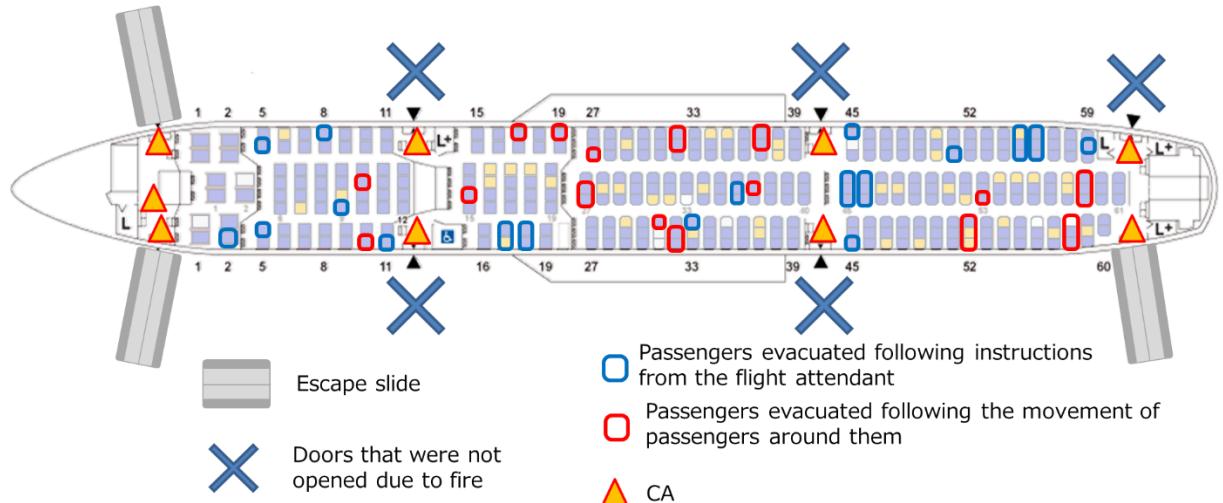
Figure 4: Crew evacuation instructions transmitted (interview with some passengers)
(from the First Interim Report)

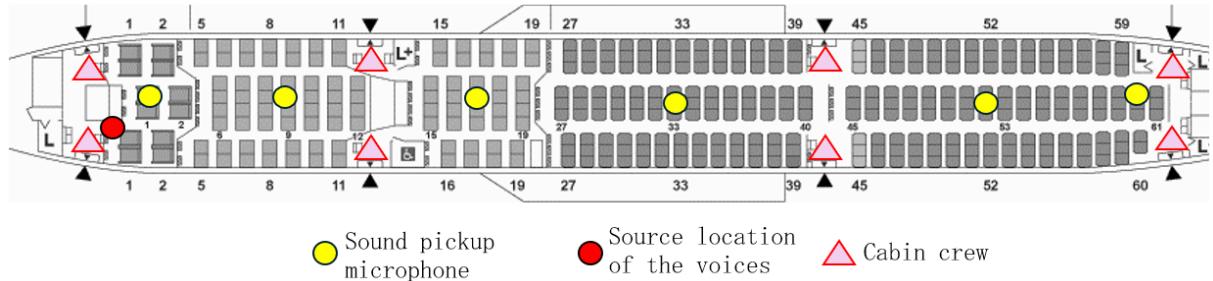
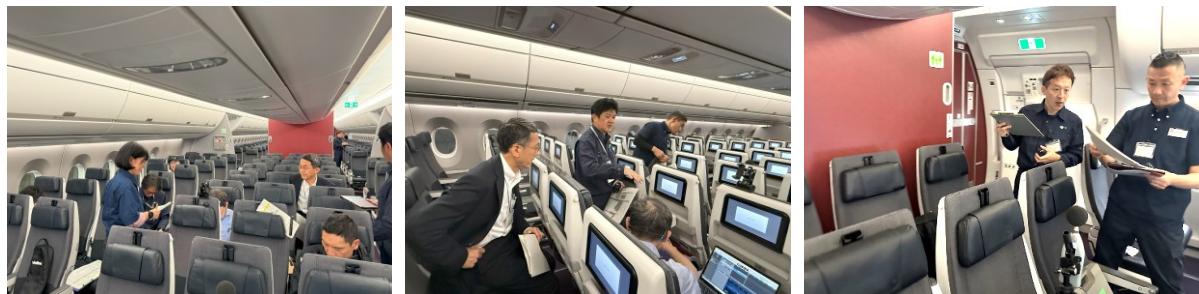
During the emergency evacuation of Aircraft B, smoke filled the cabin over time, reducing visibility and making voice communication critical. Taking these facts into consideration, verification experiments using a portable megaphone were carried out on board an aircraft of the same type as Aircraft B (A350-941) on May 26, 2025, to serve as a reference for analyzing communication in situations where the passenger address system was not operational. For these verification experiments, a portable megaphone was operated in the forward cabin, and the sound levels were measured using microphones installed in six locations. Evaluations were also conducted by cabin crew and investigators acting as passengers positioned throughout the cabin (see Figures 5-7). Furthermore, since the right engine continued to run during the emergency evacuation and the cabin crew were carrying out panic control measures to calm passengers, these acoustic environments were also simulated during the verification experiments, while varying conditions such as the source location of the voices and the use or

Figure 6: Onboard Activities During the Verification Experiments

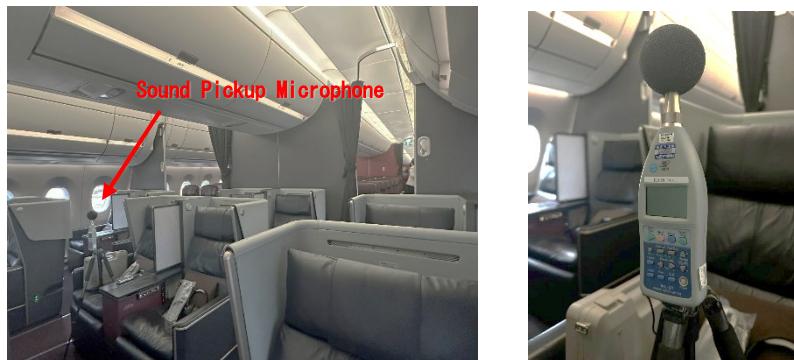
Figure 7: Sound Pickup Microphone Used During the Verification Experiments

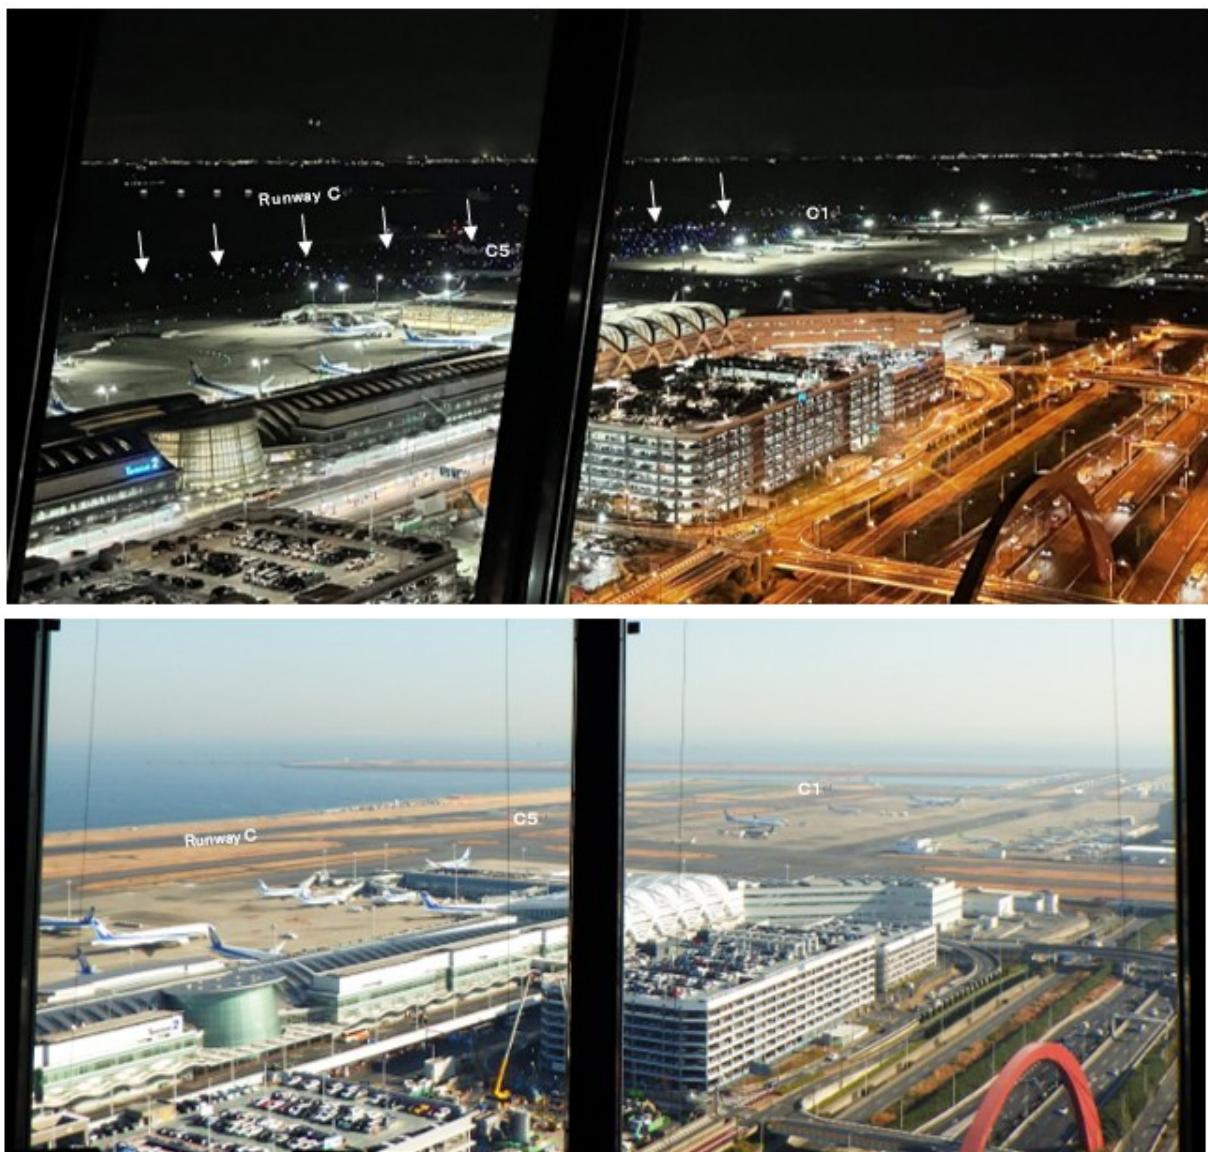
Aircraft accident investigators conducted an on-the-spot confirmation of the visibility of aircraft and various lights from the Haneda Tower at night on January 6, 2024. Based on the factual information subsequently collected and the status of analysis, a further on-the-spot confirmation was conducted on September 19, 2025(see Figure 3).

Figure 8: Image taken from the Haneda Tower (The photograph was taken from a different location than the Tower Control Position East, which was in charge of Runway 34R. The image below is a reference image taken during daytime hours.)
