**MARINE ACCIDENT
INVESTIGATION REPORT**

Vessel type and name: Fishing vessel, Nikko-maru

Accident Type: Foundering

Date and time: approximately 03:44, April 5, 2008 (local time, UTC+9 hours)

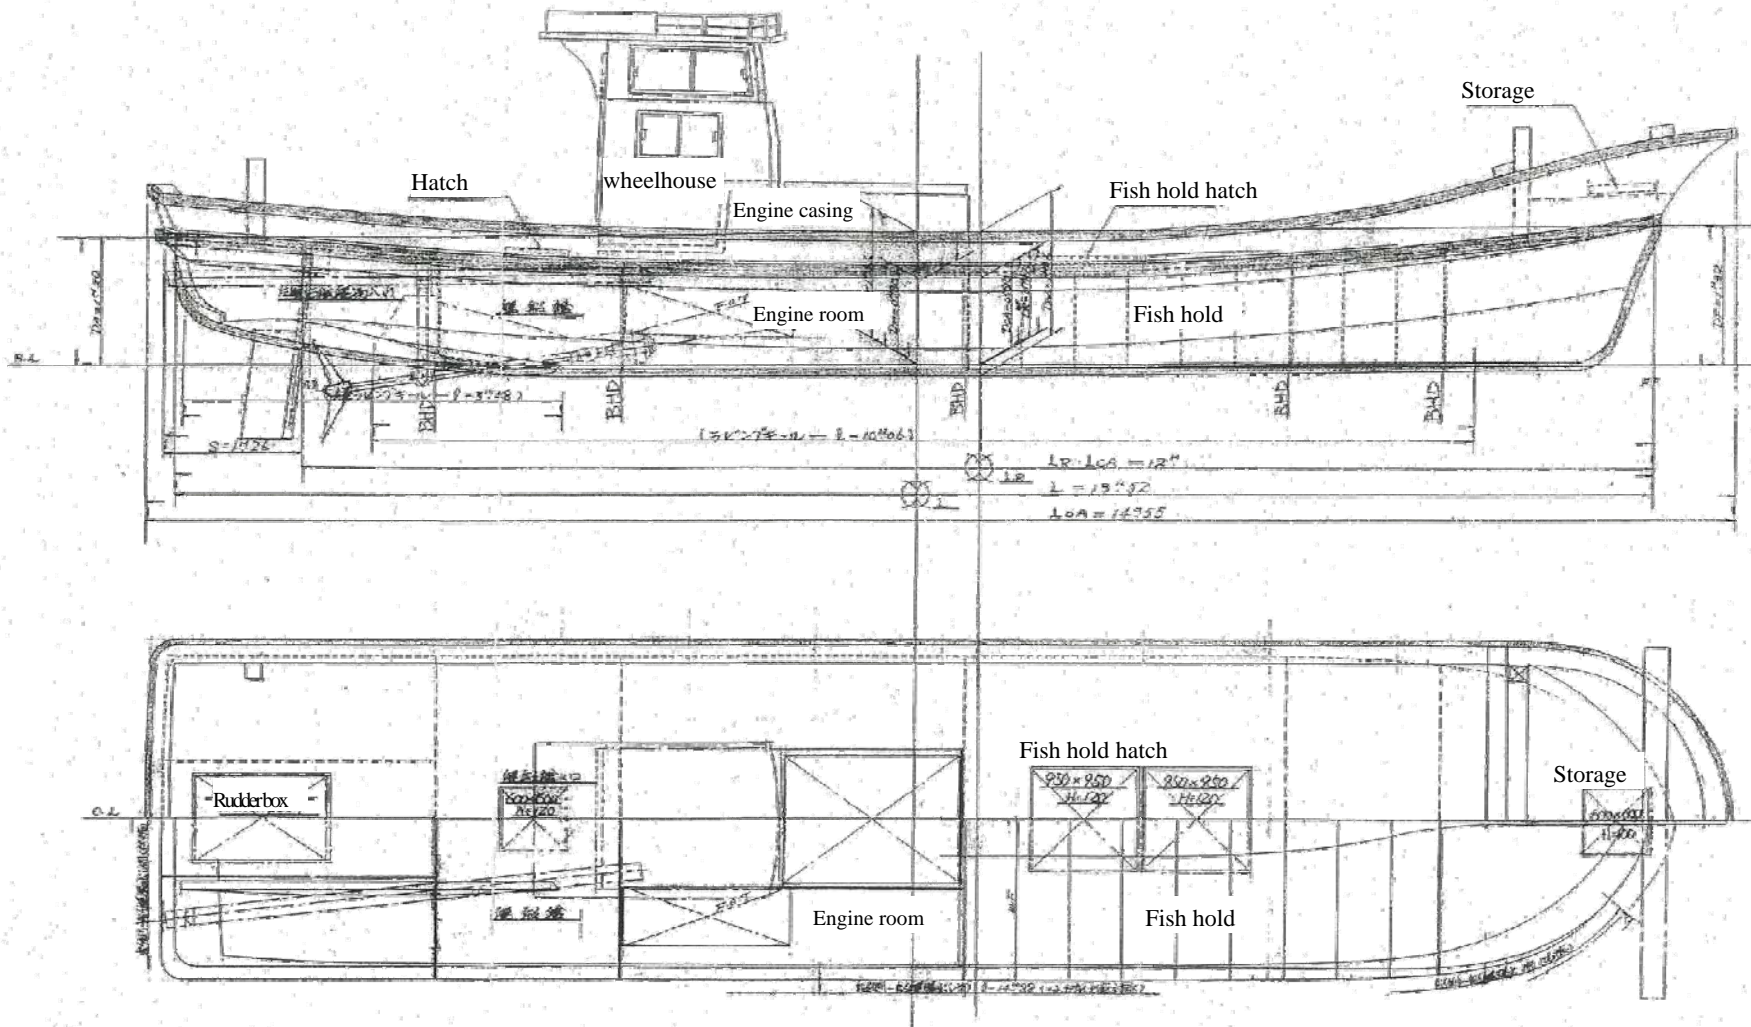
Figure 3 General Arrangement of Ship A (outline plan)

Ship A was equipped with a crane (maximum lifting capacity: 500 kgf; Maximum operating radius: 8.0 m, fully rotational, total weight: 700 kgf) with an extendable boom in front of the wheelhouse and one electric roller aft of the wheelhouse on the port side.

According to the shipbuilder of Ship A, Ship A was designed so that the central part of the hull was extended 0.70 m over the standard model and added a wheelhouse over the engine room.

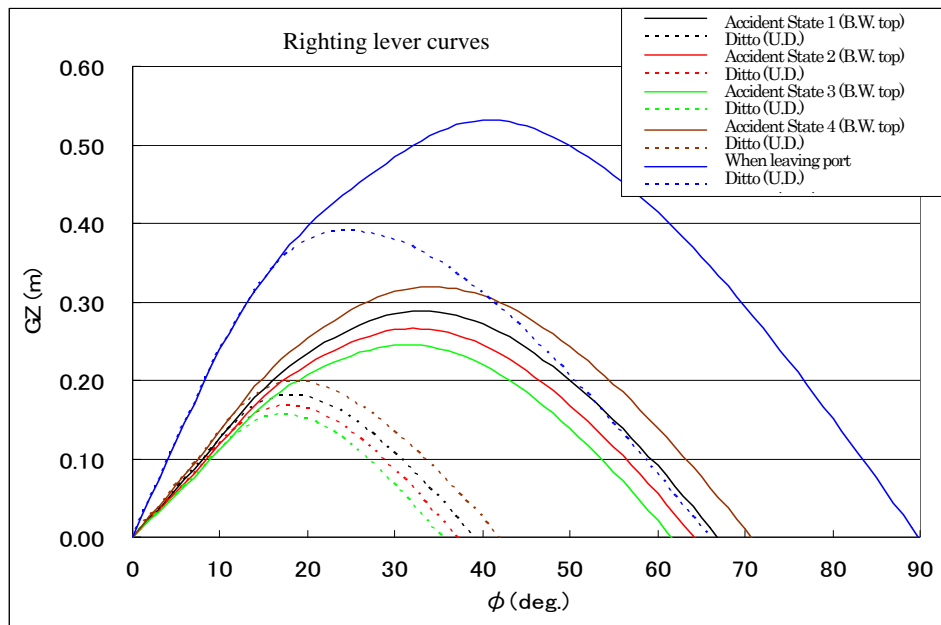
2. Righting lever curves (Calculated Results)

With these calculations by the shipbuilder (calculated with the buoyancy extents up to the upper edge of the bulwarks), it was found that the righting arm in the normally equipped state was a maximum of approximately 0.58 m at an angle of heel of 40°.

NB) The solid lines (B.W. top) mean that GZ is calculated as the buoyancy extent included up to the top edge of the bulwarks. The broken lines (U.D.) mean that GZ is calculated as the buoyancy extent included up to the deck. The horizontal axis is the angle of heel, and the vertical axis is the righting lever.

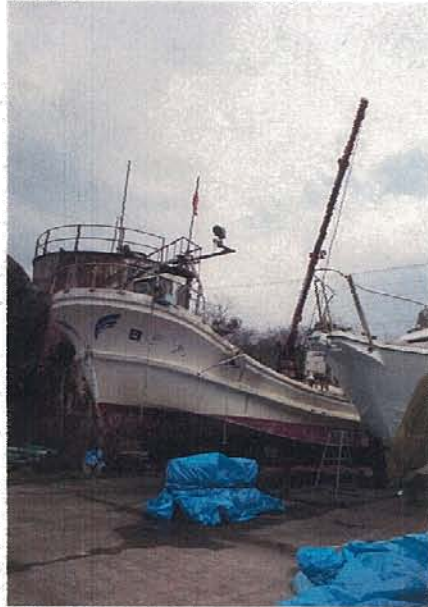
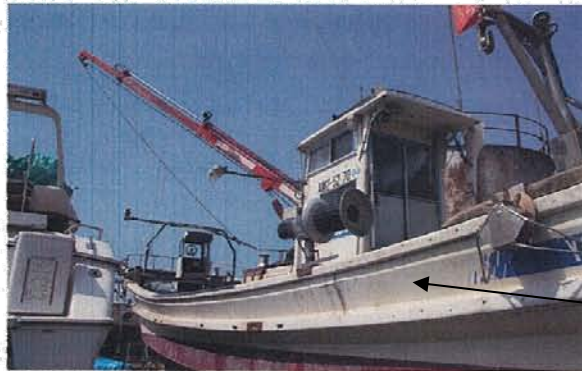
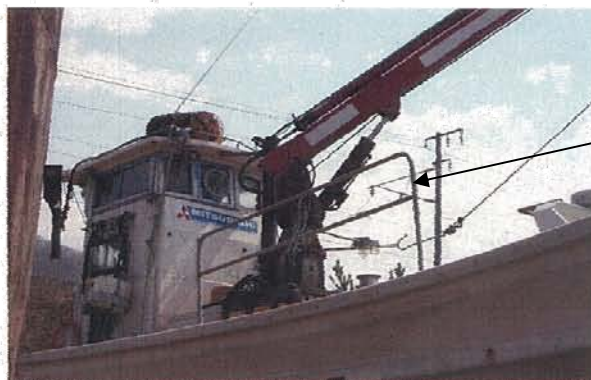
Photo 1 Ship A After Refloated

There was no damage to the hull of the sunken Ship A.

As described in 2.10.4, Ship A was discovered with the helm 75° to port, but at the same time, the main engine remote controller was in neutral. So, it is not known whether the vessel had any speed. The rudder was also raised up to the deck, which mean that it is not known whether Ship A was turning at the time of the accident. Additionally, as described in 3.1.1 (5), the return course to port is considered to be generally 135°. And, as described in 2.10.3, the bow of the ship was facing 080° when it foundered, but it is not certain whether this 55° change in bow heading was caused by Ship A turning or from uneven pressure flow during its submergence from the sea surface to the bed.
