MA2009-12

**MARINE ACCIDENT
INVESTIGATION REPORT**

MARINE ACCIDENT INVESTIGATION REPORT

Vessel type and name: Recreational fishing vessel Koyo Maru No. 7
Vessel number: 220-17774 Niigata
Gross tonnage: 3.2 tons

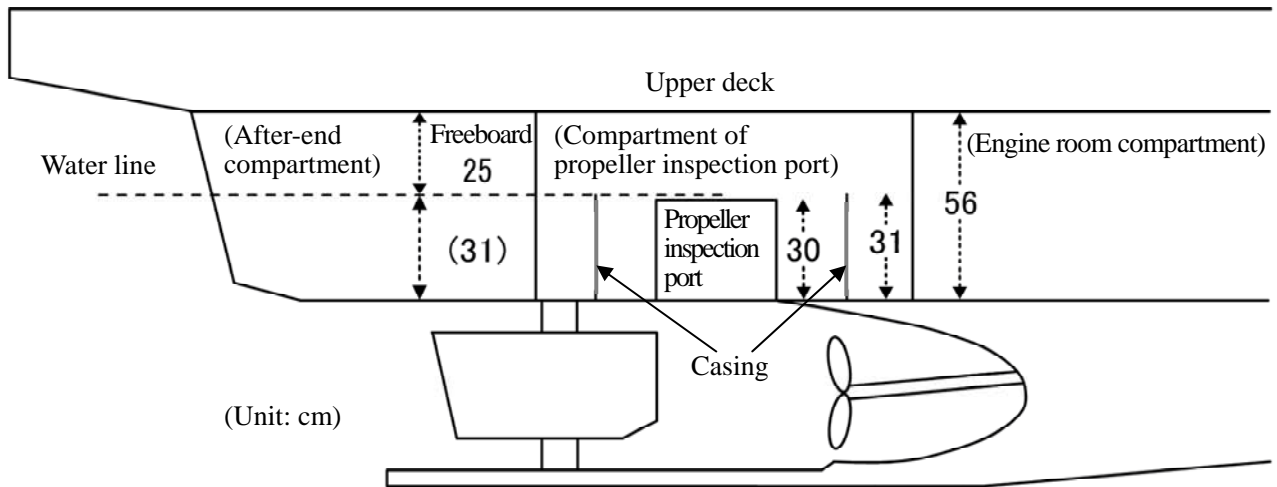
Arrangement around the propeller inspection port compartment

From 2.7.2 (1), 2.7.4 (2), 2.7.5, 2.7.6, 3.2.2 and 3.3.1, the freeboard near the propeller inspection port was about 25 cm, and the water line (about 31 cm) was about 1 cm above the upper end of the propeller inspection port (about 30 cm), therefore, it is considered probable that seawater gushed out of the inspection port.

In addition, although the upper end (about 31 cm) of the casing surrounding the propeller inspection port was of the same level as the water line, it is considered probable that the seawater entered, from the same casing, and filled up the compartment of the propeller inspection port, as a result of vessel oscillation caused by Vessel A's movement through the water and waves, and water pressure caused by propeller revolutions. The vessel passed a renewal survey in April 2007, which means that the vessel is considered to have probably met the requirements at that point in time. However, it could not be determined if the vessel satisfied the structural standards of the propeller inspection port, as specified in 2.7.6, at the material time of the accident.

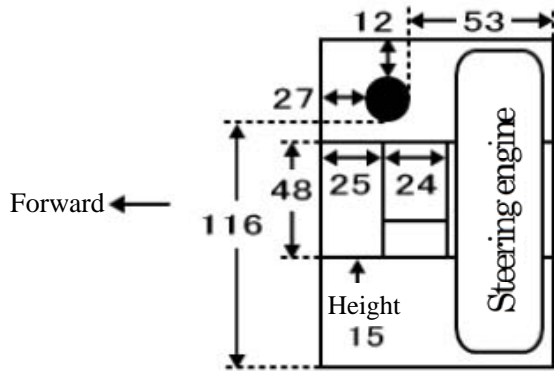
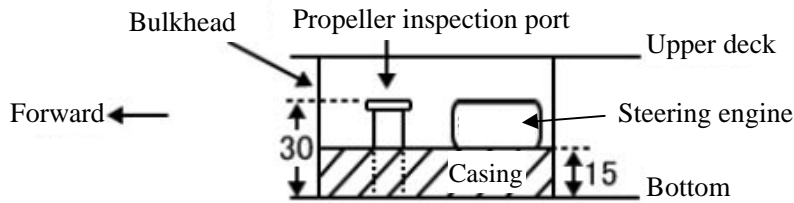
Steering engine room
(compartment of propeller inspection port)

(1) The compartment of the propeller inspection port was dirty and the brass frame of the window was partly stained with verdigris, indicating a lack of daily maintenance.

It is considered probable that, as part of an inspection before departure, the skipper should have opened the hatch cover to check for the presence of bilge water in the compartment of the propeller inspection port, and to inspect the condition of the inspection port itself.

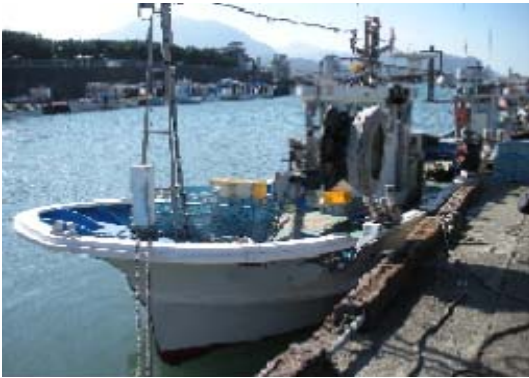
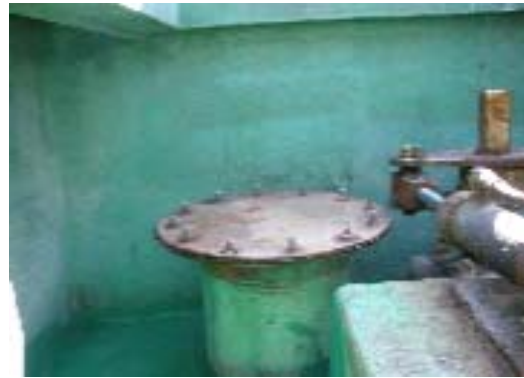
Photo 6 Vessel D

(1) The investigators inspected, at a fishing port near Shipbuilder A, a vessel (hereinafter called 'Vessel D') similar in structure to Vessel A in the aspect of having a cylindrical, propeller inspection port. The following facts were found:

1) The cylindrical, FRP propeller inspection port of Vessel D was about 30 cm high. The top end was covered with an about 0.3 cm thick, FRP lid of about 35 cm in diameter, which was fixed, on a rubber packing, with 12 stainless bolts and nuts.
