**MARINE ACCIDENT
INVESTIGATION REPORT**

Vessel type and name: Cargo ship "NORD POWER"

Vessel type and name: Cargo ship "HAI YING"

Accident type: Collision

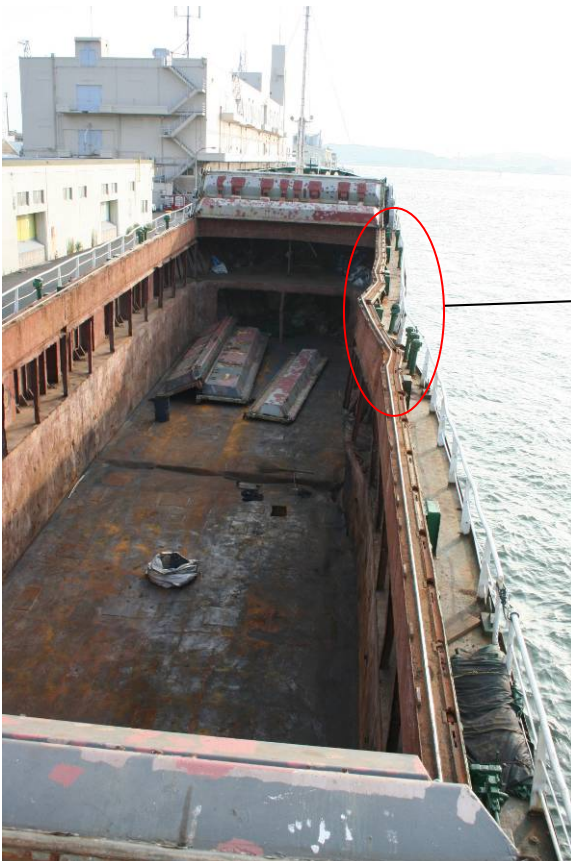
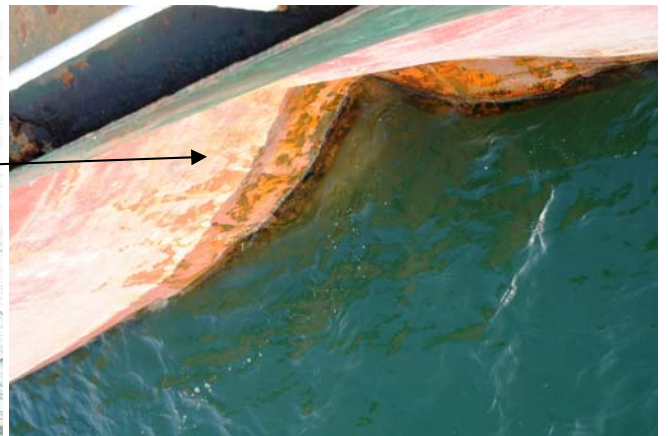
Photo 4 Starboard of Vessel B

Vessel B had a dent near the upper deck on the hull, 10 meters wide at the widest point, from the upper deck near the middle part of the starboard side to the bottom. There was another vertical wedge-shaped dent from the upper dent to the bottom, about 0.7 meters deep at the deepest point. The cargo hold was flooded with seawater from the crack on the hull below sea level. The cargo of packaged graphite became wet and the hull listed 24° to the starboard side, but the vessel did not capsize. The hatch cover and hatch coaming on the upper deck were bent in the collision.

Damage near the starboard waterline
