**MARINE ACCIDENT  
INVESTIGATION REPORT**

Vessel type and name: Car carrier; CYGNUS ACE

Vessel type and name: Multi-purpose cargo ship; ORCHID PIA

Accident type: Collision

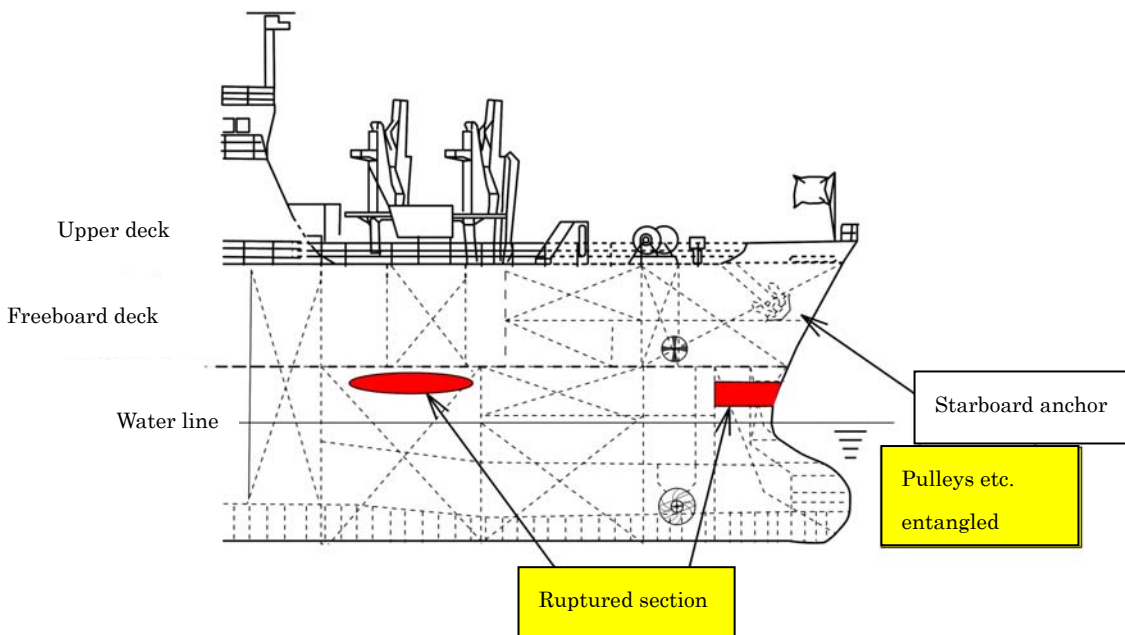
Figure 21: Damages to the bow section of Vessel A

Ruptures in several locations of the bow section resulted in leaks, and damage including dents were also present in the starboard bow bulwark and port bow ramp way and others.

- (a) Foremost bow section near the waterline; length: approx. 4.1 meter; height: approx. 1.0 meter
- (b) Starboard bow section (No.2 ballast tank, approx. 13.0 meter astern of the foremost rupture, approx. 2.0 meters above the waterline); length approx. 6.0 meters; breadth approx. 1.2 meters

It is considered probable that the damage was caused by contact with the tip of the forward-facing boom for Vessel B's No.2 derrick.

It is considered probable that the damage was caused by contact with the upper section of the platform attached to the derrick post of Vessel B's No.2 derrick.

In multi-purpose cargo ships like Vessel B, longitudinally extended frames are often integrated into the hull structure as reinforcement members. It is considered probable that the damage was the result of the bulbous bow section contacting with the upper portion of such members.

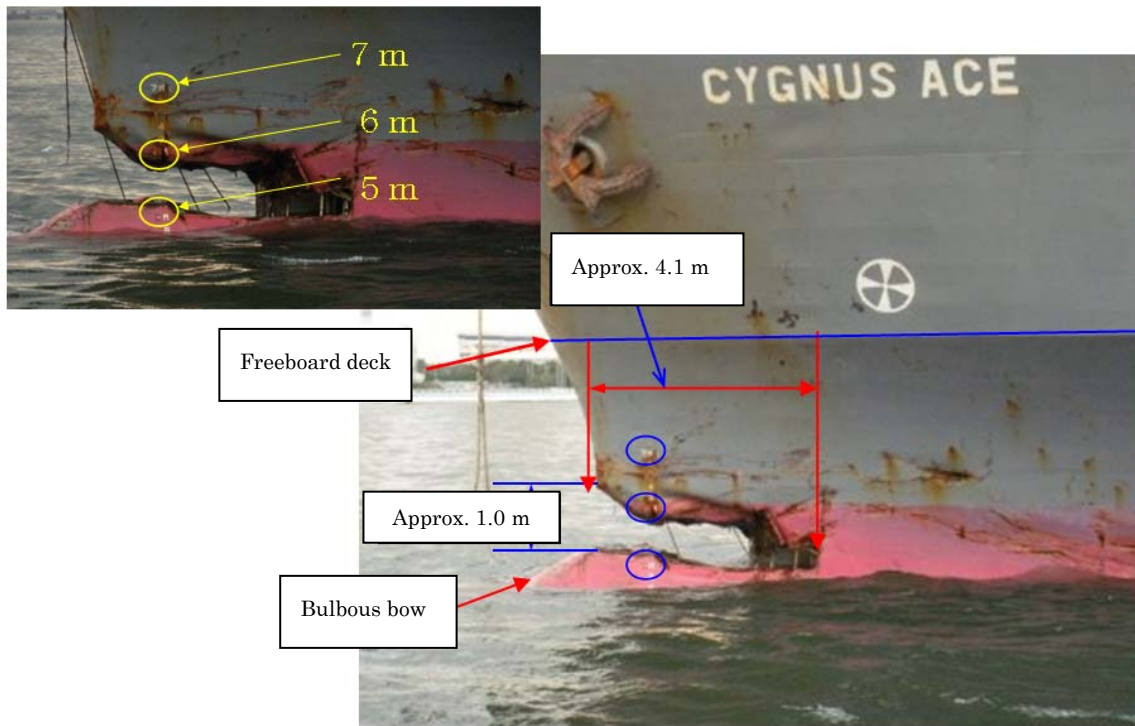
Photograph 1: Damages above the waterline of Vessel A (1)

These dents were caused by the foremost section of the bow of Vessel A contacting with the tip of the forward boom of No.2 derrick on Vessel B, which was parked on the port side above the cargo hatch.

These ruptures were caused by the starboard section of the bow of Vessel A contacting with the upper port section of No. 2 derrick post platform on Vessel B.

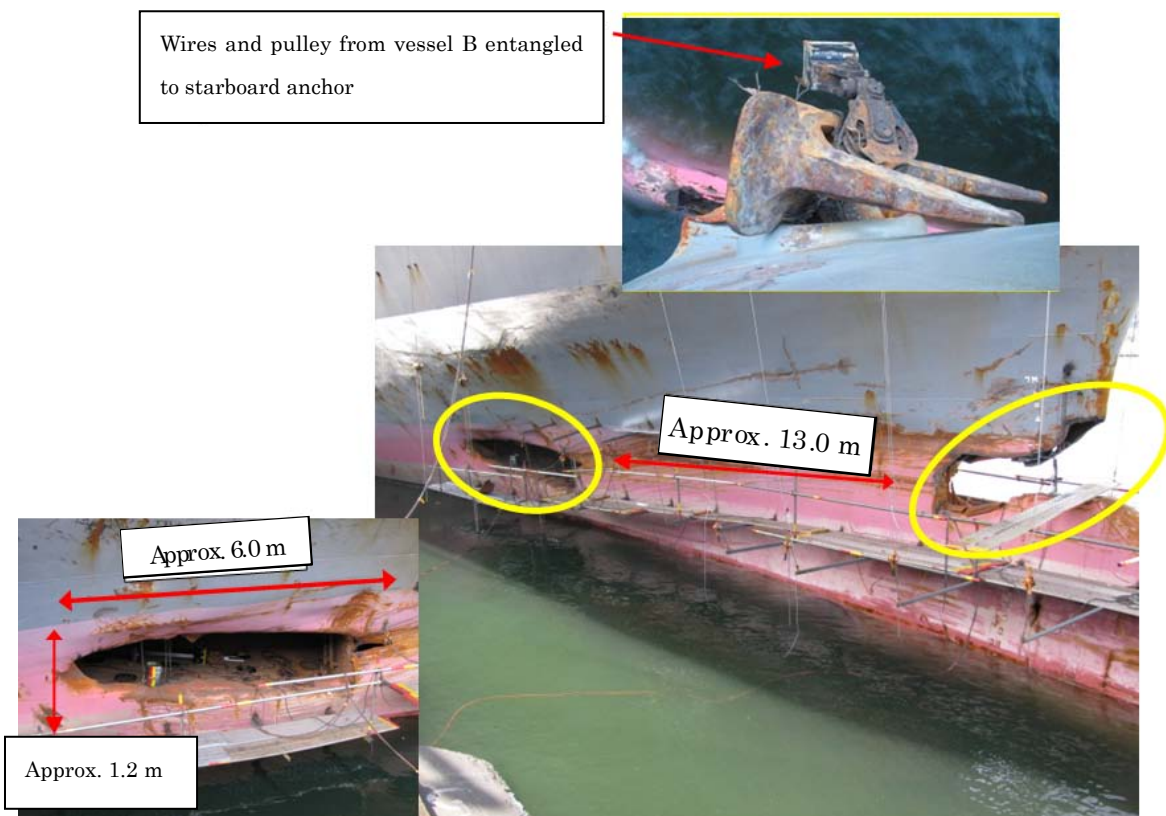
Photograph 2: Damages above the waterline of Vessel A (2)

These dents and scratches were caused when the port bow section and forward ramp way of Vessel A violently contacted with the numerous pulleys and wires

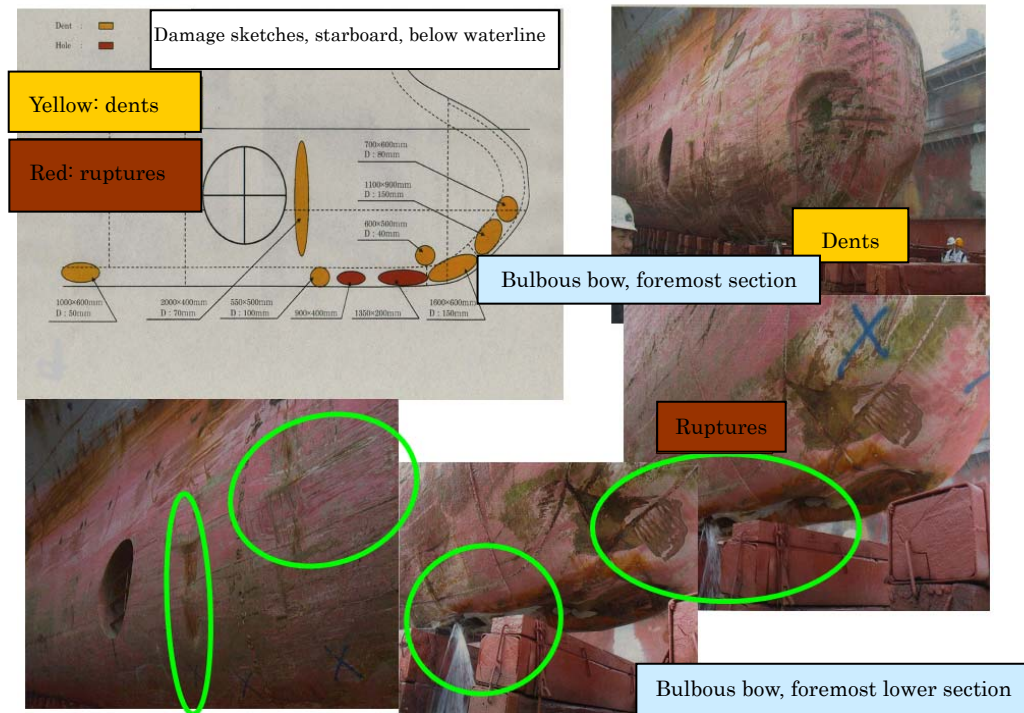
Photograph 3: Damages below the waterline of Vessel A (starboard)

Rupture major-- length approx. 1.35 meters; breadth approx. 0.2 meter

Dents (Significant damage to lower areas of the bulbous bow)

These ruptures were caused when Vessel A ran onto the port deck of Vessel B, contacting with the side edges of the hull and the cargo hatch area.

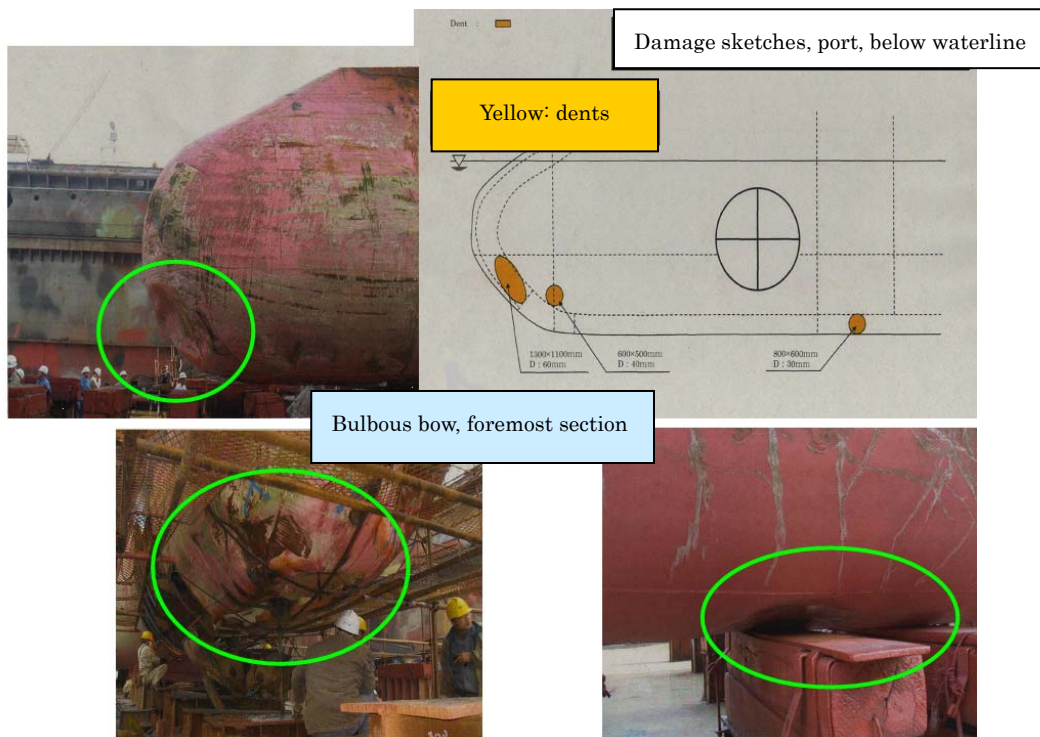
Photograph 4: Damages below the waterline of Vessel A (port)

No ruptures caused

Dents (Significant damage to lower areas of the bulbous bow)
