MA2012-4

**MARINE ACCIDENT  
INVESTIGATION REPORT**

**Japan Transport Safety Board**

| Vessel type and name | Cargo ship | SINGAPORE GRACE |

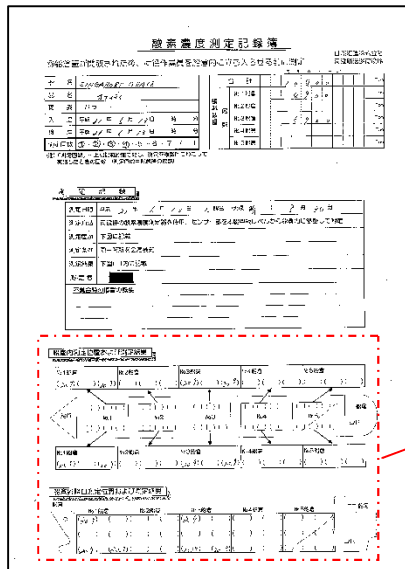
"Copy of Record Book"

However workers had measured O<sub>2</sub> concentration at other points instead of entrance-hatch due to difficulties of measuring by change of structure beside with increased size of vessels (adoption of slanting ladder, landing and others) without the stevedoring company's noticing it. The stevedoring company perceived it after the accident.

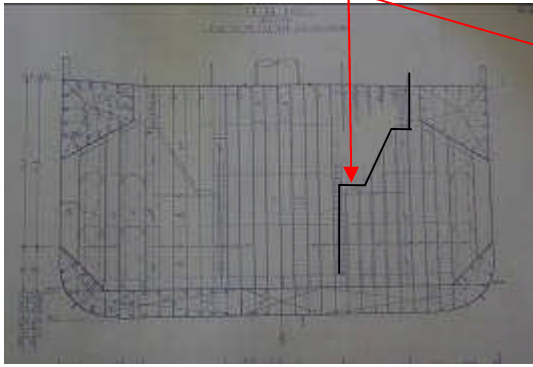
It should be noted that the horizontal length from the aft end of the left side of the hatch coaming to the point below the second landing was 5-6m (as indicated in “Section of Hold (excerpt)” (2.1.6. (6))).

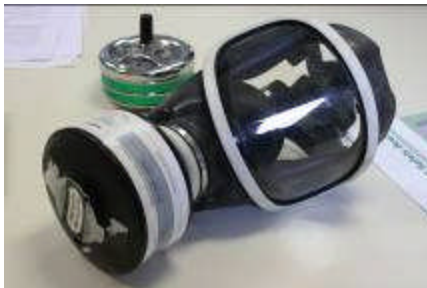
“Gas Mask and Canister”

When Operators C and F were catching their breath, crew of the ship provided them with gas masks<sup>20</sup>. On the canister attached to the gas mask “INORGANIC GASES & VAPOROUS” was written.

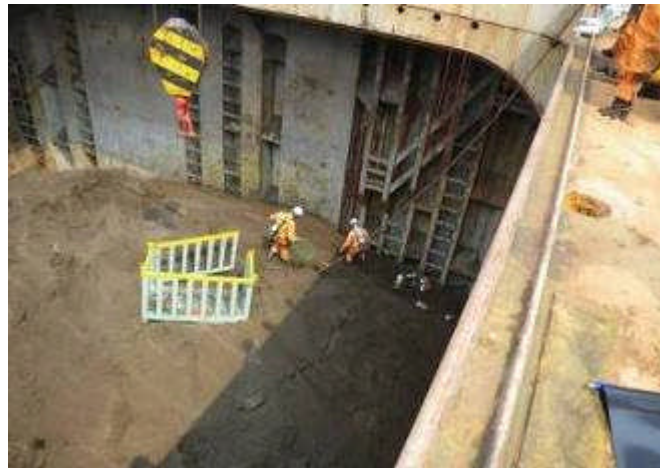
“Rescue Conditions”

Consumption per minute of air is 40 ( $\ell$ /min.) for light work, 60 ( $\ell$ /min.) for medium work and 80 ( $\ell$ /min.) for heavy work. The actions of the rescue team are always regarded as heavy work, hence the calculated usable time is 12 minutes.
