**MARINE ACCIDENT
INVESTIGATION REPORT**

Accident type	Fatality of stevedore
Date and time	At around 1830–1832 hours on August 18, 2010
Location	Pier P, Hattaro Area of the Port of Hachinohe, Hachinohe City, Aomori Prefecture, Japan (Approximate position: 40°33.8'N 141°29.3'E)
Summary of the accident	<p>At around 1830–1832 hours on August 18, 2010, while cargo was being discharged from the No. 4 cargo hold on the cargo ship STAR KVARVEN moored at a pier in the Port of Hachinohe, a signal person, who was traveling from the hatch covers laid on the No. 3 cargo hold to the hatch covers on the No. 5 cargo hold, fell from either a hatch cover on the No. 3 cargo hold or the maintenance ladder at the foot of the gantry crane.</p> <p>The signal person was taken to a hospital, but was later pronounced dead.</p>
Process and progress of the investigation	<p>(1) Setup of the investigation The Japan Transport Safety Board appointed an investigator-in-charge, a marine accident investigator and a regional investigator (from the Sendai Regional Office) to investigate this accident on August 20, 2010.</p> <p>(2) Collection of evidence August 20, 2010: Interviews August 20 and 23, 2010: Collection

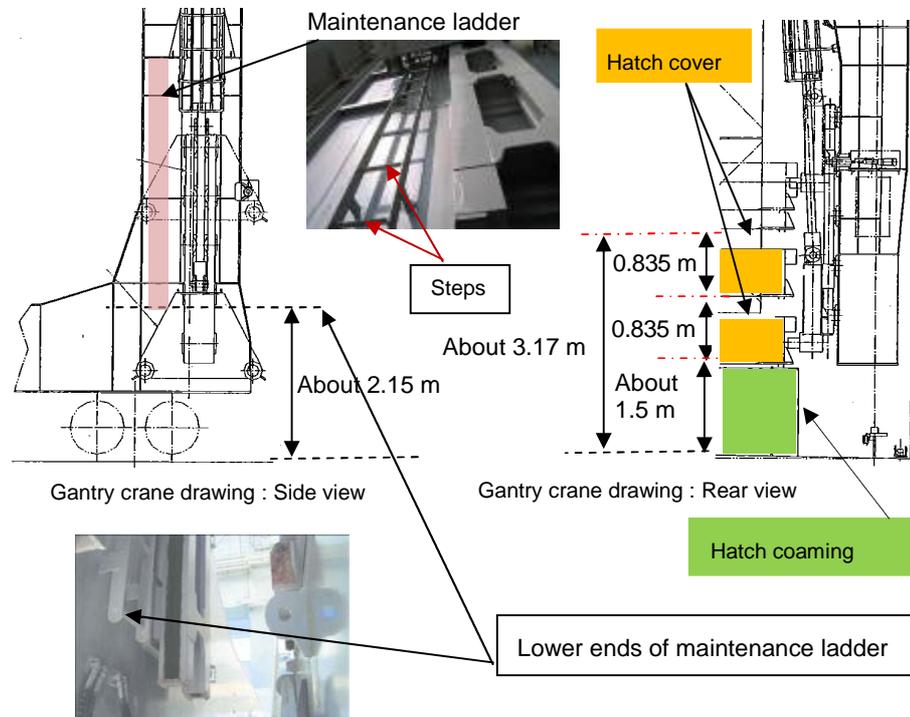
(3) Maintenance ladder

- 1) A maintenance ladder was provided at the forward legs of both sides of the gantry crane.
- 2) The lower end of the maintenance ladder was located at about 2.15 m above the upper deck. Each step of the ladder was made of a steel square bar, with each side measuring about 2 cm. The steps were about 23 cm apart from each other.

Actions taken	<p>(1) After the accident, Company A implemented following measures:</p> <ol style="list-style-type: none"> 1) Only the signal person shall issue orders to the crane operator. 2) Traveling to/from hatch covers shall be made via the hatch coaming-mounted ladders (steps). The use of the maintenance ladders installed on the gantry cranes shall be banned. 3) Travel between work sites and other operations shall be carried out by at least two persons wherever practically possible to ensure cross monitoring of each other's working conditions. <p>(2) The management company for the Ship implemented following measures:</p> <ol style="list-style-type: none"> 1) Soon after learning of the accident, the company instructed all its managing ships to paint one metre wide around all hatch covers with anti slip paint same as the ship and her sister ships that already painted when delivered to owner. 2) In order to facilitate the lifting from the upper deck to the hatch covers, the ladders were moved or redesigned.

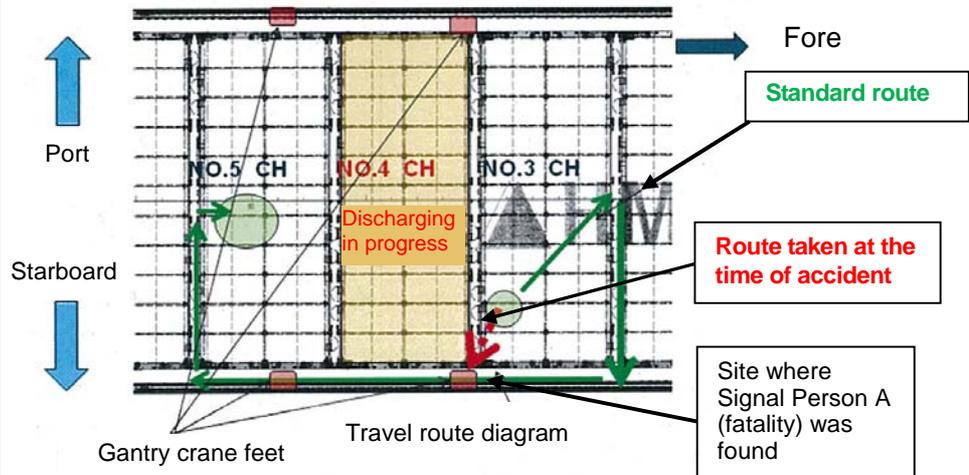
Near the accident site

Onboard Worker A, thinking that he could reach the hatch cover on the No. 5 cargo hold more quickly by using the maintenance ladder at the starboard-bow foot of the gantry crane (hereafter referred to as "the Maintenance Ladder") that just happened to come into his view at that time, traveled from the hatch covers laid on the No. 3 cargo hold to the Maintenance Ladder, and then moved along the hatch coaming and the gantry crane foot members to the starboard upper deck.

When Onboard Worker A and the foreman took the route described above using the Maintenance Ladder, they realized that the ladder ended short of the upper deck.

Onboard Worker A, who thought that Signal Person A had been following him, was unable to find him anywhere near the hatch cover on the No. 5 cargo hold. When he looked toward the starboard upper deck, he discovered Signal Person A lying there. He ran to Signal Person A.

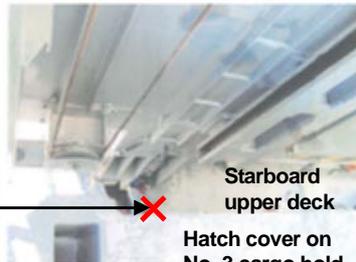
Starboard upper deck
Hatch cover on No. 3 cargo hold
Photo – Near Maintenance Ladder (2)

Site where Signal Person A was found

Analysis	
Contribution of stevedores	Yes
Contribution of crew members	No
Contribution of vessel, engine, etc.	Yes
Contribution of weather and sea conditions	No
Analysis of the findings	<p>(1) The cause for Signal Person A's death was pulmonary contusion.</p> <p>(2) It is considered probable that, during discharging of cargoes from the Ship moored at Hachinohe Port, and while the foreman, Signal Person A and Onboard Worker A were engaged in operations on the hatch covers laid on the No. 3 cargo hold associated with cargo discharging from the No. 4 cargo hold, a twisted shackle was found, which then had to be corrected after moving the grab bucket onto the hatch cover for the No. 5 cargo hold, which made it necessary for the three men including the foreman to travel to the hatch cover on the No. 5 cargo hold.</p> <p>(3) It is considered probable that the foreman and Onboard Worker A, while traveling to the hatch cover, found the Maintenance Ladder that just happened to come into their view to be handy as it would provide a quicker route, and therefore used the Maintenance Ladder, instead of taking the specified route, to descend to the starboard upper deck.</p> <p>(4) Based on the location where Signal Person A was found and the route that Onboard Worker A and the foreman took before the accident, it is considered somewhat likely that Signal Person A intended to use the Maintenance Ladder as he traveled and, in doing that, fell from the hatch covers laid on the No. 3 cargo hold or from the Maintenance Ladder to his death. Due to the fact that Signal Person A was dead and that there were no witnesses, it was not possible to determine why Signal Person A fell.</p> <p>(5) It is considered highly probable that the top face of the hatch cover laid on the No. 3 cargo hold was about 3 m high above the upper deck.</p> <p>(6) It is considered highly probable that the lower end of the Maintenance Ladder was short of the upper deck, ending at about 2 m above the upper deck.</p> <p>(7) It is considered somewhat likely that Signal Person A intended to travel to the hatch cover on the No. 5 cargo hold by following the route of the foreman and Onboard Worker A.</p>
