MA2012-8

**MARINE ACCIDENT  
INVESTIGATION REPORT**

Vessel type and Name: Pure car carrier VEGA LEADER  
IMO number: 9213818  
Gross tonnage: 51,496 tons

Accident type: Injuries on longshoremen  
Date and time: About 0950 hrs, December 1, 2010  
Location: Nissan Motor Honmoku Wharf, Yokohama Section 5, Keihin Port  
305° true, about 200 m from Nissan Honmoku Wharf Lighthouse at  
Yokohama City, Kanagawa Prefecture  
(Approximately 35°25.4'N, 139°40.7'E)

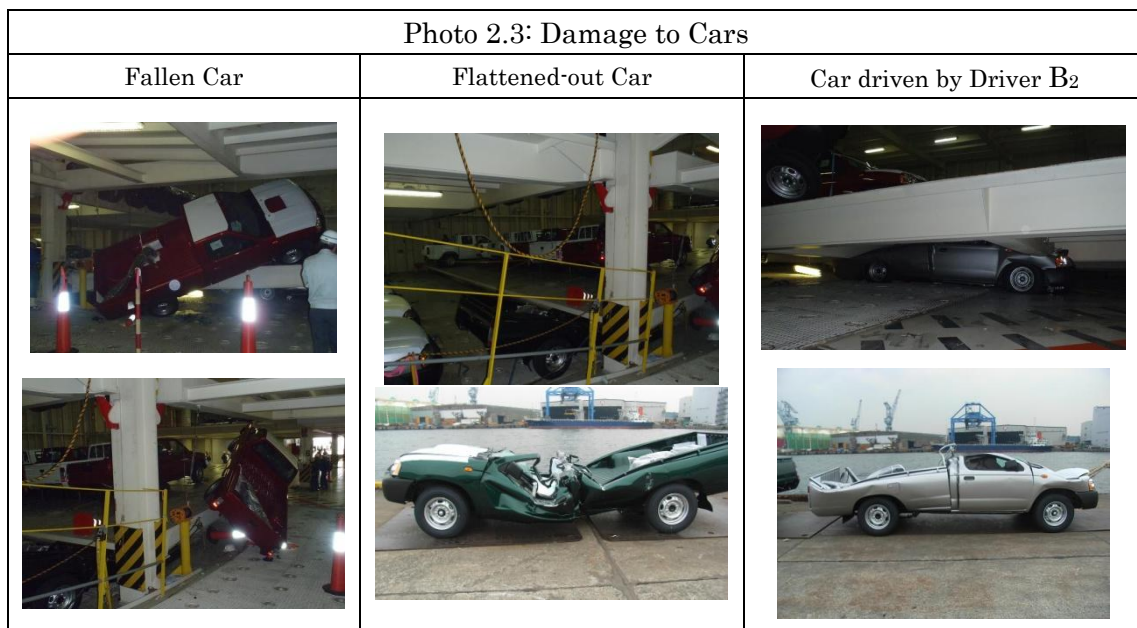
2.3 Damage to Cars

One of the cars placed on the Deck Panel fell down onto car deck No. 6 and was damaged; two of the cars placed immediately below the Deck Panel on car deck No. 6 were flattened by the Deck Panel. (Refer to Photo 2.3: Damage to Cars.)

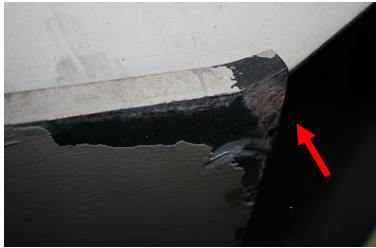
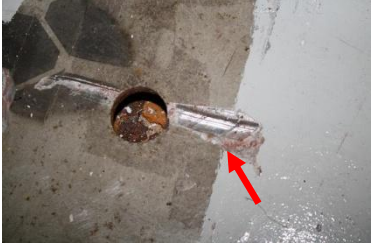
Photo 2.5.4-1: Damage to the Deck Panel	
Tip of the starboard-bow-side corner of the lower surface	Surface dent in car deck No. 6

Significant damage, as shown in the photo below (Photo 2.5.4-1: Damage on the Deck Panel), was a bend on the tip of the starboard-bow-side corner of the lower surface. In addition, the surface of car deck No. 6 immediately below the Deck Panel was damaged in the form of dent.

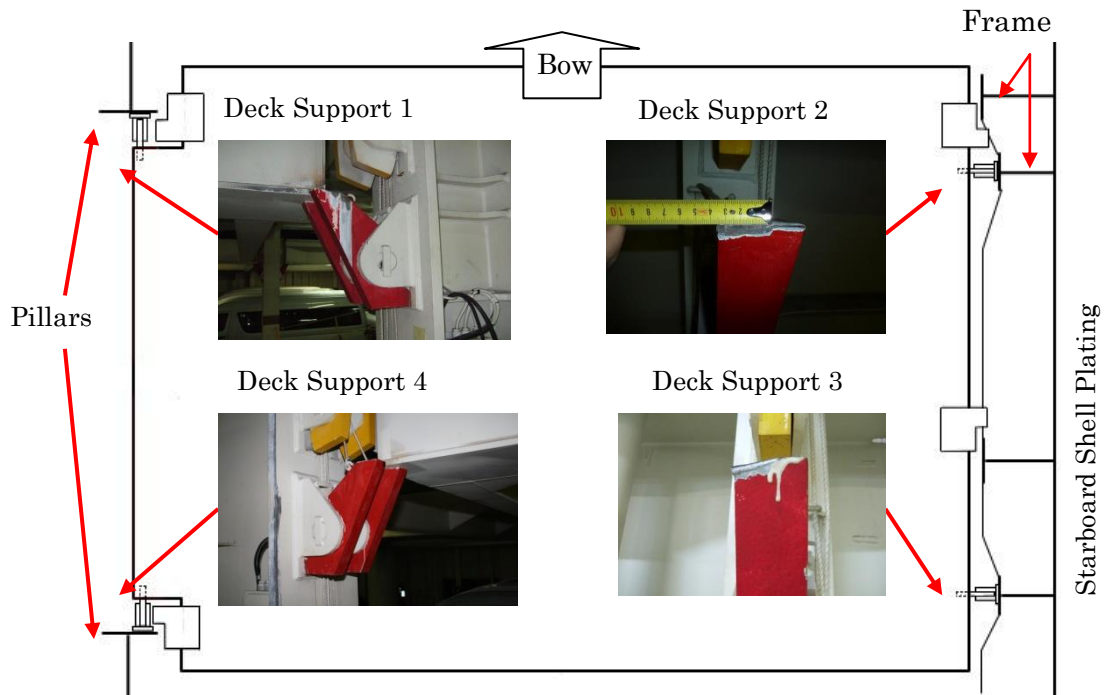
Figure 2.5.4-5: Damage to Deck Supports

- a Deck Support 1 had scratch marks running in a lengthwise direction on the painted side-surface.
- b Deck Support 2 had, at its tip, a deflection about 36 mm wide and about 3 mm deep, and a scratch mark about 24 mm wide; in addition, the Deck Panel had a deflection of about 25 mm wide and a scratch mark of about 36 mm wide at its lower surface corner supported by Deck Support 2 (contact surface). (Refer to Photo 2.5.4-3: Damage to Deck Support 2)

- c Deck Support 3 had plastic deformation on its tip.
- d Deck Support 4 had no damage.

According to 2.5.4 (2) to (4), it is probable that the damage to the Deck Panel, Horizontal Guide-Plates 2 to 4, and Deck Supports 1 and 3 were caused when the Deck Panel fell down.

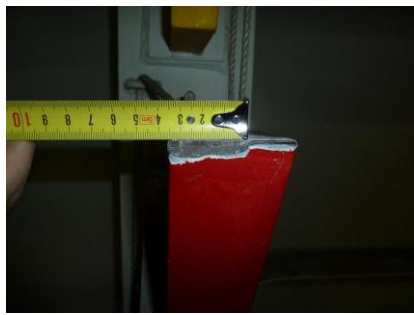
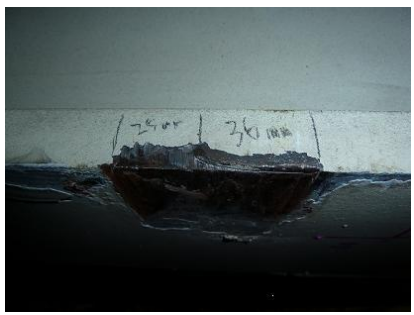
Photo 2.5.4-3: Damage to Deck Support 2	
Damage to Deck Support 2 (magnified)	Damage to the Deck Panel, on the Contact Surface with Deck Support 2

In addition, it is somewhat likely that the damage to Deck Support 2, which was not completely lowered to the supposed supporting position when the deck panel was lowered to the normal position, was caused by the lower-surface corner of the Deck Panel hitting the tip of Deck Support 2.

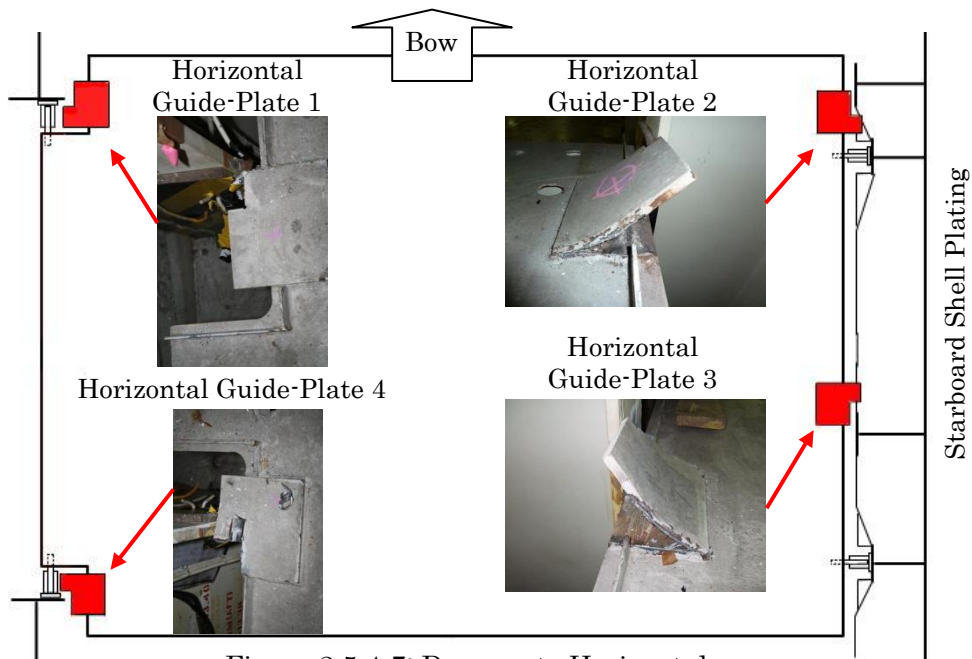
Figure 2.5.4-7: Damage to Horizontal Guide-Plates

- a Horizontal Guide-Plate 1 had no damage
- b Horizontal Guide-Plate 2 and 3 had their portions extruding out of the Deck Panel bent upward; the weld lines on both sides were broken (refer to Photo 2.5.4-4: Fracture Cross-Section of Weld Line)
- c Horizontal Guide-Plate 4 has grind marks around the cut; however, the weld lines were not broken.

Horizontal Guide-Plates 2 and 3 were mounted in such a way that, at the normal position, their tips overlap the upper surface of the sidestringer to support the Deck Panel, the weld lines on Horizontal Guide-Plates 2 and 3 were ruptured during the accident, and Horizontal Guide-Plates 2 and 3 were bent upward.

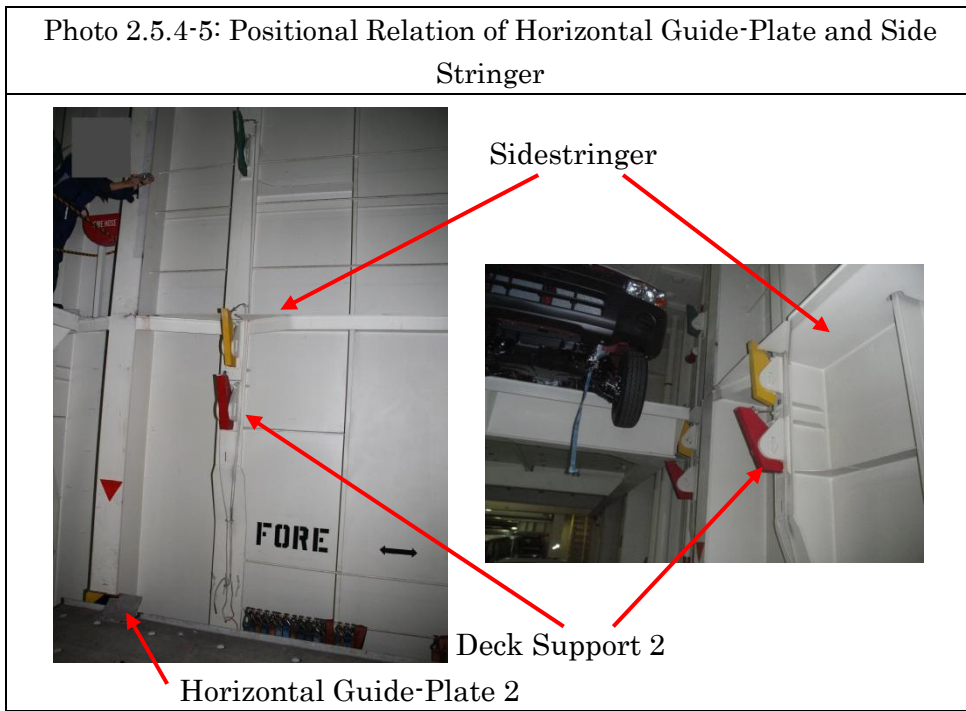
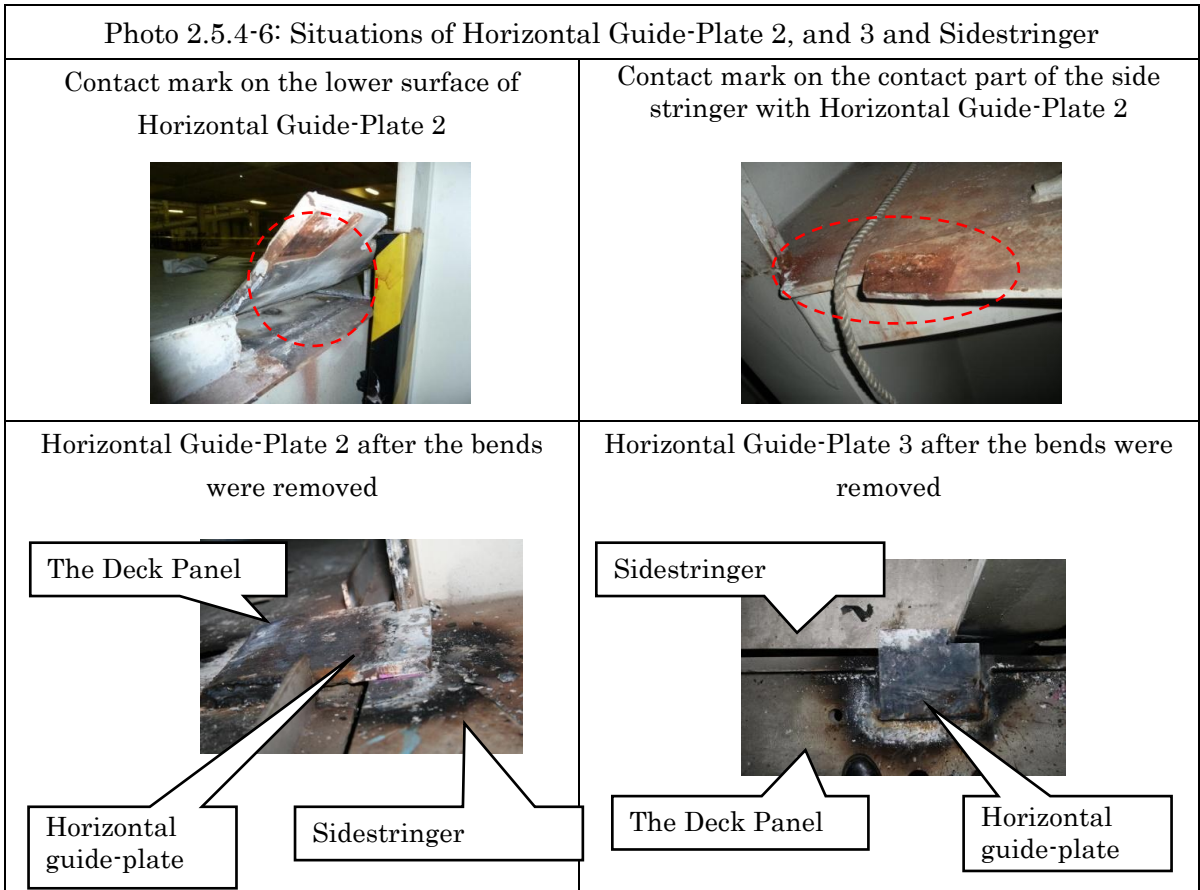
As shown in the photos below (Photo 2.5.4-5: Positional Relation of Horizontal Guide-Plate 2 and Sidestringer), the sidestringer was installed in such a way that, when the Deck Panel was set on its normal position, the upper surface of the Deck Panel leveled the sidestringer installed as a ship structure.

As shown in the photos below (Photo 2.5.4-6: Situations of Horizontal Guide-Plate 2, Horizontal Guide-Plate 3, and Sidestringer), the contact mark on the lower surface of Horizontal Guide-Plate 2 was identical to that on the upper surface of the sidestringer.

In addition, when the Deck Panel was lifted up to the normal position, and the bends of Horizontal Guide-Plate 2 and Horizontal guide-Plate 3 were removed, the tips of Horizontal Guide-Plate 2 and 3 overlapped the sidestringer.

According to 2.5.4(4){2}, 2.5.4(4){3}, and 2.5.5(2), it is probable that the tips of Horizontal Guide-Plates 2 and 3, overlapping the upper surface of the side stringer when the Deck Panel was in the normal position, were structured to be able to support the Deck Panel (refer to the figure below), and Horizontal Guide-Plates 2 and 3 got bent upward due to the rupture of the weld lined on both sides. Also, it is probable that the load applied on Horizontal Guide-Plate 2 at the time of the occurrence of the accident caused a weld-line rupture, leading to a

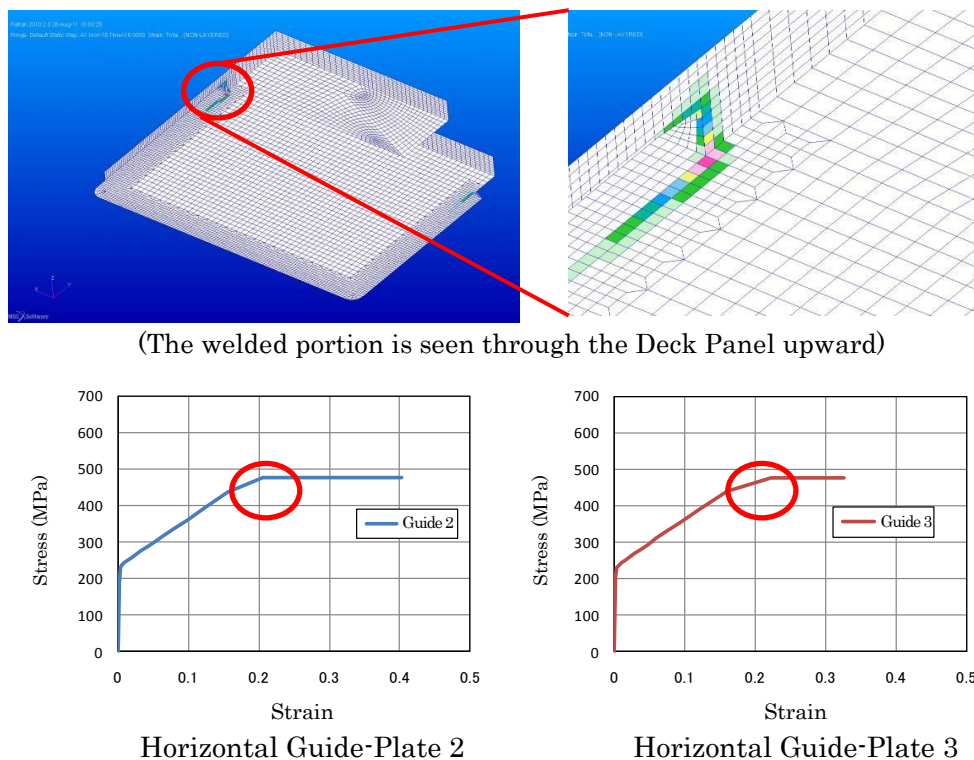
Figure 2.5.5-3: Corresponding Stress Distribution Contour (Horizontal Guide-Plate 2)

The stress stops growing and stays at a constant value when the strain approaches the elastic limit of the horizontal guide-plate material (designated by a red circle around 0.2). It is considered that the ruptures of the weld line of the horizontal guide-plate begins around there, where the load applied on the horizontal guide-plate is estimated to be about 9.5 tf for Horizontal Guide-Plate 2, and about 8.5 tf for Horizontal Guide-Plate 3. After the loaded point is ruptured, the stress on the weld edge becomes larger, and then the break-down grows sequentially at the load.

Also, it is probable that the weld lines of Horizontal Guide-Plate 2 under a load the same as that applied at the time of the accident occurrence is ruptured first, and then the weld lines on Horizontal Guide-Plate 3 is ruptured.
