MA2013-5

**MARINE ACCIDENT
INVESTIGATION REPORT**

Vessel type and name Cargo ship OUTSAILING 9
IMO number 9546318
Gross tonnage 2,926 tons

Accident type Collision
Date and time Around 00:11, March 28, 2010
Location South of the Naruto Strait
 Around 084° true bearing, 280 m from the Narutotobishima
 Lighthouse, Naruto City, Tokushima Prefecture
 (Approximately 34°13.9' N, 134°39.1' E)

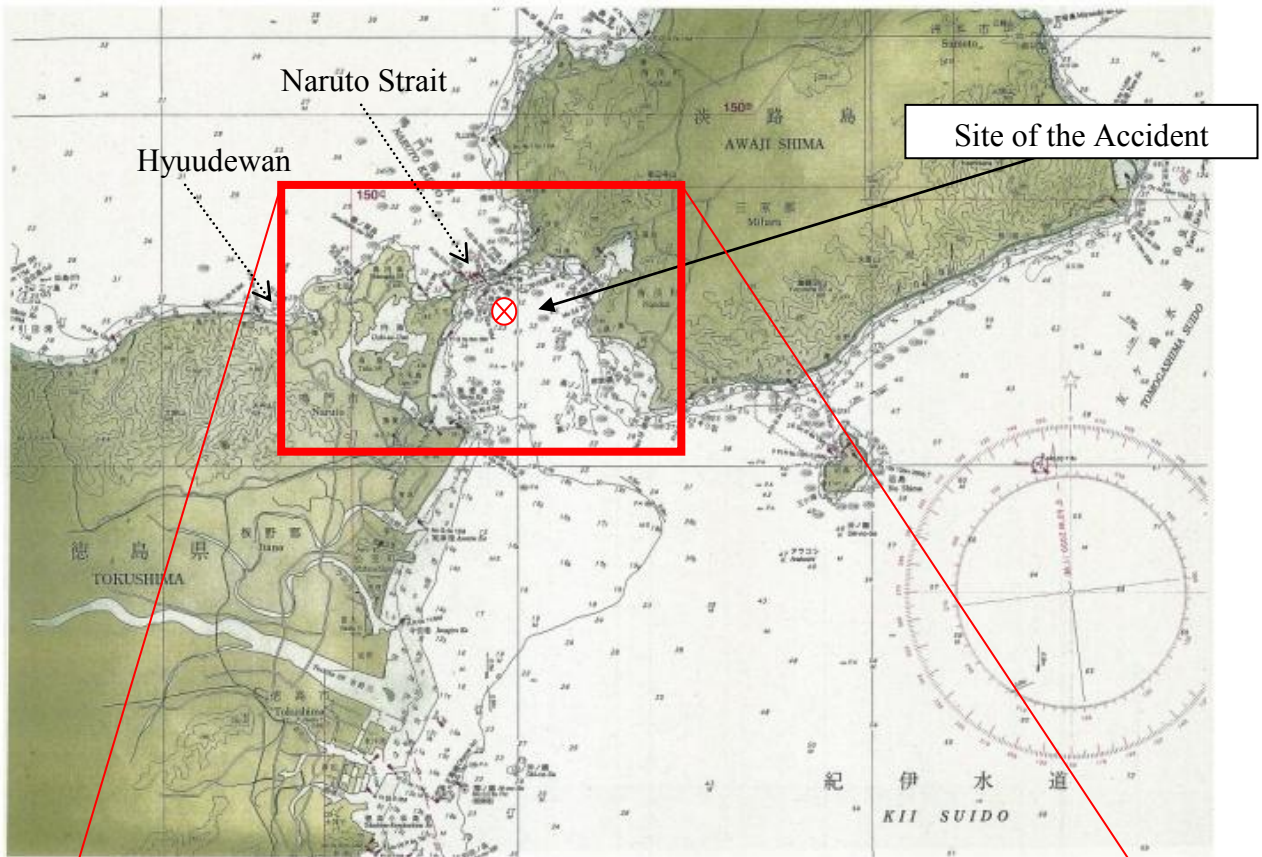
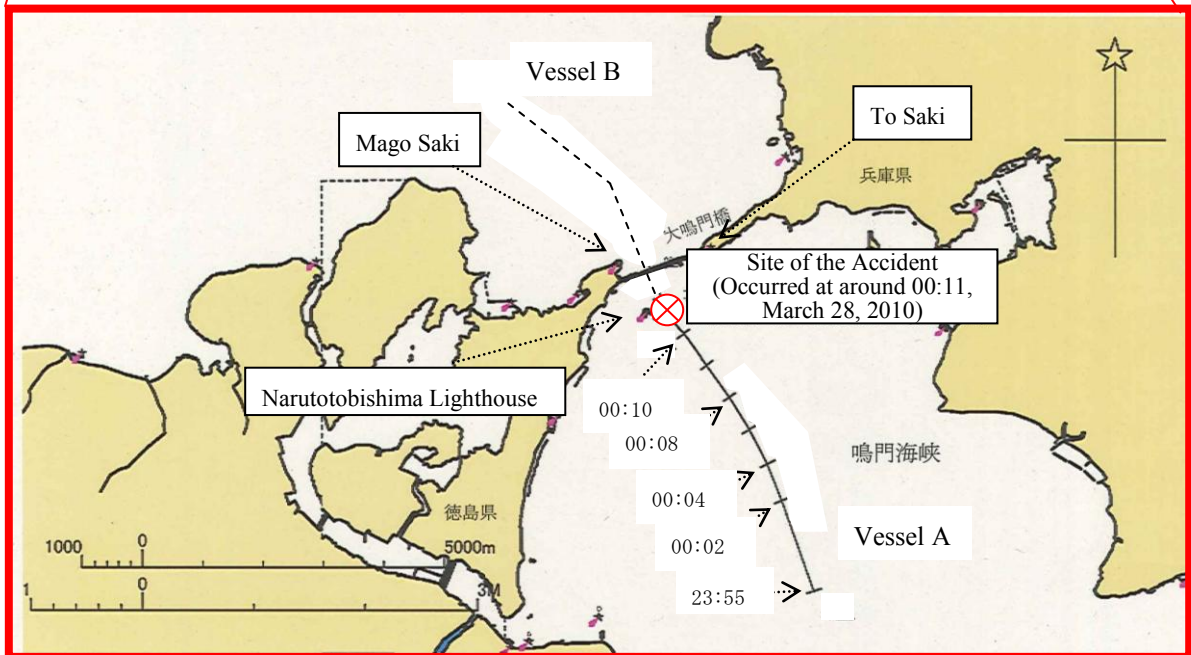
Attached figure 1 Estimated Route

The date and time when the accident occurred was about 00:11 on March 28, 2010. The position of the occurrence was in the vicinity of 084° 280 m from the Naruto Tobishima Lighthouse.

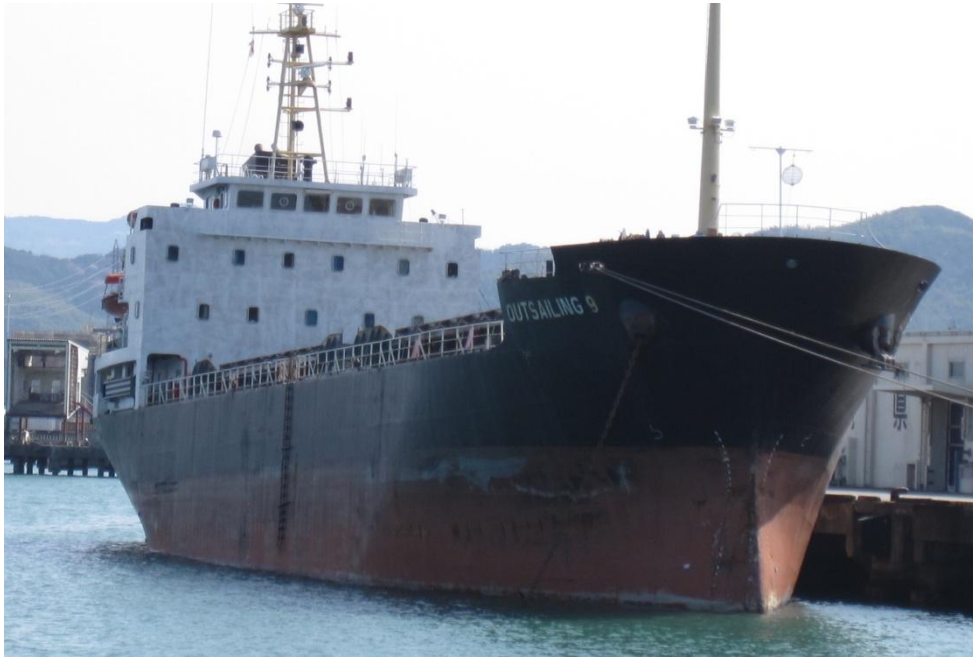
Picture 1 Condition of Vessel A

Vessel A had a dented bow.

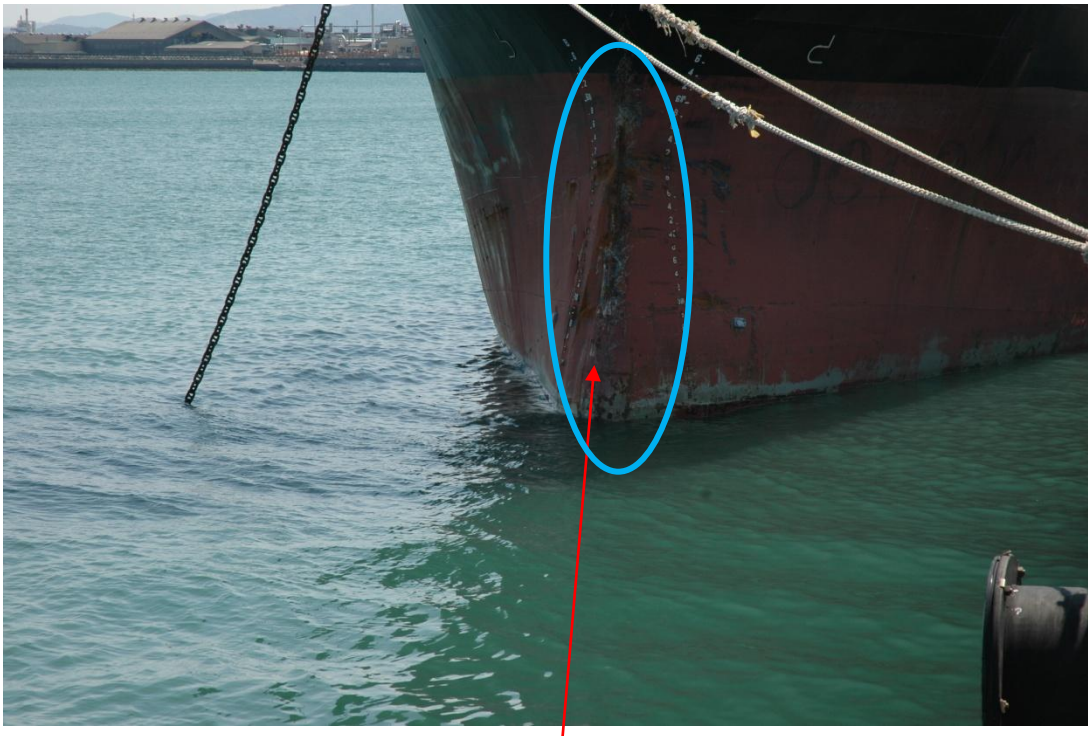
Picture 2 Damage Condition of Vessel A

Dents and scratches
