MA2013-10

**MARINE ACCIDENT
INVESTIGATION REPORT**

October 25, 2013

Accident type	Collision
Date and time	Around 0440 on September 11, 2011 (local time, UTC+9 hours)
Location	Southwest off Sada Misaki, Ikata-cho, Ehime Prefecture 214° true, 1.8 nautical miles (M) from the Sada Misaki Lighthouse (approximately 33° 19.1'N, 131° 59.7'E)
Process and Progress of the Investigation	<p>(1) Setup of the Investigation</p> <p>The Japan Transport Safety Board appointed an investigator-in-charge from Hiroshima Office and one other investigator to investigate this accident on September 12, 2011.</p> <p>(2) Comments from Parties Relevant to the Cause</p> <p>Comments on the draft report were invited from parties relevant to the cause of the accident.</p> <p>(3) Comments from Flag State</p> <p>Comments on the draft report were invited from the Hong Kong Special Administrative Region of the People's Republic of China, the flag State of the tanker "SONG LIN WAN" and Antigua and Barbuda, the flag State of the cargo ship "BBC TEXAS."</p>

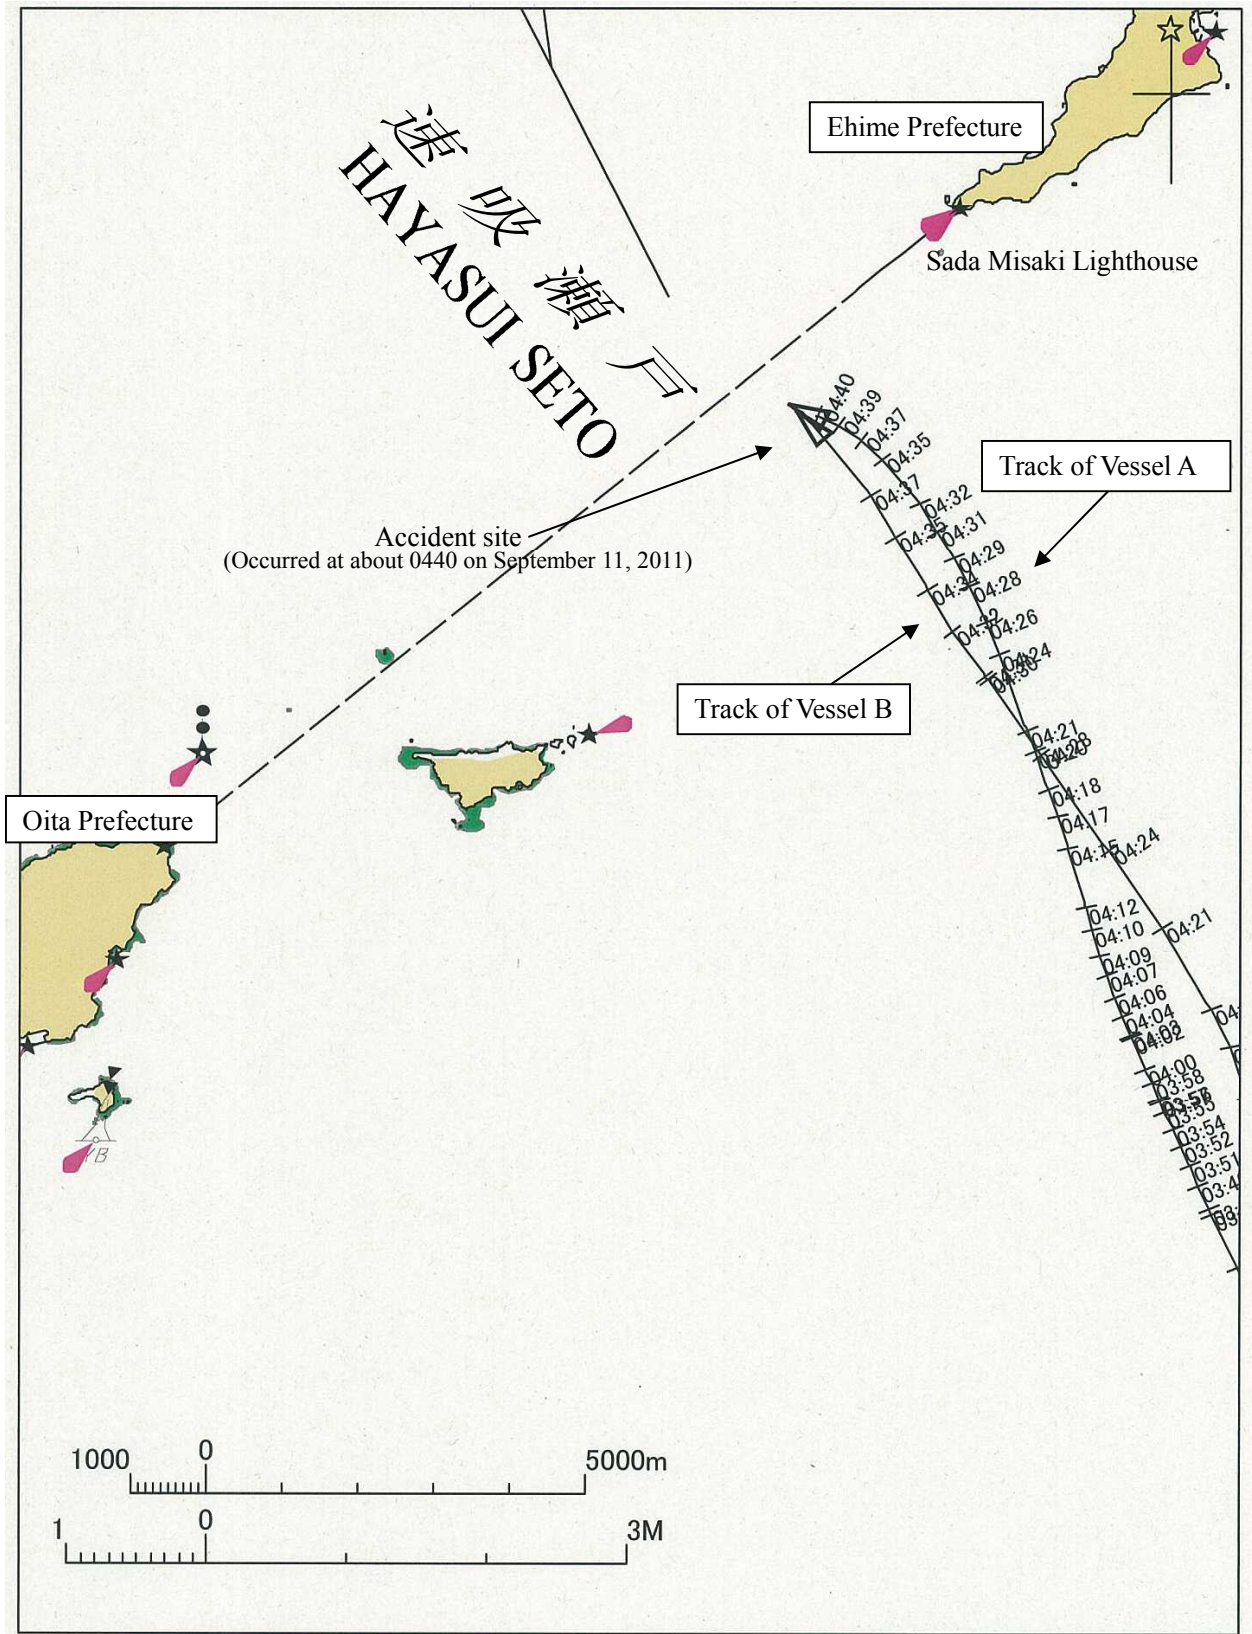
Figure: Navigation Route

<p>(valid until March 1, 2012)</p> <p>Vessel B</p> <p>Officer B (Nationality: Ukraine), male, age 27</p> <p>Certificate of Chief Officer (issued by Ukraine)</p> <p>Date of issue: September 22, 2009</p> <p>(valid until August 11, 2014)</p>
Injuries to Persons	None
Damage to Vessel	<p>Vessel A A rupture and abrasions on the port bow</p> <p>Vessel B Collapse of a bulwark and abrasions on the starboard bow</p>
Events Leading to the Accident	<p>Vessel A, with Master A and 23 crew members on board, was loaded with about 49,511 tons of naphtha. While Master A was conning the vessel with Officer of the Watch A assigned as an assistant and Able Seaman A assigned to manual steering, Vessel A was proceeding north-northwestward on manual steering, south off Sada Misaki toward eastern Hayasui Seto, with the engine at harbour full ahead and the navigation lights turned on as prescribed.</p> <p>At about 0424 on September 11, 2011, Master A started to gradually alter the course to port in order to enter Oita Port, Oita City, Oita Prefecture, and at about 0426 when the vessel reached the position of 177° (true bearing; the same shall apply hereinafter) and 3.0 M from the Sada Misaki Lighthouse, the vessel was navigating on a course of about 328° and at about 9.8 kn (speed over the ground; the same shall apply hereinafter).</p> <p>Master A continued to turn Vessel A to port and at about 0435, he confirmed on a radar display with ARPA that Vessel B, which had been confirmed to be 5-6 M off on the starboard quarter of Vessel A, was approaching the port quarter of Vessel A. Since he believed that the overtaking Vessel B would keep out of the way of Vessel A, he did not visually confirm the position of Vessel B and further continued to turn to port at about 7.5 kn.</p> <p>At about 0438, as Master A saw Vessel B approaching the port side of Vessel A, he set the engine to half ahead after putting the engine in neutral, and put the helm hard to starboard in order to stop turning to port. At about 0440, the port bow of Vessel A and the starboard bow of Vessel B collided with each other southwest off Sada Misaki.</p> <p>Vessel B, with Master B and 14 crew members on board, was loaded with 3,724 tons of steel pipes and others. At about 0400, Officer B and Able Seaman B took over the bridge watch duty, and Officer B assigned Able Seaman B to manual steering, and Vessel B, with the navigation lights turned on as prescribed, was proceeding north-northwestward in the waters of south off Sada Misaki toward the center of Hayasui Seto on a course of about 322° and at 14.1 kn.</p>

<p>At about 0410, Vessel B was proceeding on a course of about 340° to keep out of the way of a forward fishing boat and a crossing ferry boat. At about 0412, Officer B confirmed with AIS and others that Vessel A was proceeding about 2.7 M off the port bow, on a course of about 343° and at a speed of about 7.2 kn. Since the course ahead seemed to be narrow, and the course for overtaking Vessel A on the starboard side seemed much narrower; consequently, Officer B was navigating Vessel B with the intention of overtaking Vessel A on the port side.</p> <p>At about 0423, when Officer B eased the course to about 322° after keeping out of the way of the boats, he observed doubtfully Vessel A increasing speed to 10 kn, and saw Vessel A about 1.5 M off the starboard bow. At about 0430, he observed the bow of Vessel A slightly turn from starboard to port, anticipated that the courses of the both vessels would intersect, and confirmed that the CPA with Vessel A was 0.7 M.</p> <p>At about 0437 when Vessel A continued to turn to port and approached Vessel B, Officer B ordered Able Seaman B to put the helm hard to port. Subsequently, Vessel B collided with Vessel A.</p> <p>Officer B immediately contacted Master B; accordingly, at about 0441, Master B came up to the bridge.</p> <p>(See Figure: Navigation Route, Table 1: AIS Records of Vessel A (Excerpt), and Table 2: AIS Records of Vessel B (Excerpt))</p>
