MA2013-5

**MARINE ACCIDENT
INVESTIGATION REPORT**

Accident Type	Grounding
Date and Time	Around 00:34, January 30, 2011 (local time, UTC+9 hours)
Location	Kanazawa Port in Kanazawa City, Ishikawa Prefecture Around 187° true, 1,420 m from Kanazawa Ko West Breakwater Lighthouse (Approximately 36°37.9' N, 136°35.9' E)
Process and Progress of the Investigation	The Japan Transport Safety Board appointed an investigator-in-charge from the Kobe Office and another investigator to investigate this accident on January 30, 2011. Comments on the draft report were invited from parties relevant to the cause of the accident. Comments on the draft report were invited from the flag State.
Factual Information Vessel type and name, gross tonnage: Vessel number, owner, etc.: L×B×D, hull material: Engine, output, date of launch, etc.	Cargo Ship BOHAI CHALLENGE (registered in Republic of Panama), 8,708 tons 9423243 (IMO number), AI SHIPPING S.A. 119.05 m × 19.40 m × 14.10 m, Steel Diesel engine, 3,900 kW, September 12, 2007

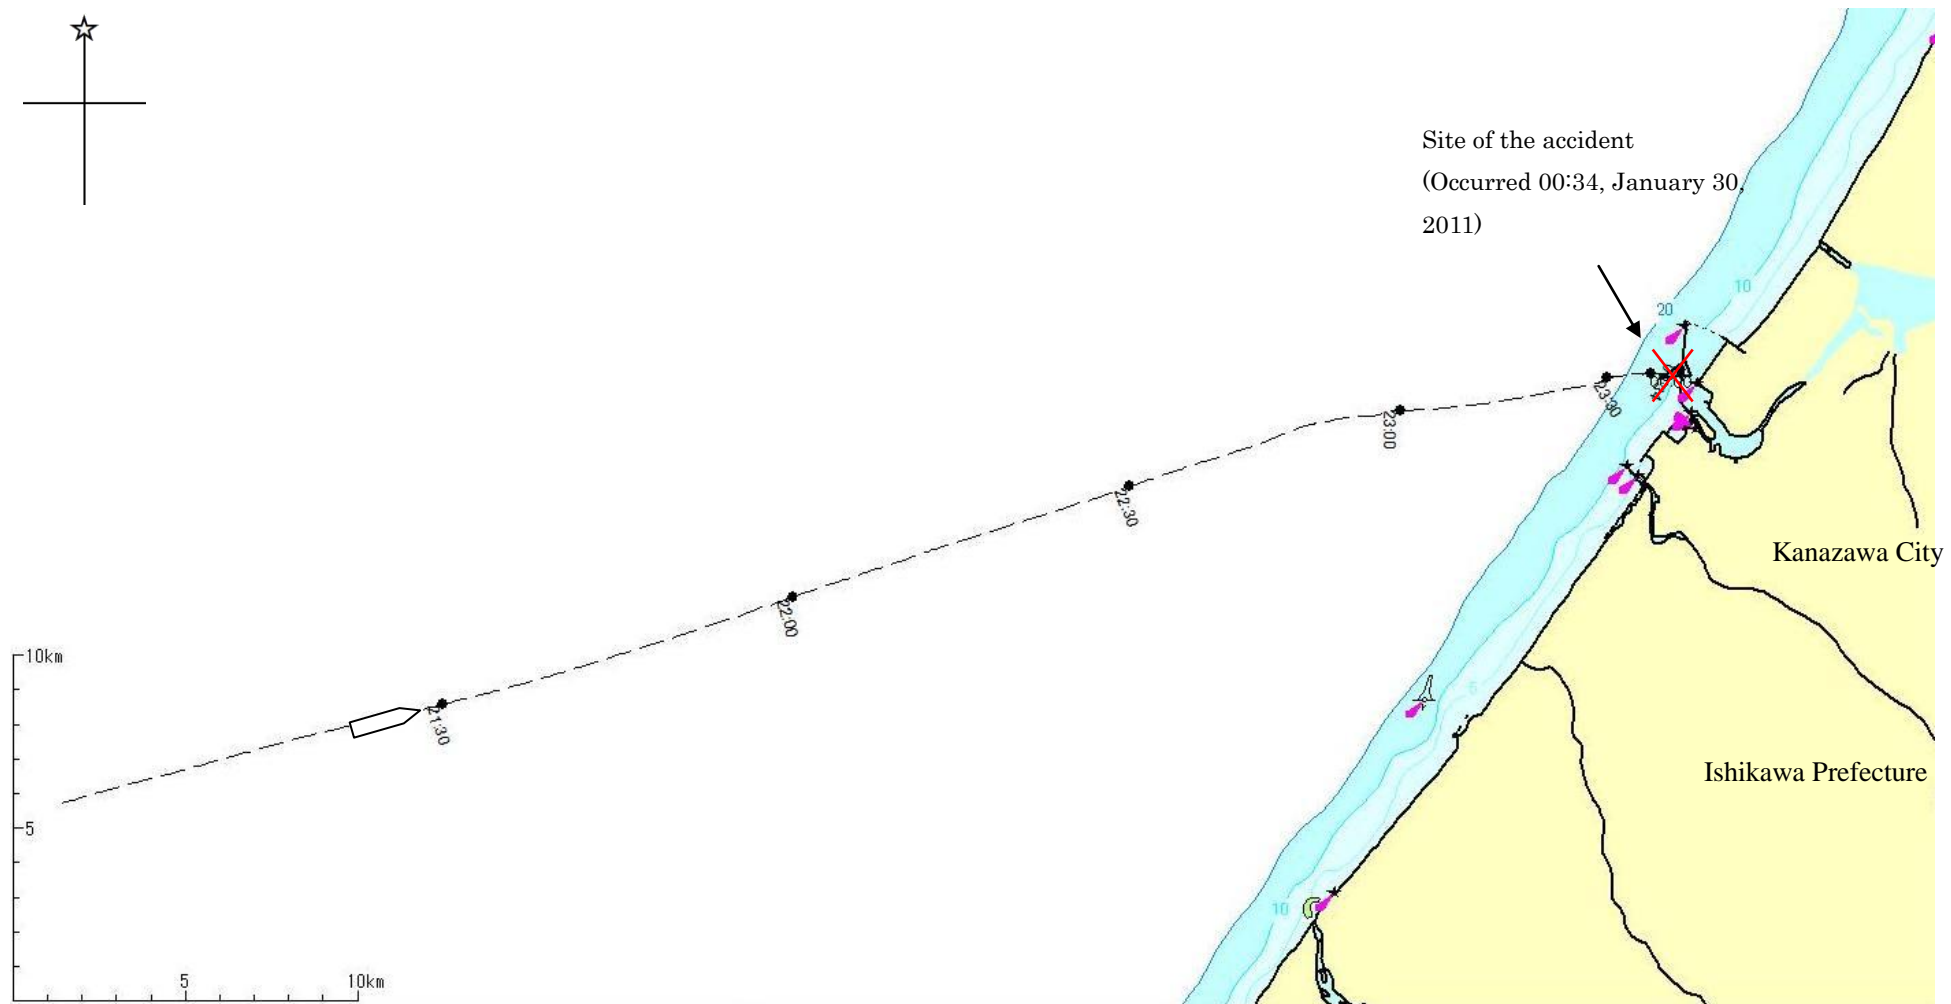
Attached Figure 1 Track Chart

The vessel continued drifting eastward and, at around 00:34 on the 30th, ran aground the shallows west of Kanazawa Port West Breakwater (hereinafter referred to as "West Breakwater"), around 187°, 1,420 m from Kanazawa Ko West Breakwater Lighthouse. Immediately thereafter, the stern of the vessel collided with breakwater blocks placed on the west side of the West Breakwater.
