MA2013-4

**MARINE ACCIDENT
INVESTIGATION REPORT**

Accident Type	Injury of crew members
Date and Time	At around 1700 hours (local time, UTC+9 hours) on November 15, 2011.
Location	In the northwestern waters of Tsunoshima, Shimonoseki City, Yamaguchi Prefecture, Japan. At around 312° true bearing, 10.2 nautical miles from Tsunoshima Light House (Approximately 34°28.1' N., 130°41.3' E.)
Process and Progress of the Investigation	(1) Set up of the Accident Investigation The Japan Transport Safety Board appointed an investigator-in-charge from Moji Office and one other investigator to investigate this accident on November 16, 2011. (2) Comments from parties relevant to the cause of accident Comments on the draft report were invited from parties relevant to the cause of the accident. (3) Comments from the flag State Comments on the draft report were invited from the flag State of a cargo ship, CABRERA.
Factual Information Vessel type and name, Gross Tonnage, Vessel number, Owner, etc. L × B × D, Hull material, Engine, Output, Date of launch, etc.	A Cargo ship CABRERA (registered in Republic of Malta), 24,210 tons, 9537977 (IMO No.), CABRERA SHIPPING A/S (hereinafter referred to as "Comp

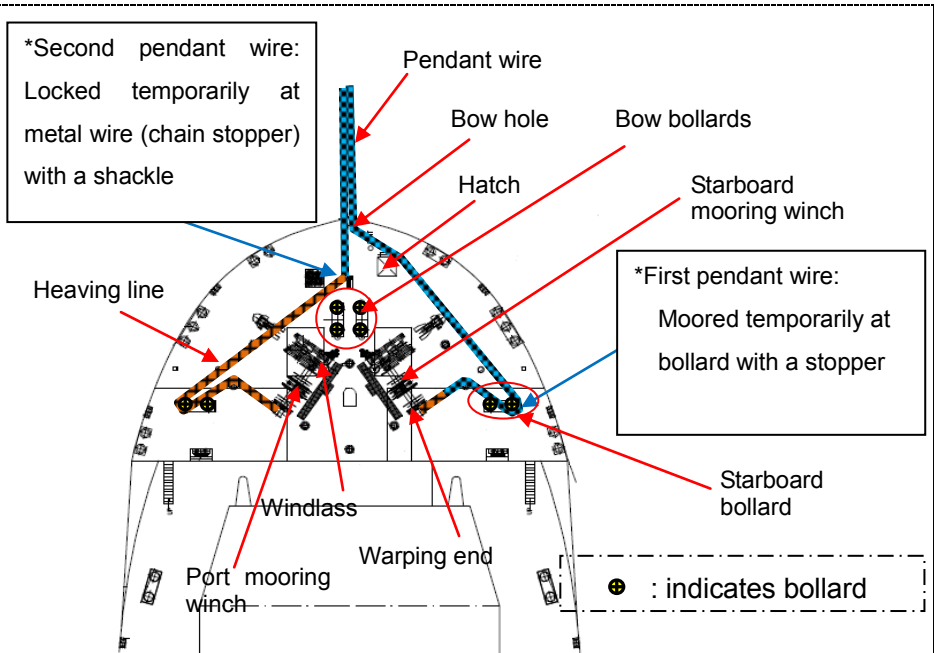
“Towing Rope Arrangement”

The heaving line and the pendant wire being wound with the warping end of the starboard mooring winch were in contact with the corner of the hatch located towards starboard bow of the forecastle deck.

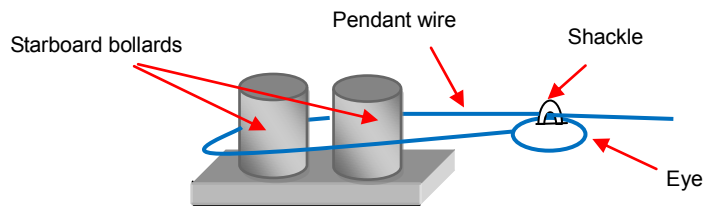
“Assumed Status of Pendant Wire Locking”

The ordinary seaman A_1 was standing right side of the starboard bollard with a backup stopper to replace the cut-off stopper, and the ordinary seaman A_2 was standing about 1 m away from the bow, while they were taking the stopper to the starboard bollard in order to moor the pendant wire temporarily at the said starboard, when, at about 17 00 hours, the heaving line was broken, and the pendant wire hit the lower leg of the ordinary seaman A_1 and A_2 , knocking both of them down screaming.

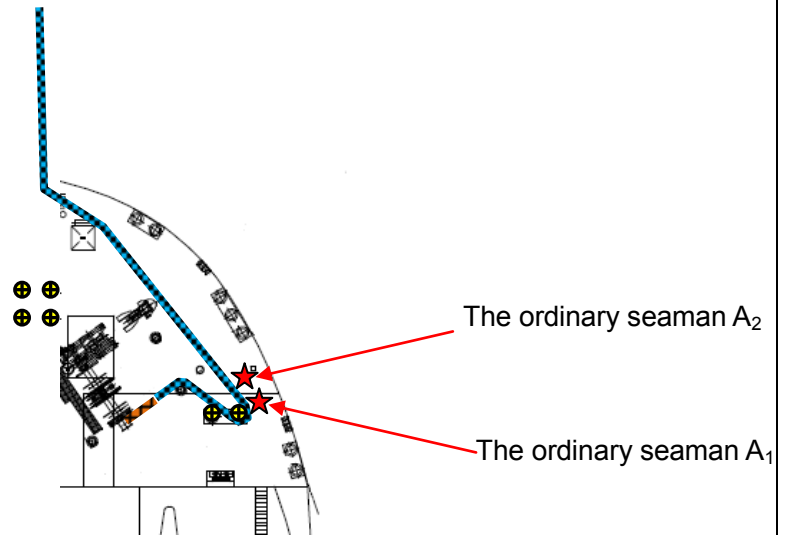
“Location of the ordinary seaman A₁ and ordinary seaman A₂
at Time of Accident”

<p>not be clarified as no one witnessed the situation wherein the said line was broken.</p> <ul style="list-style-type: none"> • It is possible that when Vessel B was oscillating up and down due to the waves, breaking load over the capacity was imposed on the heaving line. • It is possible that the breaking load capacity of the heaving line had been weakened since it had been passed for about 14 years since the vessel's launch. • It is possible that the heaving line was passed through the bow hole, instead of the starboard fairlead as planned by the Vessel B, and therefore when it was wound up with the warping end of the starboard mooring winch, it came in contact with the hatch corner in front of the starboard forecastle deck, which thus impaired the line strength.
<p>Probable Cause</p>	<p>It is probable that this accident took place while the Vessel A was working on the mooring of the towing rope with Vessel B in the northwestern waters of Tsunoshima, they tried to moor temporarily the pendant wire, which were picked up by heaving line rolled by warping end of the starboard mooring winch, with the starboard bollard and attached the stopper to the said bollard, when the heaving line was broken and thus the pendant wire hit and injured the lower legs of Ordinary Seaman A₁ and Ordinary Seaman A₂ working there.</p>

<p>Actions Required</p>	<p>The following are possible measures to prevent the recurrence of similar accidents:</p> <ul style="list-style-type: none"> • When engaging in mooring operation of towing ropes, crews of a towing boat and a towed vessel shall have full discussion on mooring method and safe towing method by giving consideration to the arrangement of mooring equipment of the towed vessel as well as using a mooring schematic, etc. • It is advisable to inspect the towing rope properly and replace it with a new rope as needed. • When taking a stopper, care shall be taken not to impose load on a rope of low breaking strength and to secure safety of crew members. The crew members shall engage in the work in a safe location in case the towing rope is broken. • The operation leader shall always keep in mind the behavior of the crew members so that they do not enter the danger area. • The operators of equipment machines shall not leave their assigned position except for compelling reasons such as approaching danger, and in the event of leaving the machines in operation, such
