MA2013-1

**MARINE ACCIDENT
INVESTIGATION REPORT**

Vessel type and Name: Cargo ship AQUAMARINE

Vessel type and Name: Fishing vessel HIRASHIN MARU

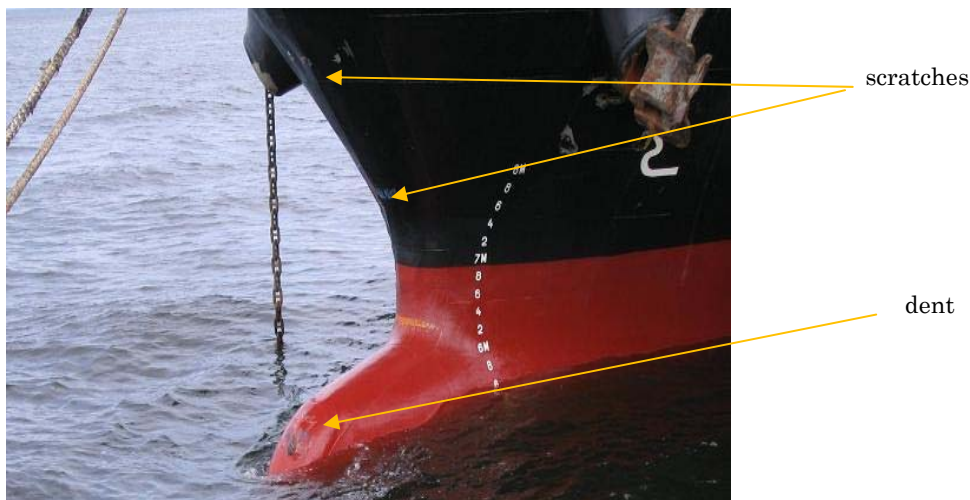
“Damage to Vessel A”

Vessel A sustained a dent on the bulbous bow, and scratches to the stem.

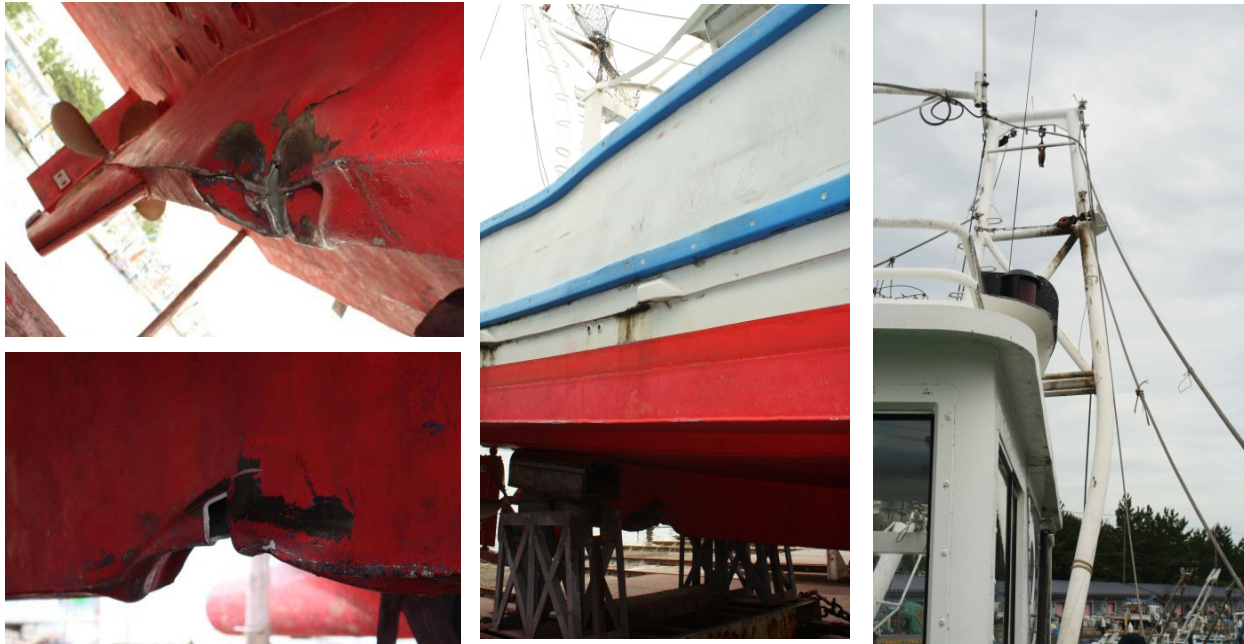
Vessel B sustained a buckling and a fracture to the keel, a dent on the shell plating at the central part of the starboard side, and a bent to the mast for drawing a fishing net, while a wet damage to the main engine and navigational equipment.

“Damage to Vessel B” (Left: a buckling and a fracture to the keel, Center: a dent to the shell plating at the central part of the starboard side, Right: a bent to the mast for drawing a fishing net)
