**MARINE ACCIDENT
INVESTIGATION REPORT**

Vessel type and name: Container ship KOTA DUTA

Vessel type and name: Cargo ship TANYA KARPINSKAYA

Accident type: Collision

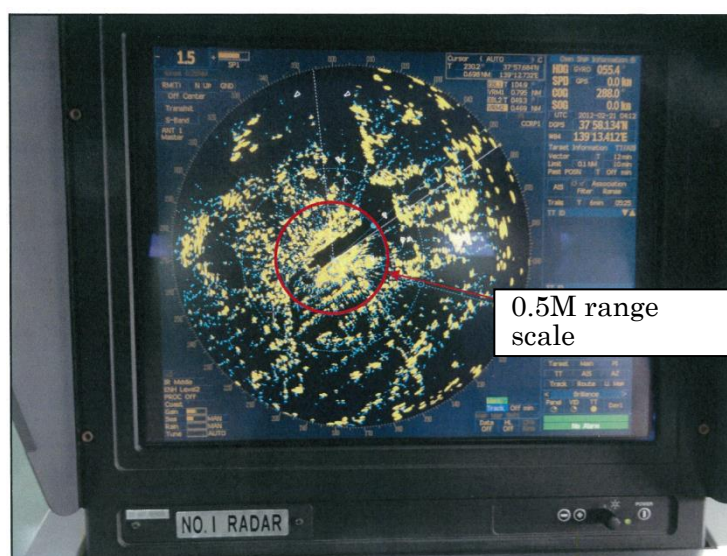
After this accident, we activated Radar A (manufacturer: TOKYO KEIKI INC., model: BR-3200) in the West Wharf No.3 Quay in Port of Niigata Higashi Ku, set the range scale to 1.5M, and detected in the vicinity of Central Wharf East Quay, from which Vessel B departed. The radar image of Central Wharf East Quay was confirmed as well as vessels (gross tonnage not confirmed) which were berthed at the Central Wharf and the Zenno Berth. In addition, Central Wharf East Quay could not be detected when the range scale was set at 0.75M.

Air draft^{*5} at the time of this accident was 36.3m, and the height of the radar scanner from the sea surface was approximately 32m.

Photo 2.5-1 Radar's detection situation (taken after this accident)

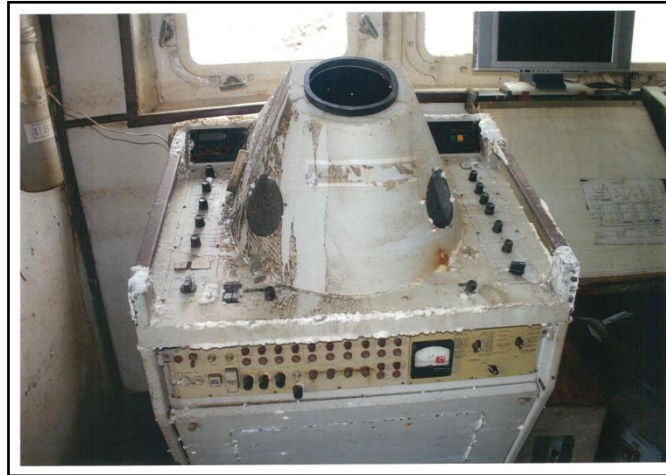
- a. Chief Officer B turned on the power for two radar units and set the range scale to 1M when stand-by the departure.
- b. Master B confirmed Vessel A with the radar image at approximately 16:19 and changed the range scale to 0.5M and to 0.25M according to the distance between Vessel A and Vessel B.

Photo 2.5-2 Vessel B radar (after being pulled out)

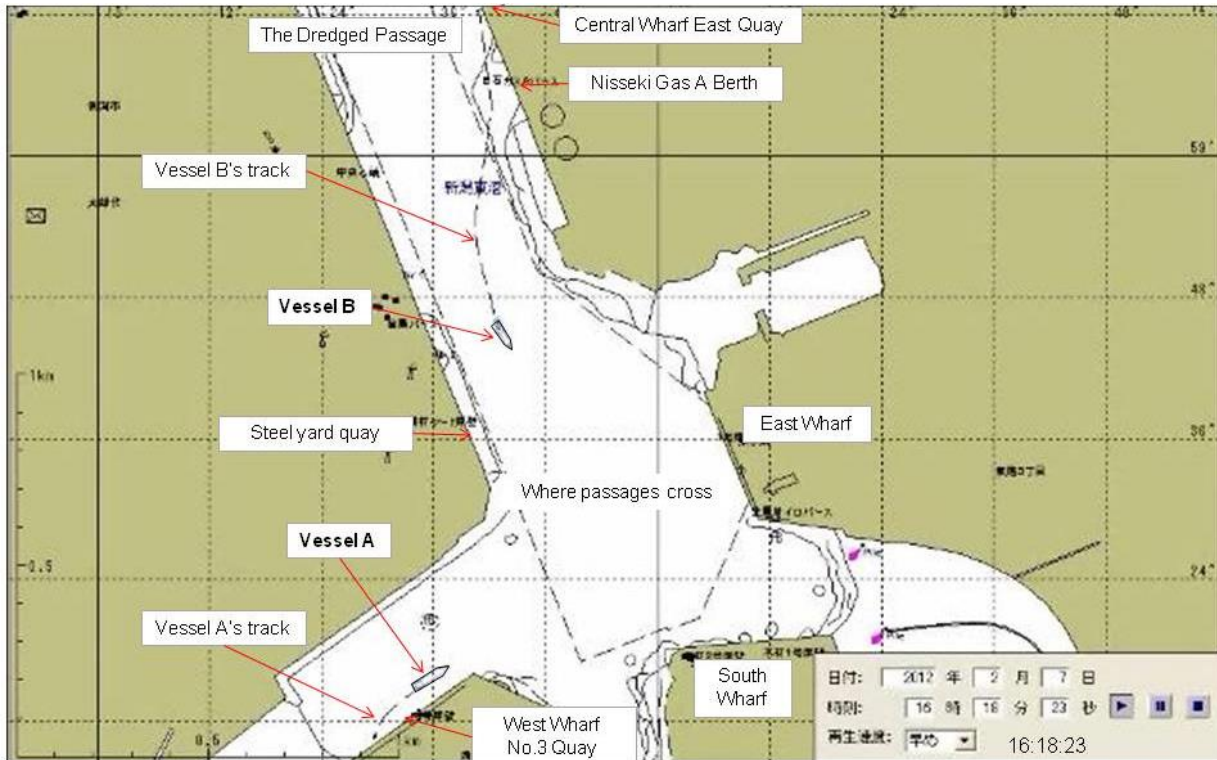
(ii) It is probable that the distance between the two vessels at approximately 16:18:18 was approximately 950m (calculated from the AIS records of 16:18:18 for Vessel A and 16:18:23 for Vessel B) and that the distance between the two vessels at

approximately 16:18:38 was approximately 890m (calculated from the AIS records of 16:18:38 for Vessel A and 16:18:43 for Vessel B) as shown in Figure 3.2-1.

Figure 3.2-1 Situation in which Master A recognized Vessel B's radar image

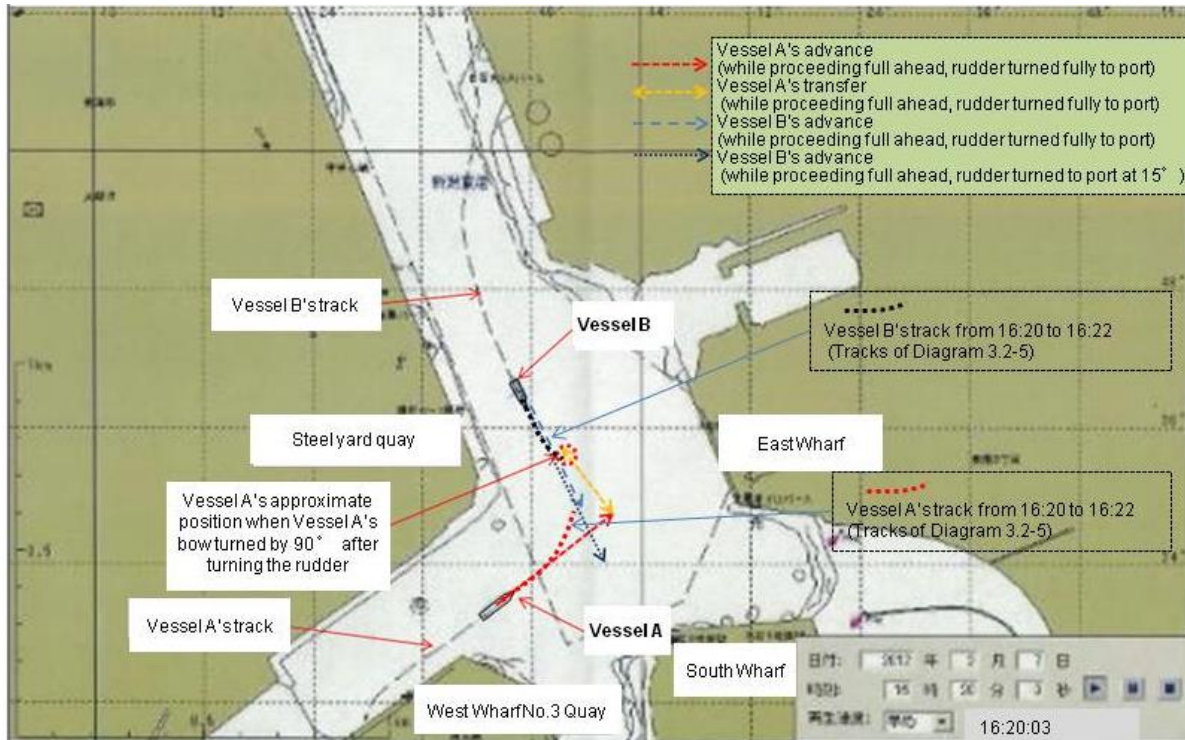
It is somewhat likely that it took approximately 20 seconds for Master A and Master B to agree on the conduct of vessel and that two vessels approached each other during this time, resulting in lack of time for them to take actions to prevent collision as later described in 3.2.8(4).

Figure 3.2-3 Situation in which Master A and Master B agreed to the conduct of vessel
(iv) It is somewhat likely that Vessel A would have approached the East Wharf after passing Vessel B on the port side if Vessel A navigated in the course and heading of 16:19:57 and Vessel B navigated in the course and heading of 16:20:03 in the vessel positions of 16:20:03 as shown in Figure 3.2-4.

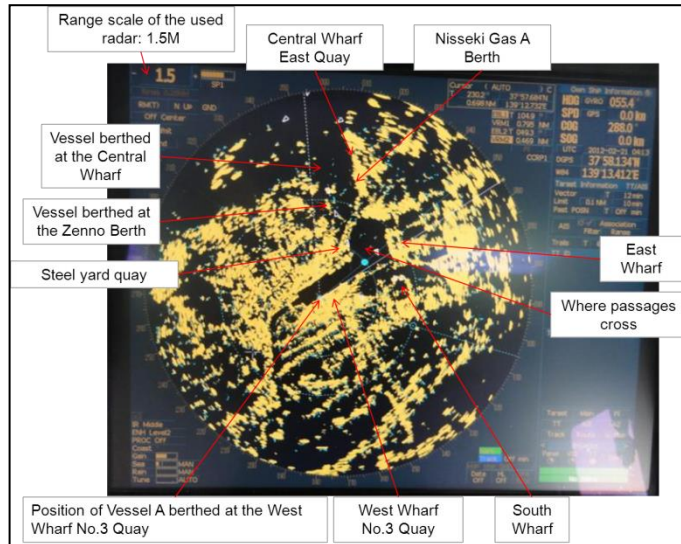
- (5) It is probable that Vessel B could have learned the existence and movements of Vessel A 2-3 minutes before sighting Vessel A behind structures at around 16:19:00 if Master B was observing the radar display at approximately 16:16:28, which was when the distance from Vessel A was 0.9M, due to the fact that the radar range scale was set to 1M.

Photo 3.2-1 Vessel A's radar image

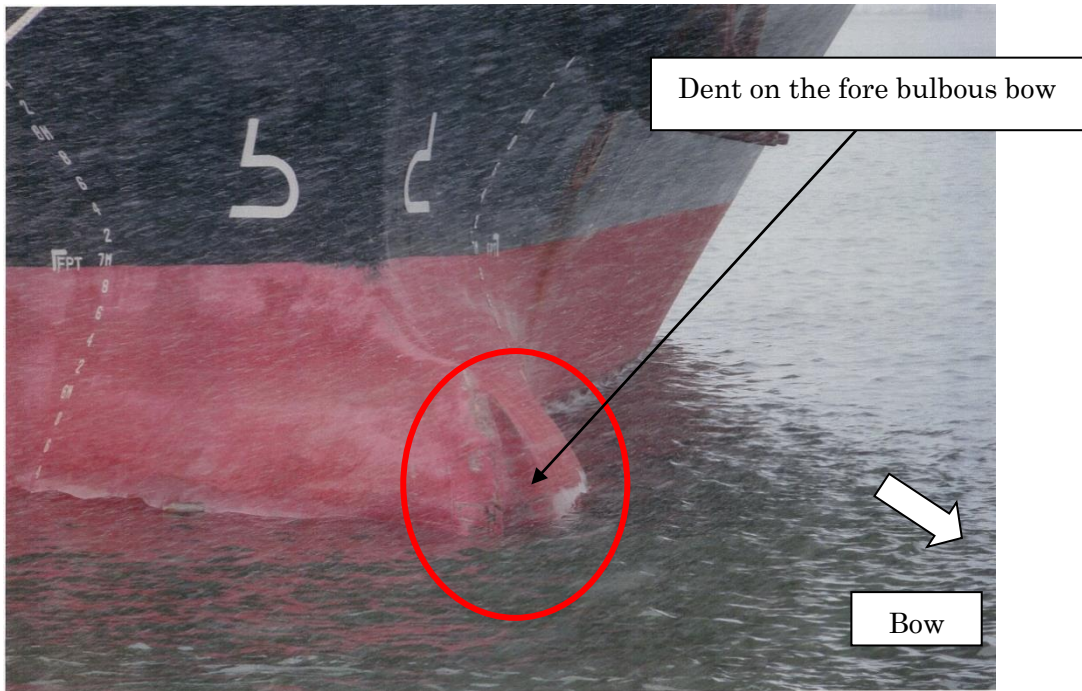
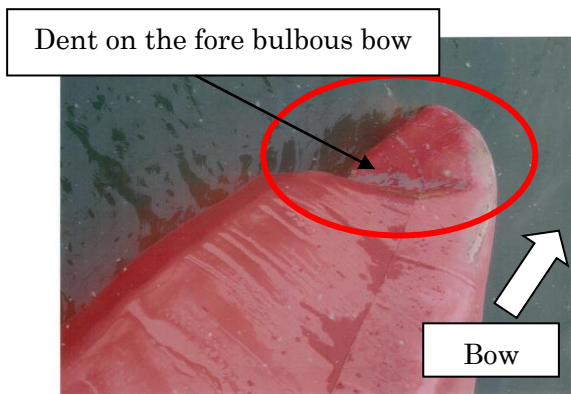
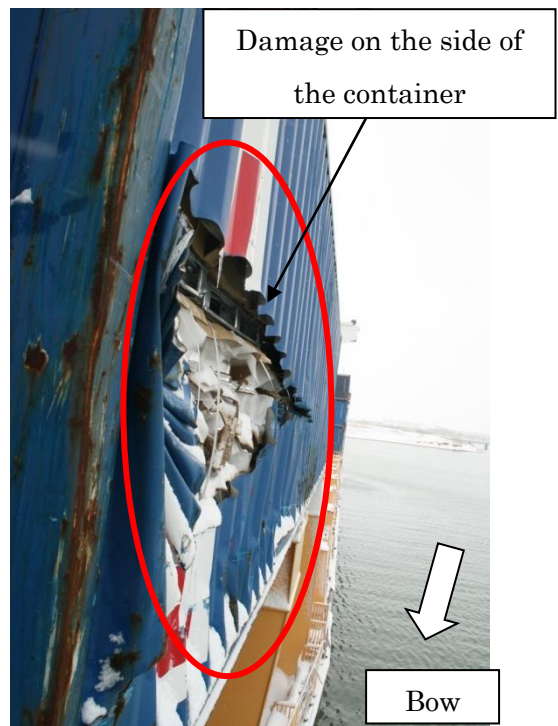
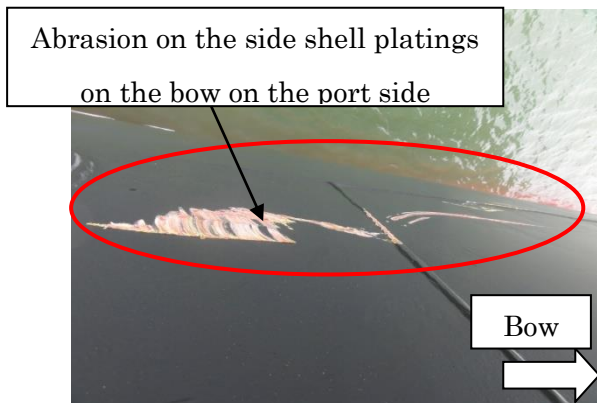
Fore bulbous bow was dented and suffered abrasion, and the side shell platings on the bow on the port side suffered abrasion. In addition, the side of a container loaded on the deck on the bow port side suffered damage.

- (1) Vessel A suffered dents and abrasions on the fore bulbous bow and abrasions on the side shell platings on the bow of the port side. In addition, the side of a container loaded on the deck on the bow of the port side suffered damage.
- (2) Vessel B suffered fractures on the side shell platings on the starboard side on No 1 cargo hold and No 2 cargo hold, and foundered at approximately 17:02.

Photo 1 Damage to Vessel A (1)

Photo 2 Damage to Vessel A (2)

Photo 3 Damage to Vessel A (3)

Photo 4 Damage to Vessel A (4)

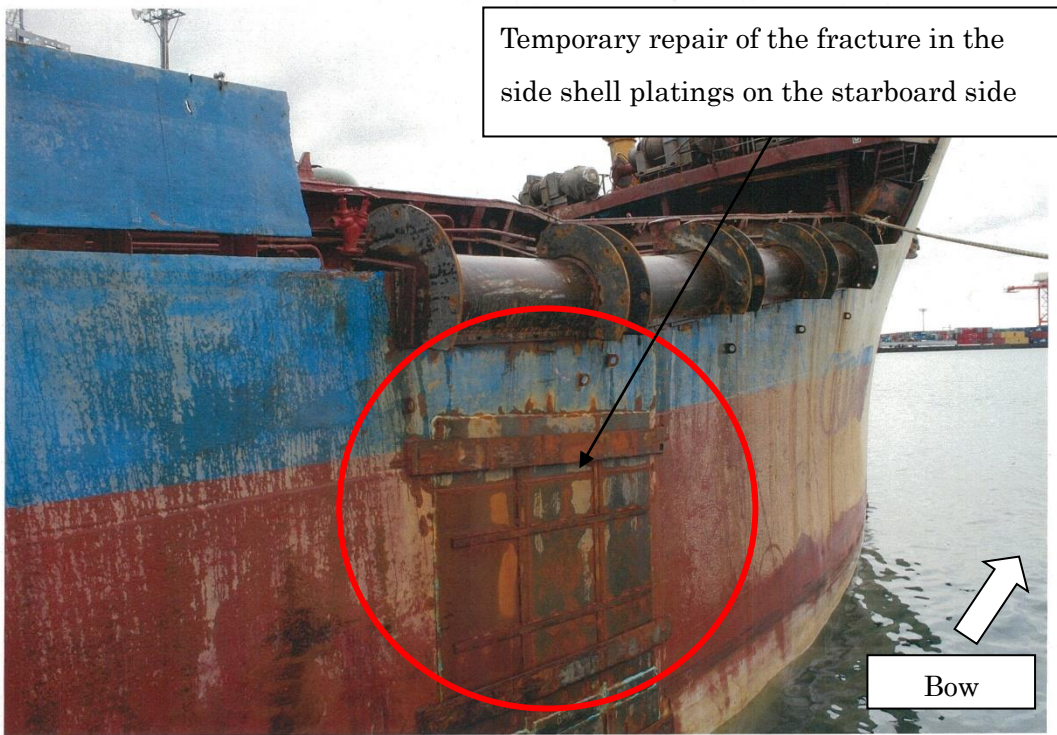
According to the information from the Japan Coast Guard, side shell platings for No 1 cargo hold and No 2 cargo hold on the starboard side suffered fractures. Vessel B foundered at approximately 17:02 on February 7, 2012. Vessel B was salvaged and decommissioned on April 30 of the same year.

Photo 5 Damage to Vessel B (1) (Temporary repair of the fracture after being salvaged)

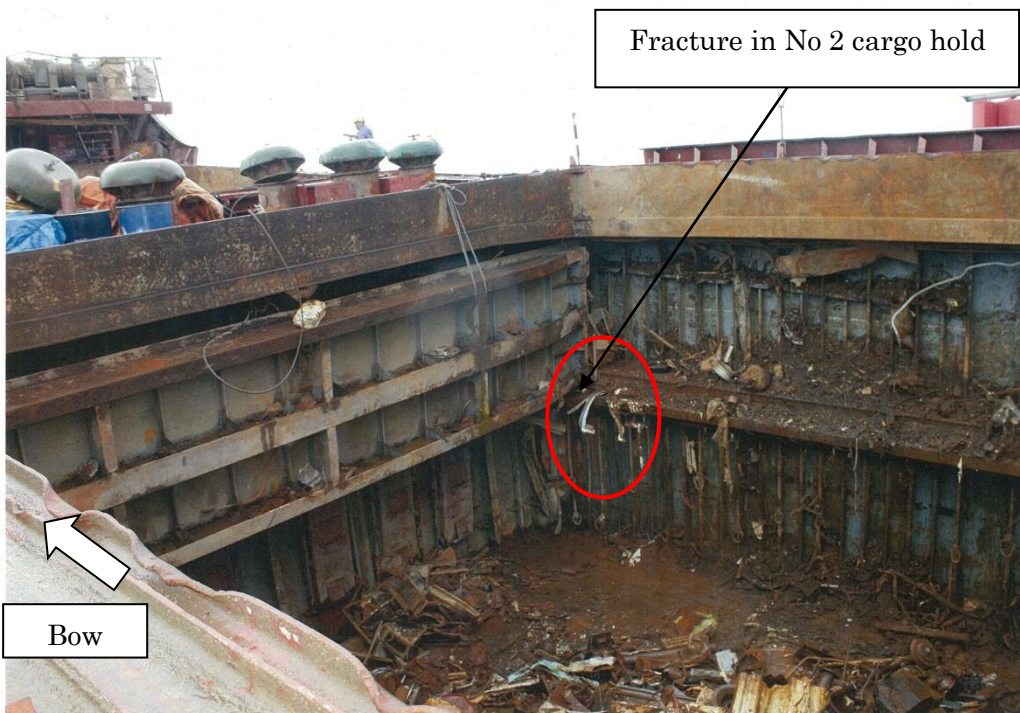
Photo 6 Damage to Vessel B (2) (Conditions after being salvaged)
