MA2014-2

**MARINE ACCIDENT
INVESTIGATION REPORT**

Accident type	Fatality and injury of crew members
Date and time	Around 11:15 on March 27, 2012 (local time, UTC+9 hours)
Location	Rokko Island Container Berth 5, Kobe Ku of Hanshin Port Around 040° true, 1400m from Kobe No. 7 breakwater west lighthouse located at Kobe City Hyogo Prefecture (approximately 34° 40.7' N, 135° 15.8' E)
Process and Progress of the Investigation	<p>The Japan Transport Safety Board appointed an investigator-in-charge and a marine accident investigator to investigate this accident on March 28, 2012.</p> <p>Comments on the draft report were invited from parties relevant to the cause of the accident.</p> <p>Comments on the draft report were invited from the flag State of ANNA MAERSK.</p>
Factual Information	<p>Vessel type and name: Container vessel ANNA MAERSK</p> <p>Gross tonnage: 93,496 tons</p> <p>IMO number: 9260421</p> <p>Port of registry: Aabenraa (the Kingdom of Denmark)</p> <p>Owner: A.P. Moller-Maersk A/S (the Kingdom of Denmark)</p> <p>Management company: MOLLER-MAERSK A/S (hereinafter referred to as “the Company A”) (the Kingdom of Denmark).</p> <p>Classification society: American Bureau of Shippi

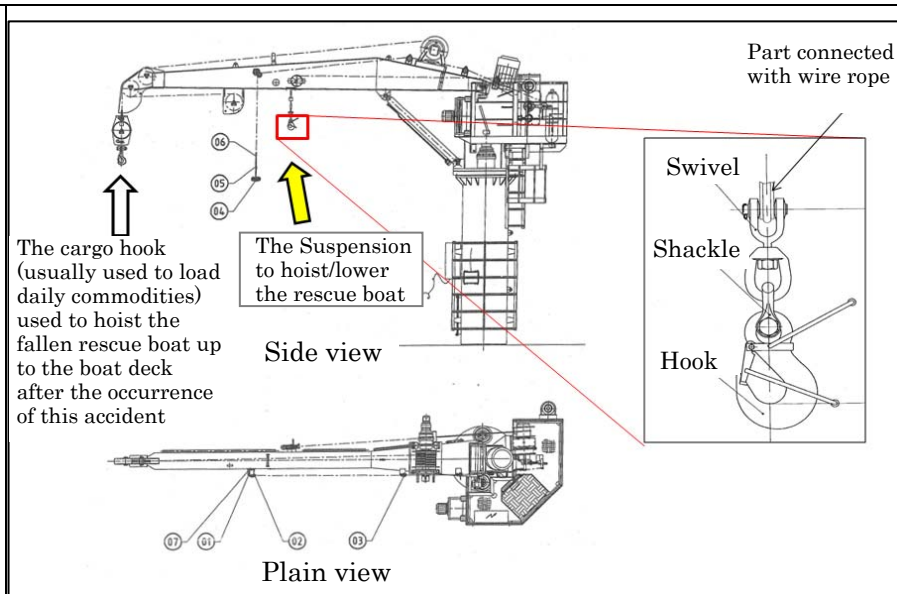
Figure 1 Design drawing of the crane and the Suspension (extract)

(6) At the time of this accident, the arrangement of the shackle and swivel of the Suspension was different from that of design drawing; they were arranged in order of the shackle, swivel, and hook to be connected with the rescue boat. The time and reasons of different arrangement were unknown. (see Photo 3)

- (9) The arrangement of the shackle and swivel of the Suspension was different from that of design drawing; they were arranged in order of the shackle, swivel, and hook to be connected with the rescue boat. The time and reasons of the upside down arrangement were not made clear.

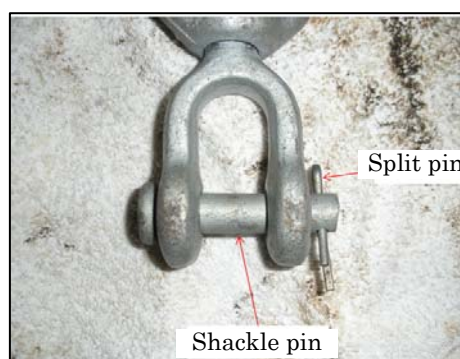
Photo 4 Shackle part of the swivel (spare part)

(7) The shackle pin of the swivel was equipped with the split pin to prevent the shackle pin from coming off. (see Photo 4)

- (5) It is probable that because the split pin in the shackle pin in the shackle part of the swivel of the Suspension was shear fractured, the shackle pin came off from the fork end eye and then the hook slipped out of the shackle part of the swivel and the rescue boat dropped eventually.

- (7) It is probable that as the swivel structure of the Suspension was designed so that preventive measures for coming off of the shackle pin in the shackle part solely depended on the split pin, the consideration and the safety measures to prevent the shackle pin from coming off due to shear fracture of the split pin were not good enough.

<p>Safety Actions</p>	<p>After this accident, the Company A took the following measures:</p> <ul style="list-style-type: none"> • Gave instructions to all ships under its control to remove the swivel if the same swivel as that of the Ship is used. • As shown in Figure 4, the swivel of the Suspension was replaced by the bow shackle composed of a bolt, nut and split pin. • Reviewed the procedures and work instructions concerning the repair, design, procurement, maintenance system, and safety system. <div style="text-align: center;">

<p>the classification society which carries out the inspection of the crane used to hoist and lower a rescue boat needs to give a guidance to the ship owners to replace the conventional swivel by the new swivel composed of a bolt, nut and split pin if the swivel composed of the shackle pin and split pin is used in the release hook for suspending the rescue boat.</p>
--	--

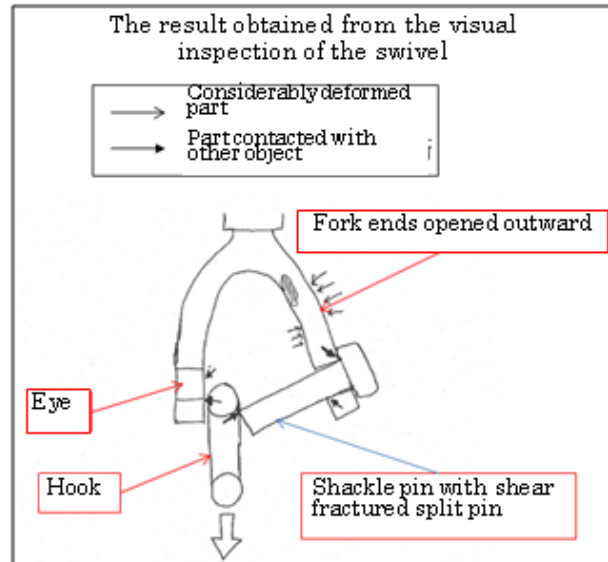
Figure 2 Results obtained from the visual inspection
(Source and issuer: FORCE Technology, issued on September 11, 2012)

- a) The galvanized swivel and shackle were mounted upside down in the Suspension compared to the design drawing; however, there were no indications that the strength of the fork ends of the swivel was inferior and there were no signs of

<p>material defects being contributory to this accident.</p> <p>b) As shown in Figure 2, the fork end leg of the swivel in the Suspension was deformed in bending. The same factor responsible for this bending has also sheared off the split pin in the swivel thus allowing the fork to open up and let the hook eye slip out of engagement with the shackle pin.</p> <p>c) The split pin of the swivel was sheared off and the fresh metallic appearances of the sheared surfaces indicate that this happened in connection with the accident.</p> <p>(12) As to the crane installation and the Suspension structure used for lifting and lowering the rescue boat, the following comments were obtained from shipyards (40 companies) and rescue boat manufacturers (three companies) in Japan:</p> <p>a) In the past, two companies handled the same type of cranes as that of the Ship; they were installed on seven ocean-going ships, but today no company handles this type of crane.</p> <p>b) As shown in Figure 3 and Photo 5, no swivel is used for a release hook currently handled in Japan; the JIS standard SB shackle composed of a bolt, nut, and split pin is used instead and the release hook is used.</p> <div style="display: flex; justify-content: space-around; align-items: center;"> <div data-bbox="564 1010 1075 1310" style="border: 1px solid black; padding: 5px;"> </div> <div data-bbox="1139 1021 1442 1408" style="border: 1px solid black; padding: 5px;"> </div> </div> <p style="text-align: center;">Figure 3 Example of a shackle handled by shipyards in Japan</p> <p style="text-align: right;">Photo 5 Example of a release hook</p>

- (6) It is somewhat likely that judging from the fact that fresh metallic surface appearance was observed on the split pin in the shackle pin of the shackle part of the swivel of the Suspension, when the chief officer and the able seaman A boarded the rescue boat being in the suspended state, the load was applied to one fork end of the swivel; therefore, the fork end was deformed and the split pin was sheared off eventually.
