MA2014-1

**MARINE ACCIDENT  
INVESTIGATION REPORT**

Vessel type and name: Container ship YONG CAI

Vessel type and name: Fishing vessel SHINYOMARU No.2

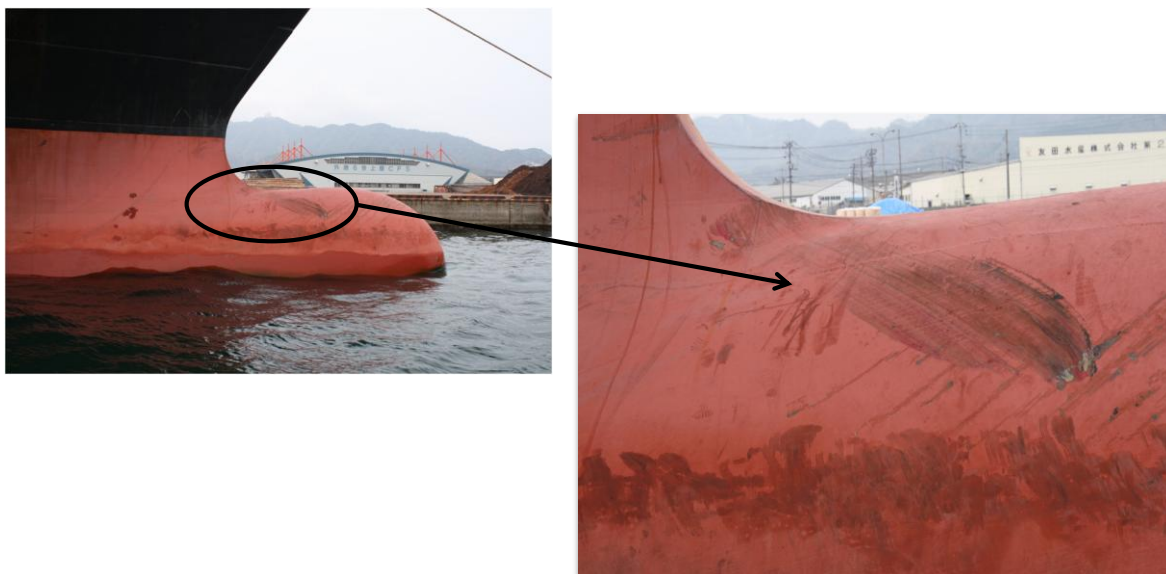
Photo 2-1 Damage to Vessel A

Vessel A suffered scratch to the upper bulbous bow on the starboard side.

According to 2.3, it is probable that Vessel A suffered scratch to the bulbous bow on the starboard side and Vessel B crushed and lost the bow and suffered damage in the fender on the stern on the starboard side, etc.

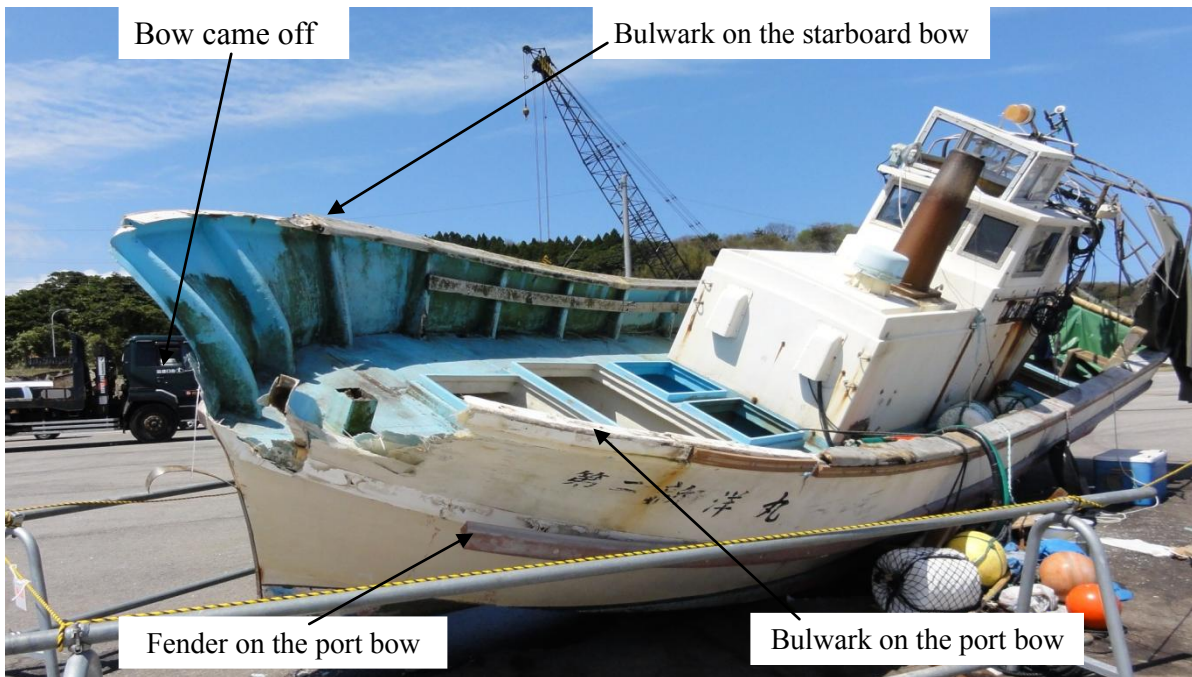
Photo 2-2 Damage to Vessel B

The bow was lost after the crush, and it suffered damage such as cracking and peeling in the side shell plating on the starboard bow, both side bulwarks on the bow, fender on the port bow, and fender on the starboard stern.

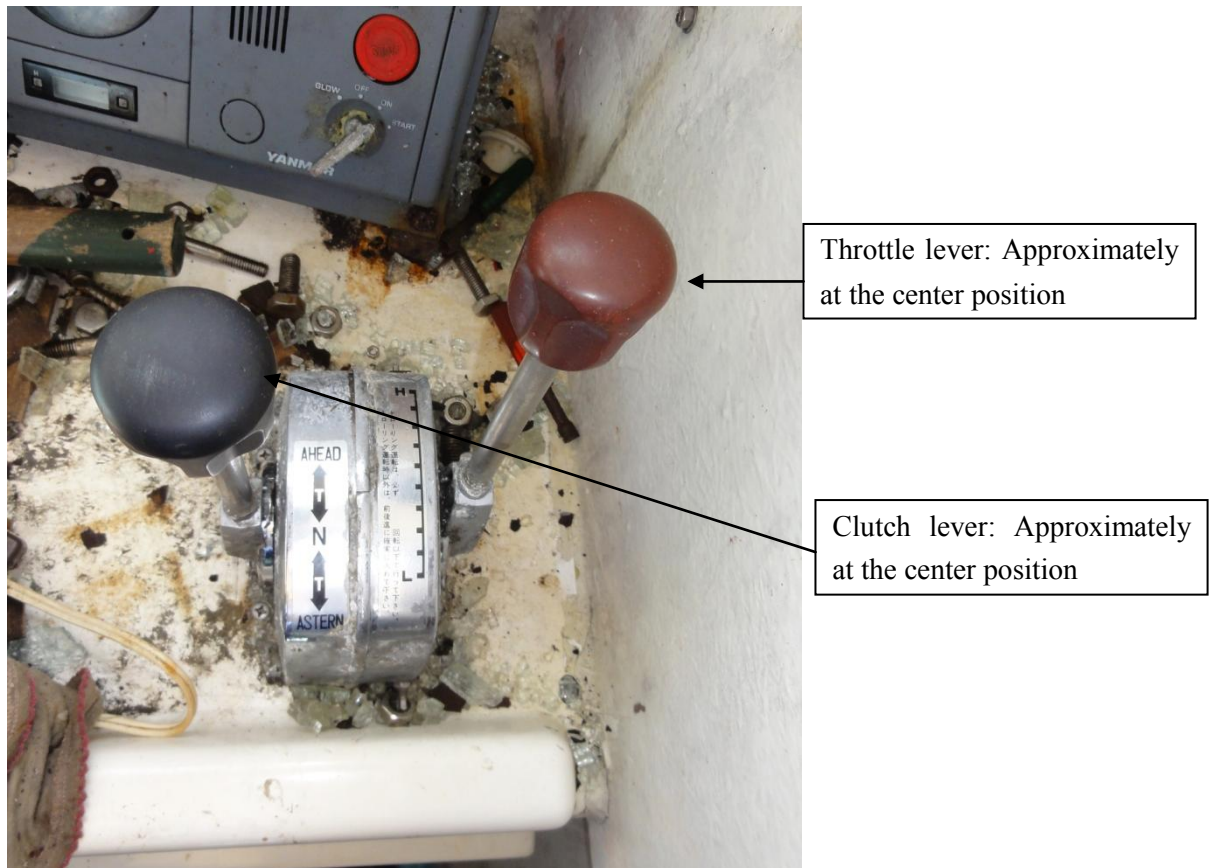
Photo 2-5 Clutch lever and throttle lever

At the time of the on-site investigation by marine accident investigators at the Noroshi Fishing Port, the main engine clutch lever (center for neutral, forward for ahead, and back for astern) was approximately at the center position. Throttle lever was also approximately at the center position.

- (i) According to 2.5.2 (2), it is probable that it was turned the rudder to starboard 40° with the remote control and set the clutch and throttle dial to full astern, but the clutch was not in astern and remained neutral.
- (ii) According to 3.1.1 (2), it is somewhat likely that Vessel B was navigating in the course of south-southwest at a speed of about 9kn.
- (iii) According to the damaged condition, which is later mentioned in 3.1.4, it is probable that Vessel A and Vessel B collided with the the starboard bow of Vessel A and the bow of Vessel B in a perpendicular angle.

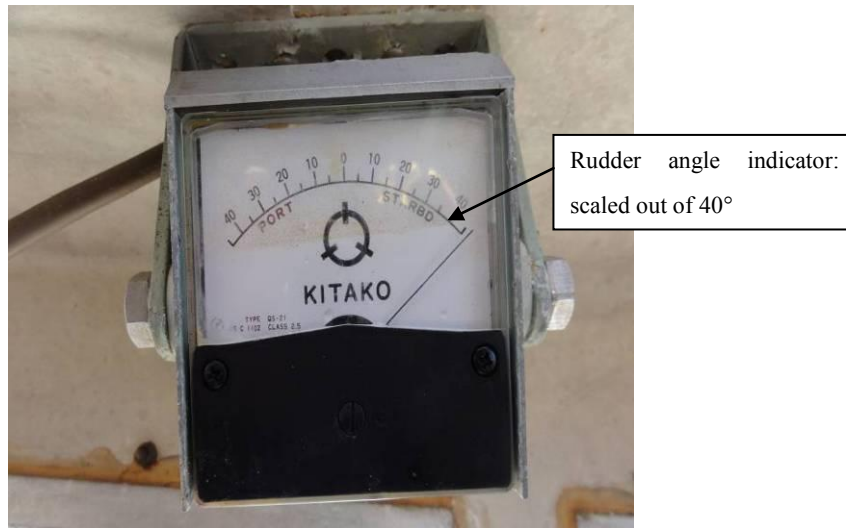
Photo 2-6 Rudder angle indicator

There were three square windows in the wheelhouse, and there was a clear view screen in the central window. The rudder angle indicator was above the central window, and its pointer was indicating past starboard 40°.

Due to the fact that the position of the remote control dial, clutch lever, throttle lever, and rudder angle indicator of Vessel B indicated full astern and the rudder angle was past starboard 40°, it is probable that Skipper B took actions to prevent the collision immediately before the collision. Due to this, it is somewhat likely that Skipper B noticed Vessel A only when it came close. However, due to the facts that Skipper B was killed and Crew B went missing, it was not possible to clarify the watchkeeping situation of Skipper B, who noticed Vessel A only when it came close.

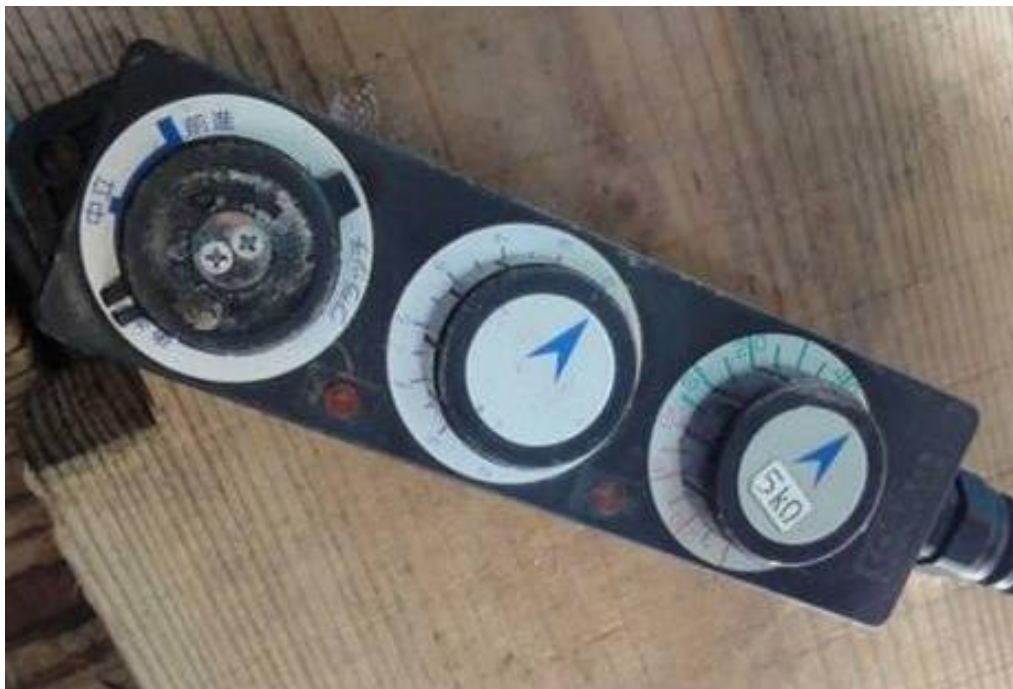
Photo 2-7 Remote control

The remote control was on the floor of the wheelhouse, and the dials showed astern for the clutch, the maximum nine for the throttle, and starboard 40° for the rudder.

(Dials indicate clutch, throttle, and rudder from the left)

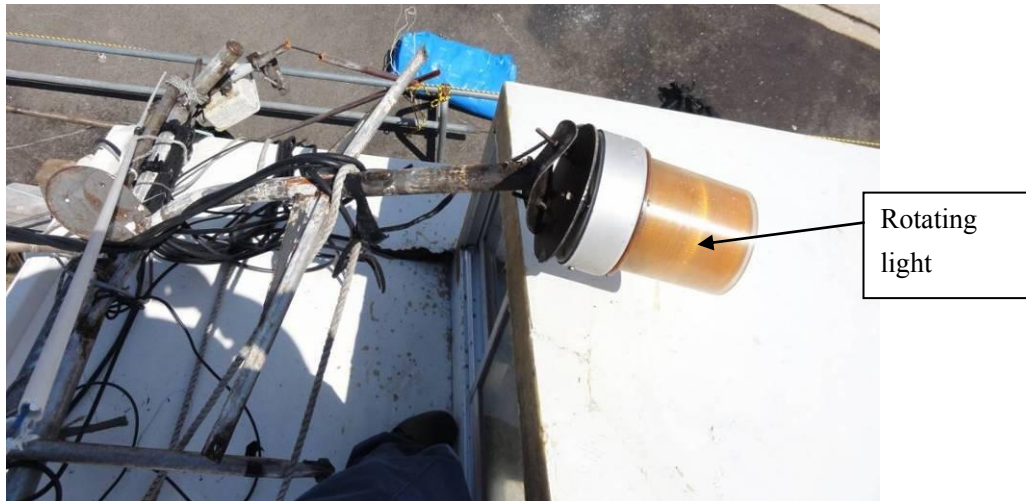
Photo 2-9 Rotating light

The cover of the rotating light was yellow with the manufacturing number, but the rest had faded and was illegible.

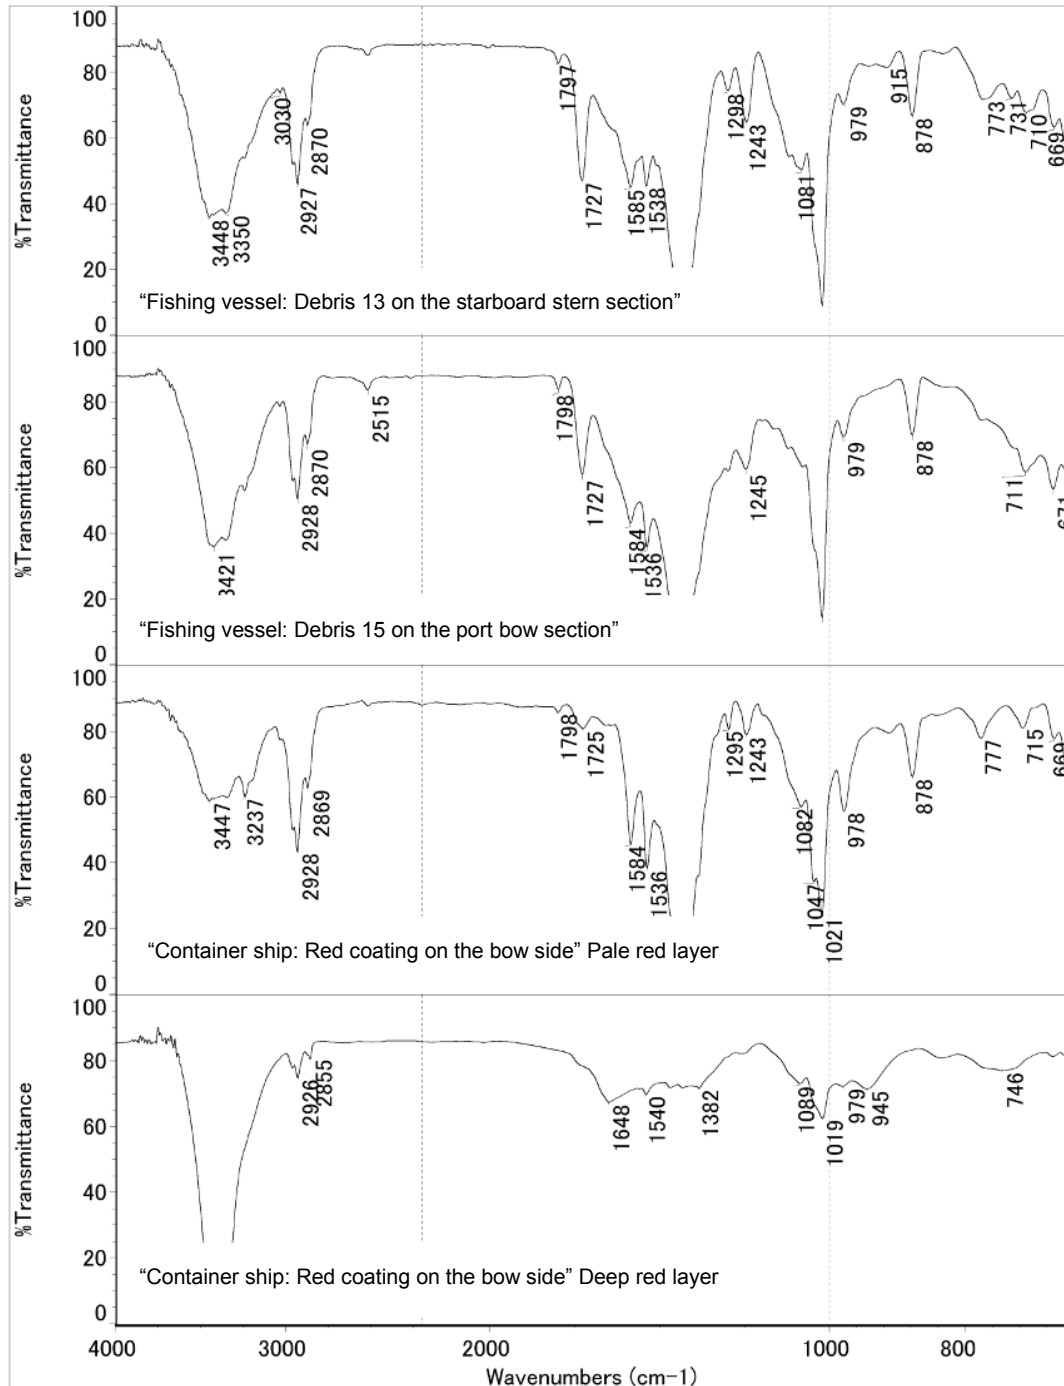
Diagram 2-2 IR spectrum comparison of the debris taken from the fishing vessel and layers of the container ship coating

The infrared ray absorption properties (IR spectra) of the debris on the starboard stern section of Vessel B, debris on the port bow section of Vessel B, red coating on the bow of Vessel A (pale red layer), and red coating on the bow of Vessel A (deep red layer) were as shown in “Diagram 2-2 IR spectrum comparison of the debris taken from the fishing vessel and layers of the container ship coating”.
