MA2014-9

**MARINE ACCIDENT
INVESTIGATION REPORT**

Accident type	Death and injury of workers
Date and Time	Around 11:10 on March 26, 2013 (local time, UTC + 9 hours)
Location	Liner Berth No. 13, Central Wharf of Port Island, Section II of the Kobe Area, Hanshin Port On a true bearing of 272° and at a distance of approximately 1,900 m from the Kobe No. 6 Breakwater Lighthouse located in Kobe City, Hyogo Prefecture (approximately 34°40.3'N, 135°13.5'E)
Summary of the Accident	At around 11:10 on March 26, 2013, while the cargo vessel JURONG with the master and 20 other crew members onboard was engaged in cargo loading operations at Liner Berth No. 13, Central Wharf of Port Island, Section II of the Kobe Area, Hanshin Port, large tires that had been temporarily placed on the tween deck of the vessel's No. 1 cargo hold fell down, killing one stevedore and injuring another, both of whom were carrying out their duties at the time.
Process and Progress of the Investigation	(1) Set up of the Investigation The Japan Transport Safety Board appointed an investigator-in-charge and another investigator to investigate this accident on March 26, 2013. (2) Collection of Evidence On-site investigat

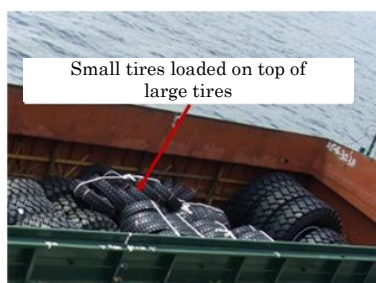
Photo 2 Tires Stowed on the Barge

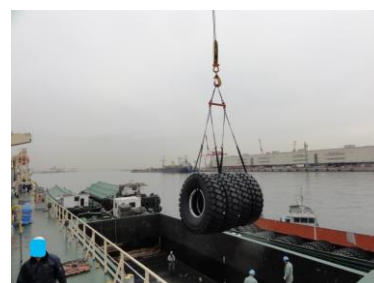
Since the small tires from the barge were temporarily placed using the Vessel's forward crane in the aft space of 'the tween deck of the No. 1 upper cargo hold' (hereinafter referred to as "the Deck"), the space available on the Deck became too small to temporarily place the large tires by resting them against other cargo or objects to prevent them from falling. To cope with the situation, the large and medium tires were temporarily placed in groups of two to five units in an upright position on the Deck.

Photo 3 Loading Large Tires onto the Vessel

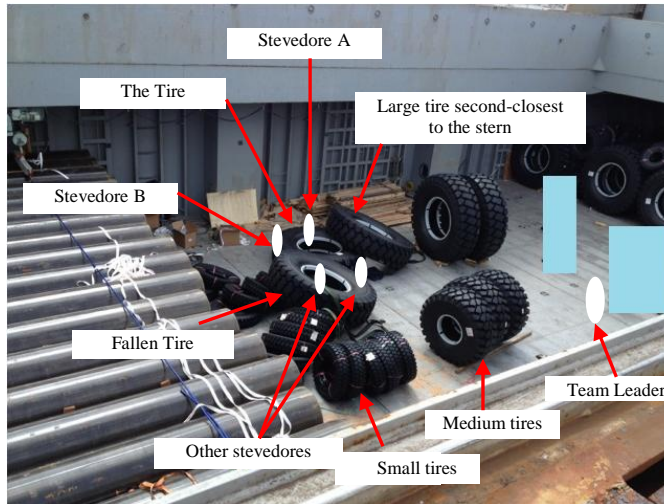
- 6) Of the four large tires temporarily placed in an upright position in the port-side on the Deck, the two tires closest to the stern fell down toward the stern at around 11:10, the time when the crane's hook block was moved toward the port side. The large tire closest to the stern (hereinafter referred to as "the Tire") trapped Stevedore A underneath it, while also hitting Stevedore B's left ankle and throwing him down.
(See Photo 4.)

Photo 4 State of the Deck Just after the Accident Occurrence (Personnel locations shown are assumed to be at the time just before the occurrence of the accident.)

- (8) It is probable that when Stevedore A was in a location on the port bow side of the Fallen Tire, two (including the Tire) stern side tires of the four large tires temporarily placed in an upright position fell down toward the stern at around 11:10, the Tire trapped Stevedore A underneath it and killed him. It is also probable that Stevedore B who was working on the port-side of the Fallen Tire, facing the starboard, was struck by the Tire on his left ankle and thrown down when the Tire fell down and bounced; he suffered an injury to his left ankle.

- (9) It is probable that the Tire temporarily placed in an upright position fell down because it was not provided with any means against a sideways fall, but the details of what led to the Tire falling could not be determined.

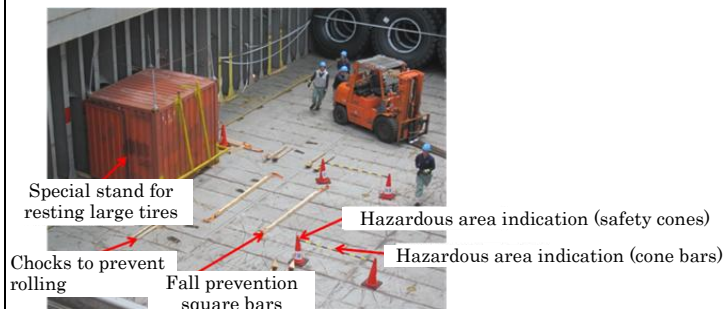
Photo 5 Temporary Tire Placement Area on Deck

Access to areas involving the risk of large tires falling is restricted by placing safety cones, cone bars, etc., during cargo handling operations.

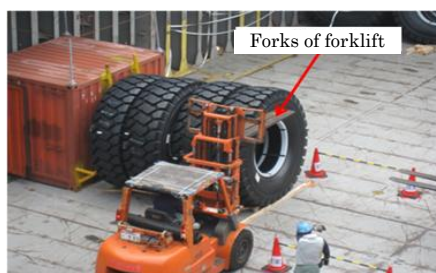
Photo 6 Tire Fall Prevention by Forklift – Example 1

<p>Safety Actions</p>	<p>It is probable that the accident occurred because the Tire, which was one of four large tires temporarily placed in an upright position on the Deck during stevedoring on the Vessel at the Berth located in Section II of the Kobe Area in Hanshin Port, fell down and caused Stevedore A to become trapped underneath the Tire and Stevedore B to be hit on his left ankle and thrown down by the Tire.</p> <p>It is probable that the Tire fell down because it was temporarily placed in an upright position and was not provided with any means against falling sideways.</p> <p>Company A did not indicate hazardous areas involving the risk of large tires falling and did not make sure no stevedore entered such hazardous areas. It is somewhat likely that not implementing these safety measures contributed to the occurrence of the accident.</p> <p>Consequently, whenever loading operations of large tires onto a vessel are carried out, it is essential to make known to all persons concerned the necessity to provide a means to prevent sideways falling of temporarily placed large tires, to provide indications preventing entry into areas involving the risk of large tires falling, and to make sure no stevedore enters such hazardous areas.</p> <p>After the accident, Company A and Company B established their cargo handling standards for large tires to implement the following measures against recurrence of similar accidents:</p> <ol style="list-style-type: none"> 1. Fall prevention measures for large tires <ol style="list-style-type: none"> 1) Special stands for resting large tires are made and always used when large tires are temporarily placed. 2) Two forklifts are commissioned, one of which is used as a support to prevent sideways falling of temporarily placed large tires

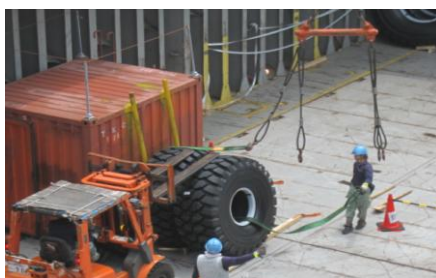
Photo 7 Tire Fall Prevention by Forklift – Example 2
