MA2014-6

**MARINE ACCIDENT
INVESTIGATION REPORT**

Vessel type and name: Cargo ship TAIGAN

Accident type: Fire

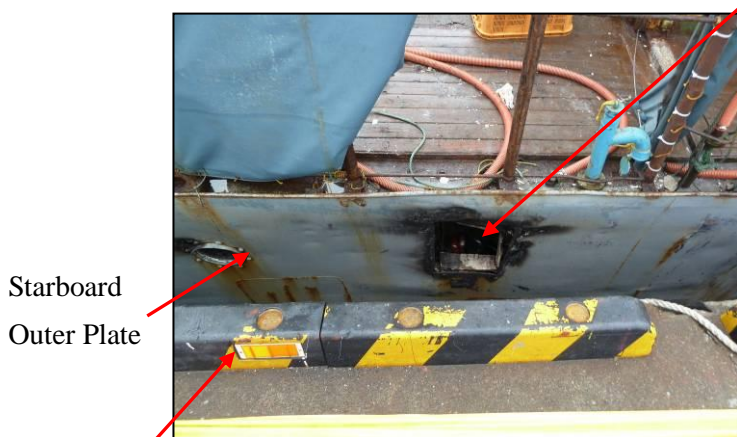
Photo ① "Opening on Galley Outer Plate
(Taken from the Pier)"

O/S E received another air tank from the fire brigade, who told him to stay in his cabin because they would be rescuing him by gas-cutting the outer plate. At about 05:20, O/S E was rescued from an opening about 40cm high and 30cm wide the shipbuilding worker opened on the outer plate on the aft side of the galley. Then, he was transported to a hospital in Wakkanai City. (See Photo ① and Photo ②)

The opening made by gas cutting to rescue O/S E

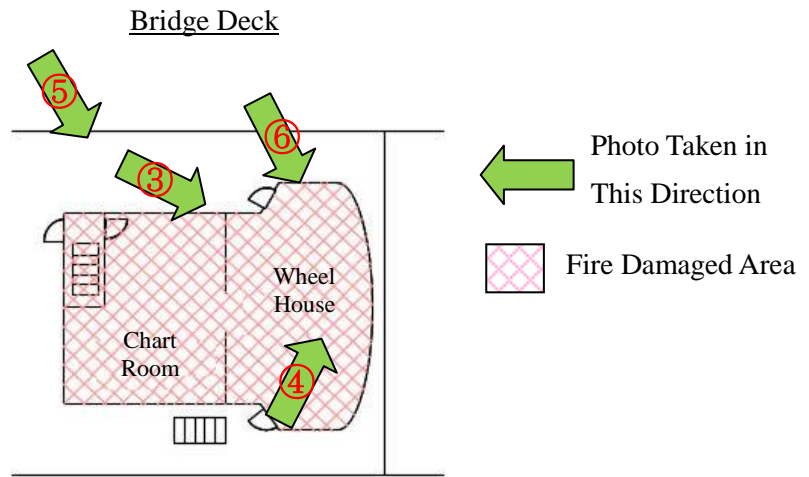
Figure 2.6-2 "Bridge Deck Fire Damaged Area"

The wheel house and the chart room including the radar, the communication device, and the engine console box almost burned out. All the windowpanes were also broken. In addition, the wooden downward stairway that connected the port quarter of the chart room to the poop deck and the entrance door to the stairway burned down.

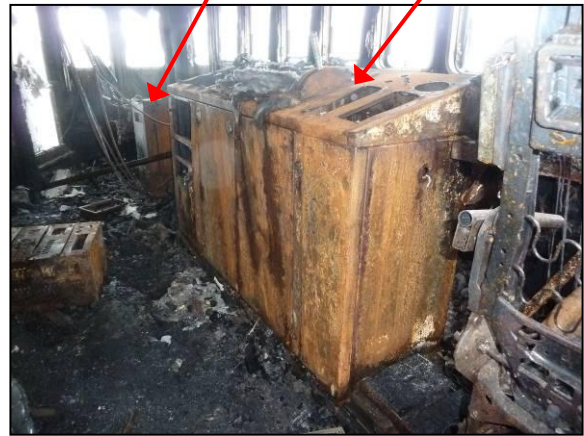
Photo ④ "Wheel House"

Radar

Engine Console box

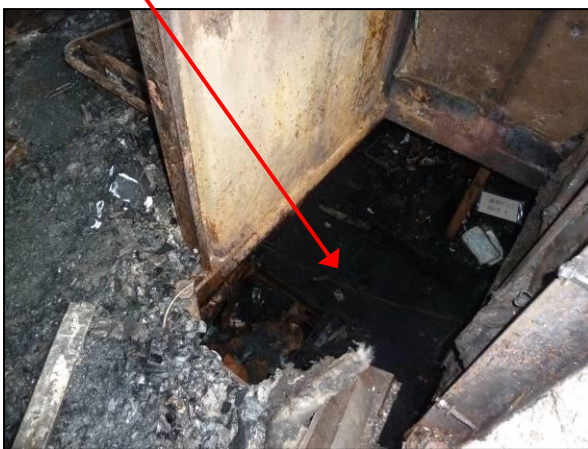
Photo ⑤ "Stairway on Aft Side of Chart Room"

Wooden Downward Stairway to Poop Deck (Burned Down)

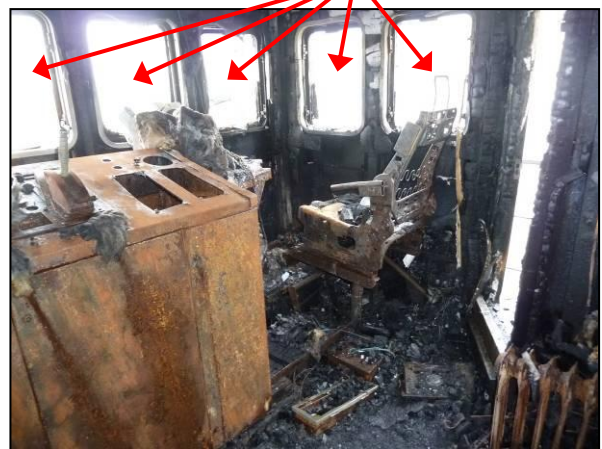
Photo ⑥ "Wheel House on Forward Starboard Area"

Windowpanes (Broken)

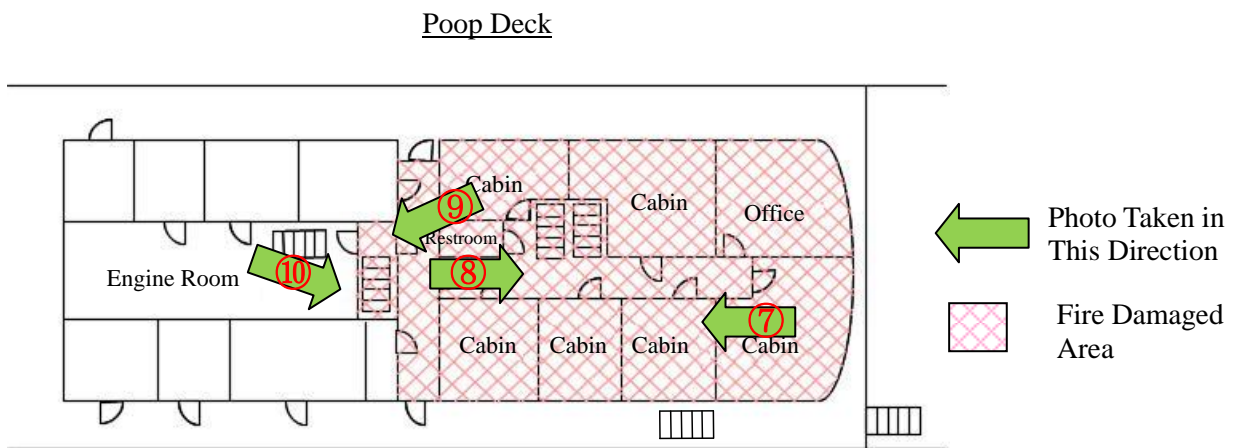
Figure 2.6-3 "Poop Deck Fire Damaged Area"

The wooden stairway between the athwartship corridor and the forward side accommodation spaces as well as the two wooden stairways in the accommodation spaces burned down. The wooden stairway from the athwartship corridor down to the aft upper deck burned out as well.

Inside the engine room on the aft side of the athwartship corridor, plastic materials burned and melted and the upper part of the starboard sidewall was blackened by soot. (See Figure 2.6-3, Photos ⑦ through ⑩, and Photo 10 "Athwartship Corridor on Poop Deck")

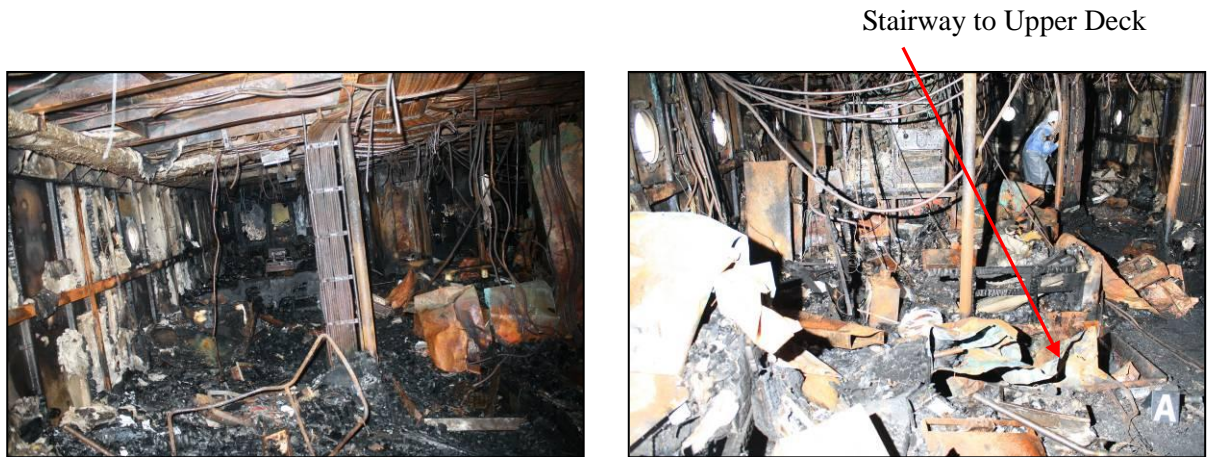
Photo ⑦ "Photo of Aft Side Taken from Fore Side"

Photo ⑧ "Fore Side of Restroom"

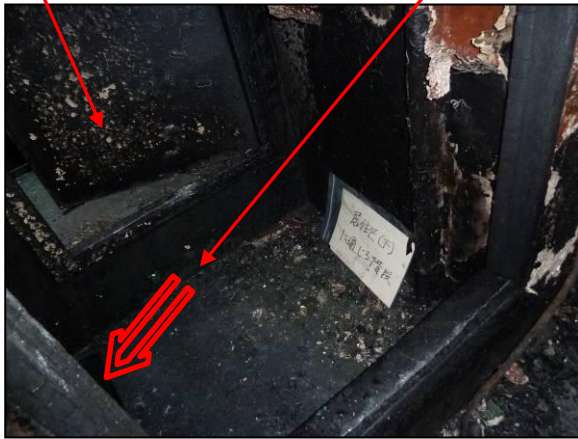
Photo ⑨ "Entrance Door to Engine Room and Stairway to Upper Deck"

Entrance Door to Engine Room

Stairway to Upper Deck

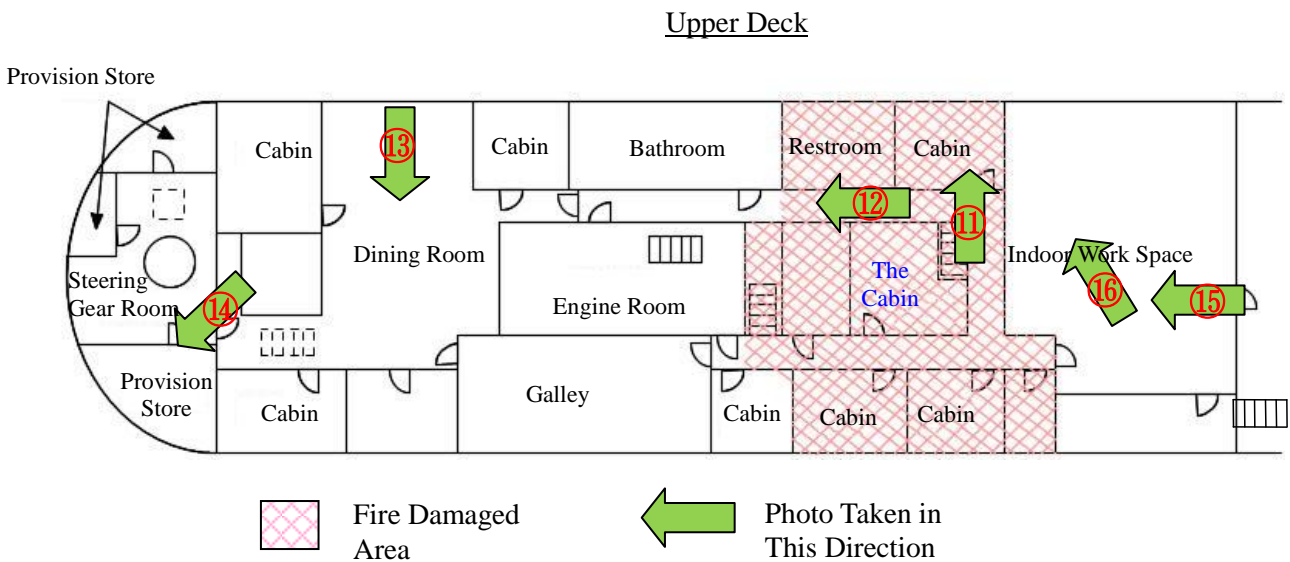
Figure 2.6-4 "Upper Deck Fire Damaged Area"

The cabins on the forward side, particularly in the Cabin, burned more severely than other cabins. But the indoor work space and the galley did not burn down, though the upper part of each room was blackened by soot. In the indoor work space, some ashtrays with cigarette butts remained unburned. The provision stores and the steering gear room at the stern were not burned.

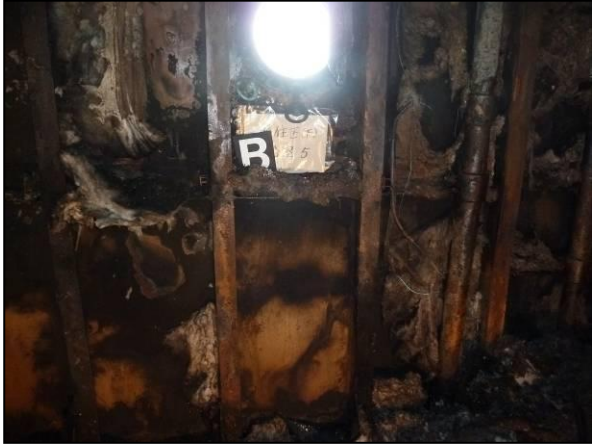
Photo ⑪ "Forward Port side cabin:
Severely Burned"

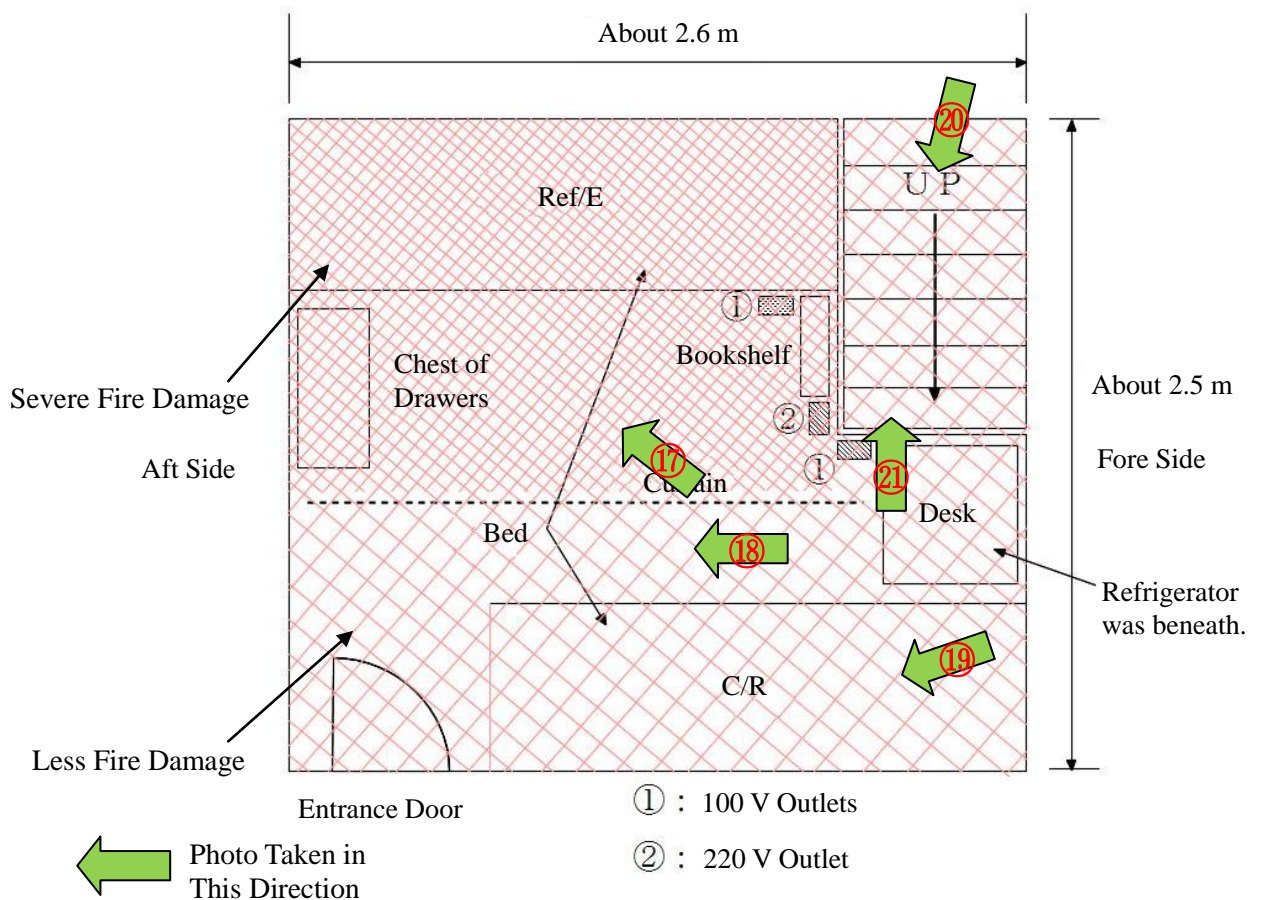
Figure 2.6-5 "Fire Damaged Conditions of the Cabin"

- (1) The aft side steel wall in the Cabin remained but all the three wooden walls burned out.
- (2) The port side bed in the Cabin, particularly on the aft side, was severely burned. The floor under the bed, the wall on the aft side of the bed, and the ducts mounted on the ceiling buckled. Besides, the chest of drawers and other fittings by the port side bed and against the aft sidewall completely burned out. The area around the starboard side bed had less fire damage than the port side bed. The starboard side bed and the drawer under the bed partially remained unburned.
- (3) The upper side of the wooden stairway on the port side burned out, with the lower three steps left unburned.

- (4) Out of the three outlets installed in the Cabin, the refrigerator's power supply cord was plugged into the 100 V outlet on the starboard side through an extension cord. The outlet, the extension cord, and the power supply cord did not burn out.
- (5) A metal ashtray was found under the stairway on the forward side of the port side bed. There were some cigarette butts in the ashtray.

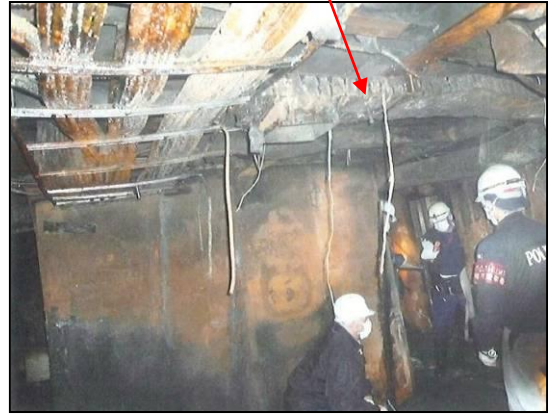
Photo ⑱ "Over Bed of Ref/E"

Buckled Duct on Ceiling

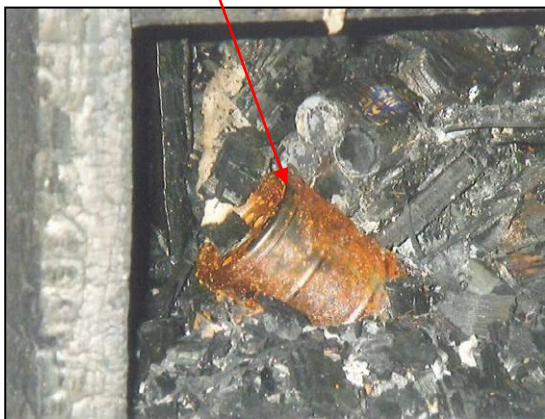
Photo ㉑ "Ashtray Found under Stairway"

The Vessel prohibited smoking onboard except in the indoor work space on the upper deck; therefore the C/R had told the Ref/E not to smoke in the Cabin. According to the fact that a metal ashtray with some cigarette butts was found under the stairway on the fore side of the port side bed, the fact the C/R had no habit of smoking, and the fact that all the ashtrays placed in the indoor work space had remained there, which makes it hard to believe that the ashtray found in the Cabin had been brought in from the indoor work space, it is somewhat likely that the Ref/E was smoking in the Cabin.

- 5) Consequently, it is probable that this accident could have been prevented if the Vessel had ensured the onboard smoking policy was observed.

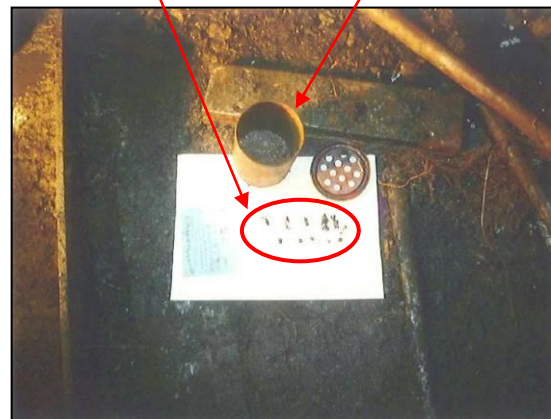
Photo ㉒ "Ashtray and Cigarette Butts"

Cigarette Butts

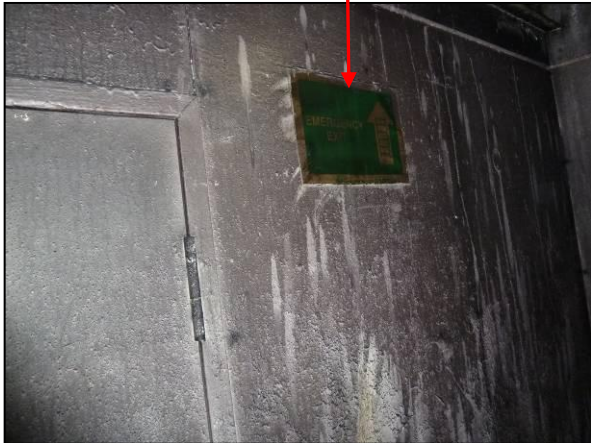
Photo 7 "Sign of EMERGENCY EXIT on Upper Deck"

According to the on-site investigation, the upward stairway in the mess room had been removed; besides, the escape hatch had been welded at the time of the accident, nevertheless there was the sign of EMERGENCY EXIT on the aft sidewall in the steering gear room.

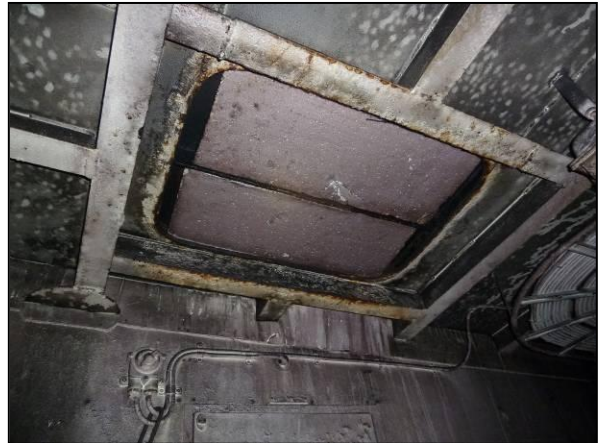
Photo 8 "Welded Escape Hatch on Upper Deck Ceiling"

- (2) The escape hatch on the portside in the Vessel's steering gear room, which led to the quarter deck, was welded. Accordingly, it is somewhat likely that the lack of an escape route from the aft part of the Vessel worsened the damage. The fire did not spread to the stern; consequently, it is somewhat likely that the casualties could have been prevented by letting some crew members get out through the escape hatch, if the Vessel had been installed with an aft side escape hatch for emergencies.

Company B is recommended to try to secure escape routes regardless where a fire breaks out, for example, by having one on the fore side and another on the aft side.
