MA2015-10

**MARINE ACCIDENT
INVESTIGATION REPORT**

MARINE ACCIDENT INVESTIGATION REPORT

Vessel type and name:	Container ship, WAN HAI 162
IMO number:	9132909
Gross tonnage	13,246 tons
Vessel type and name	Fishing vessel, SEINAN MARU No.7
Fishing vessel registration number:	OS2-1480
Gross tonnage:	9.7 tons
Vessel type and name:	Fishing vessel, SEINAN MARU No.8
Fishing vessel registration number:	OS2-1730
Gross tonnage:	9.7 tons
Accident type:	Collision
Date and time:	About 5:59am, February 25, 2013
Location:	Off the west coast of Kansai International Airport Approximately 2.7 nautical miles in approximately 274° from Kansai International Airport Offing Light Beacon A, Osaka Prefecture (Approximate position: 34°25.9' North, 135°08.3' East)

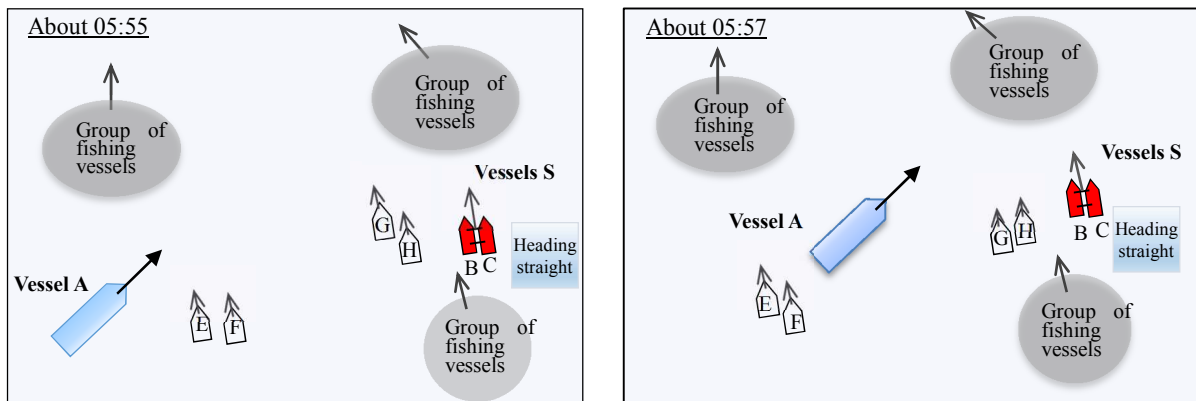
Chart 2.1: The situation prior to the accident according to Pilot A

At about 05:57, as there were no changes in the bearing of the Vessels S, which was at approximately 1,000 meters, Pilot A operated the button on the whistle control panel to blow a whistle for the purpose of alerting Vessels S (see Chart 2.1).

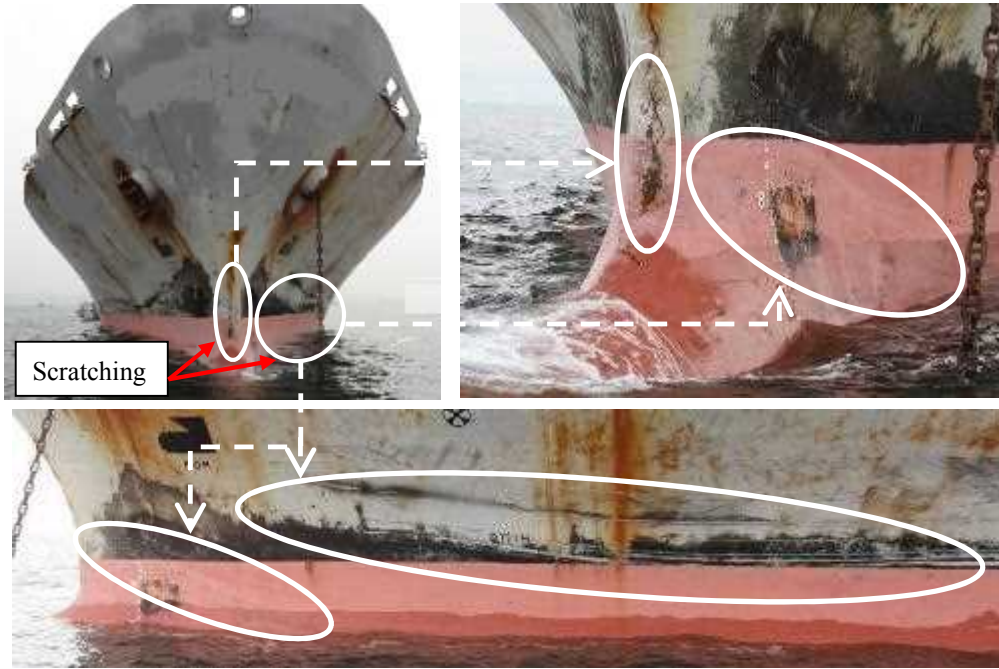
Photo 2.3-1 Damages on Vessel A

Vessel A had scratches on the stem and on the hull plate of port side fore. (see photo 2.3-1)

- (1) Vessel A sustained scratching damage to external plating on the tip of the bow and on the port side of the bow.
- (2) As for Vessels S, Vessel B sustained a puncture hole beneath the stern and its shoe piece was broken off; the stern of Vessel C was severed from the hull; and the two wire ropes used to tie Vessel B and Vessel C were severed.

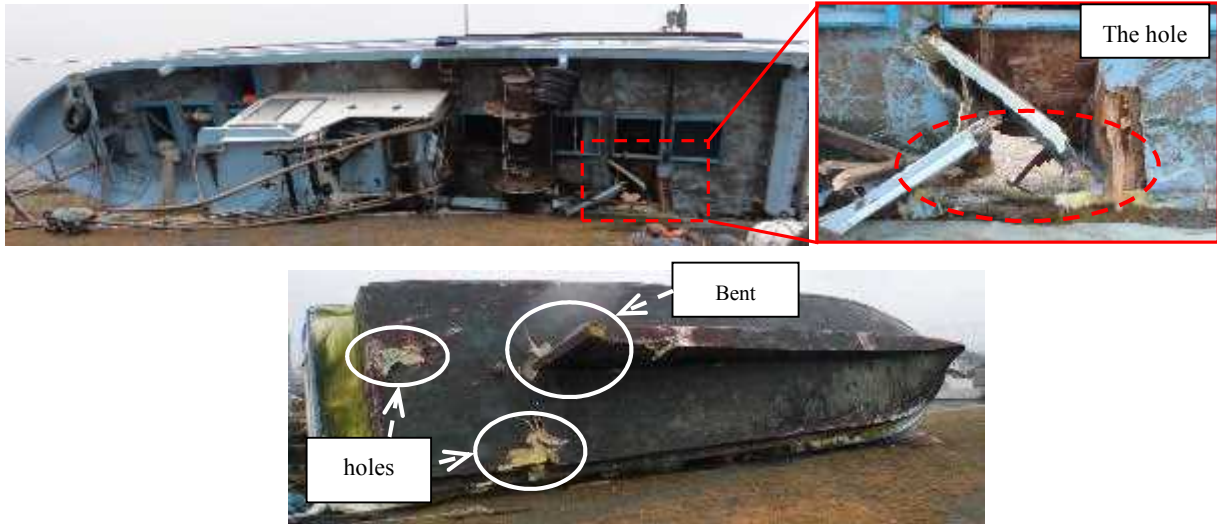
Photo 2.3-2 Damages on Vessel B

Vessel B had holes on the bottom of the stern part, was bent on the shoe piece, and the wire ropes used to tie Vessel B to Vessel C were cut off. (see photo 2.3-2)

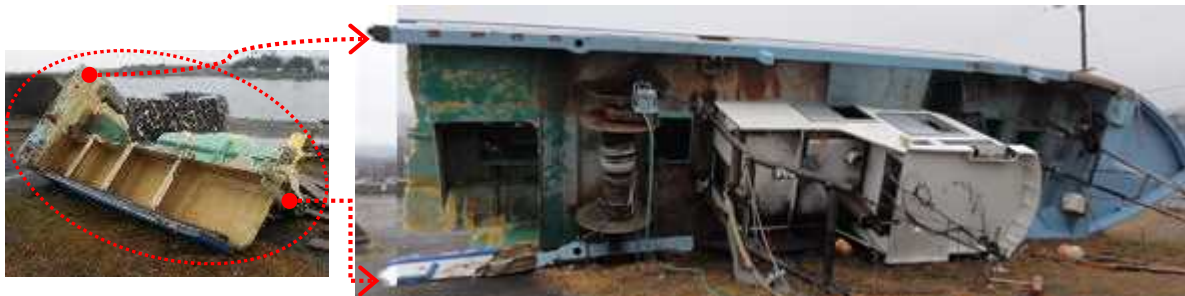
Photo 2.3-3 Damages on Vessel C

The stern part of the Vessel C was torn apart from the hull. (see photo 2.3-3)

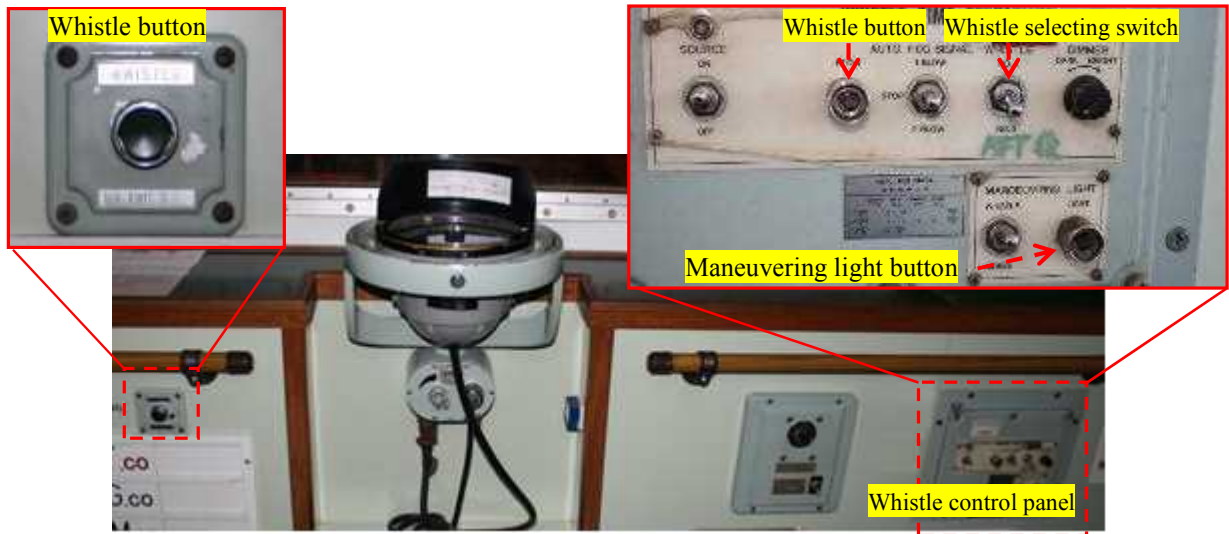
Photo 2.5-3 Whistle buttons and maneuvering light button

There was one whistle button and one repeater compass on both the port and starboard wings. (See Chart 2.5-1 and Photo 2.5-3)

- (3) Thoroughly reminding pilots to confirm after boarding a vessel the position and operating conditions of the whistle and daylight signaling lamp equipment, and ensure that they are usable at any time.

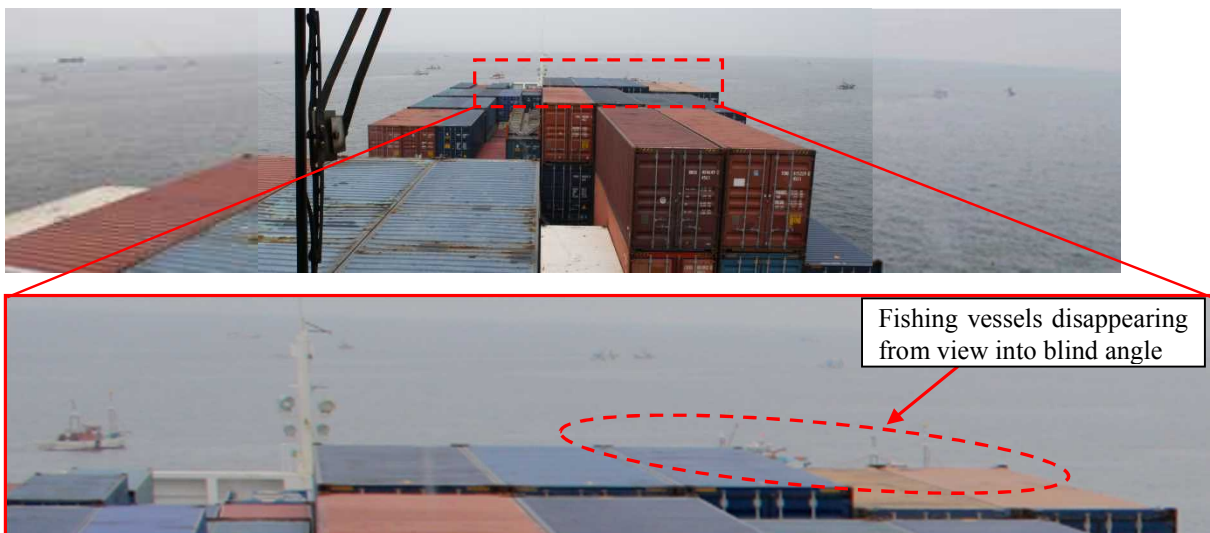
Photo 2.5-4 Navigation bridge visibility

According to Blind Distance Table of Vessel A, there was an approximately 345m of blind area forward of the bow obstructed by four layers of containers loaded on the deck (see Photo 2.5-4).

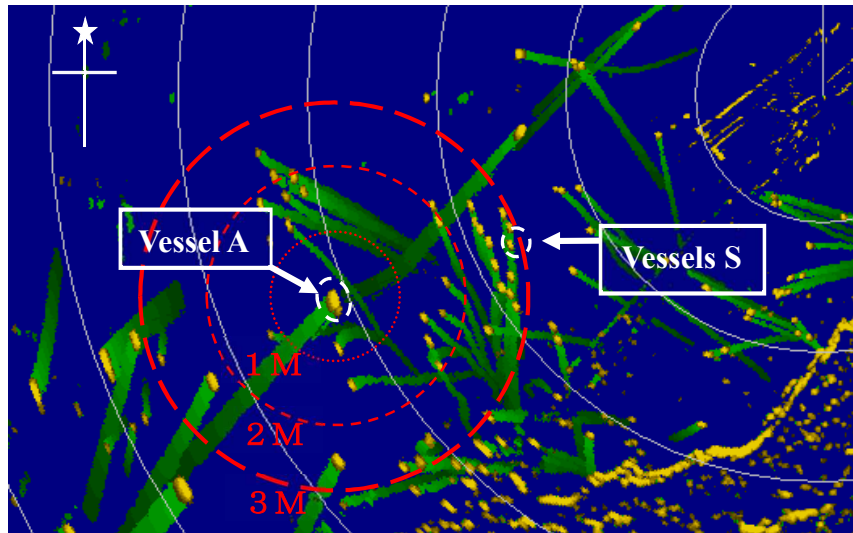
Figure 2.9 Radar image (about 05:45)

- (3) According to radar image 1, at about 05:45, there were more than 20 vessels including Vessels S, traveling in west-northwest to north bearings within a three nautical mile radius from the starboard side of Vessel A to the fore direction (see Chart 2.9).
