MA2015-3

**MARINE ACCIDENT  
INVESTIGATION REPORT**

Vessel type and name: Car Carrier NOCC OCEANIC  
IMO number: 9624029  
Gross tonnage: 58,250 tons

Accident type: Collision  
Date and time: Around 09:44, June 23, 2013 (local time, UTC+9 hours)  
Location: Off the Southeast of Kinkazan, Ishinomaki City, Miyagi Prefecture  
Around 132° true bearing, 161 nautical miles from the Kinkazan Lighthouse (approximately 32°28.1'N, 144°05.4'E)

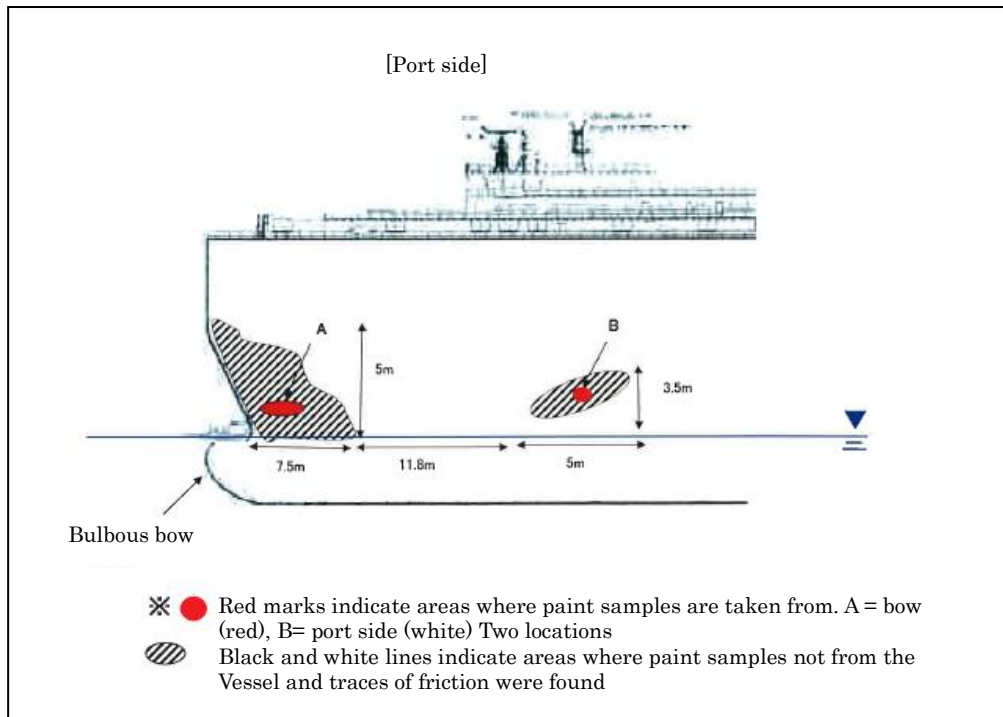
According to the on-site investigation, there were scratches on the hull at both sides of the bow of Vessel A.

Figure 2.4-1 Damage Conditions of Scratches on the Port Side of Vessel A

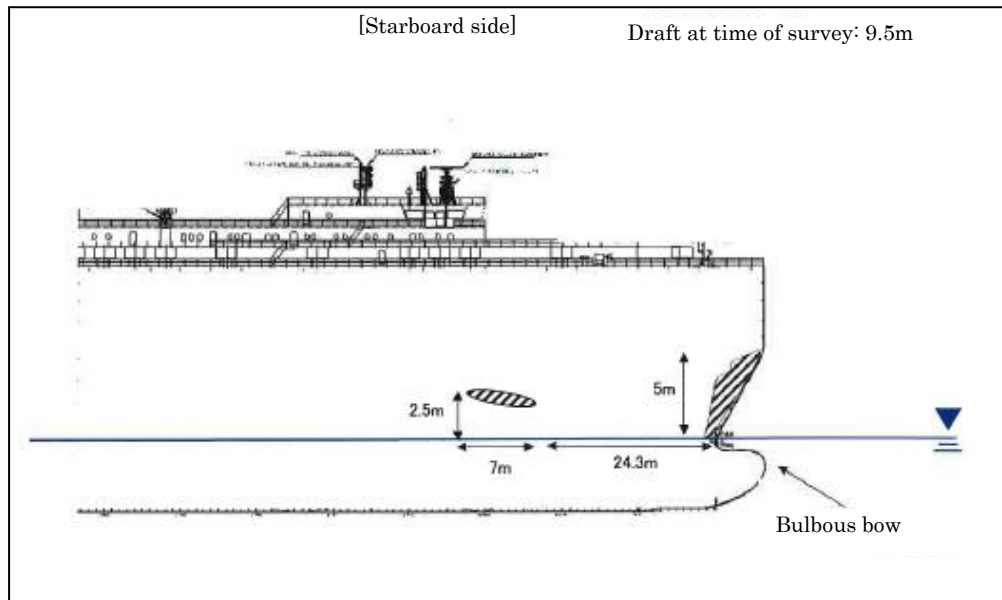
Figure 2.4-2 Damage Conditions of Scratches on the Starboard Side of Vessel A

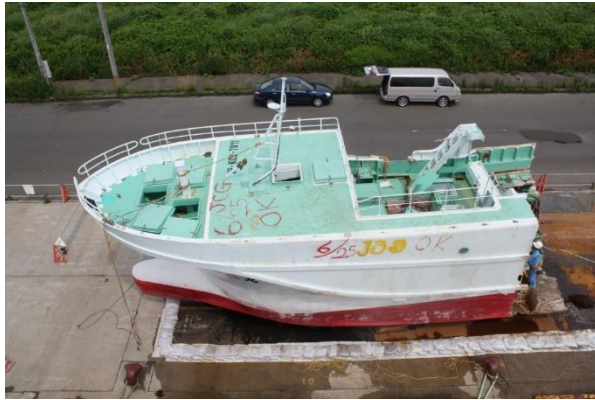
According to the on-site investigation of the forward part of Vessel B (see Photo 2.4-1) and the photos of the backward part of Vessel B provided by the Japan Coast Guard (see Photo 2.4-2), the central part including the steering room was lost, and Vessel B was separated into the forward part and the backward part. (See Figure 2.4-3)

Photo 2.4-1 Forward Part of Vessel B

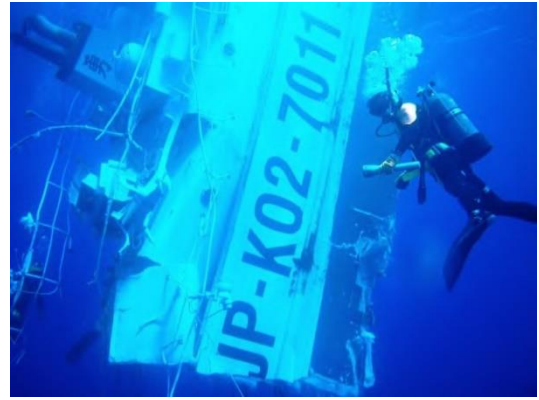
Photo 2.4-2 Backward Part of Vessel B

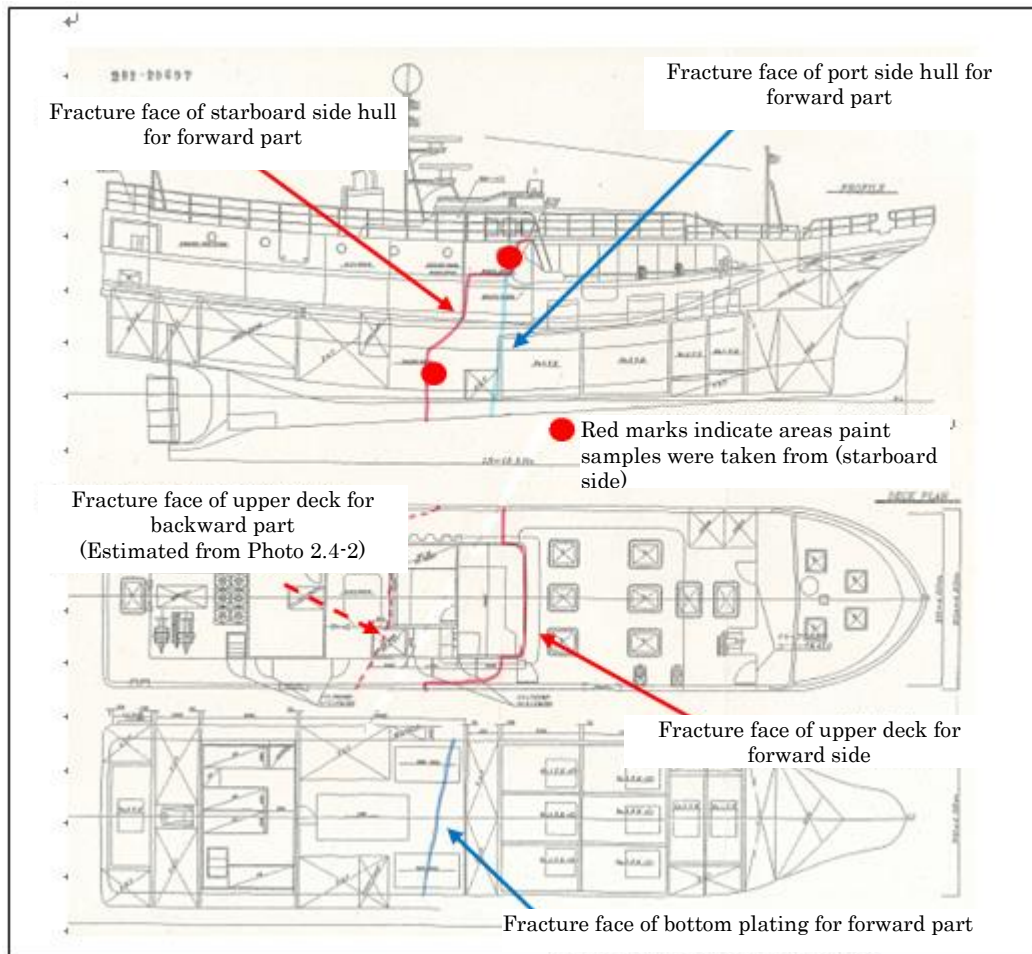
Figure 2.4-3 Damage Conditions of Vessel B

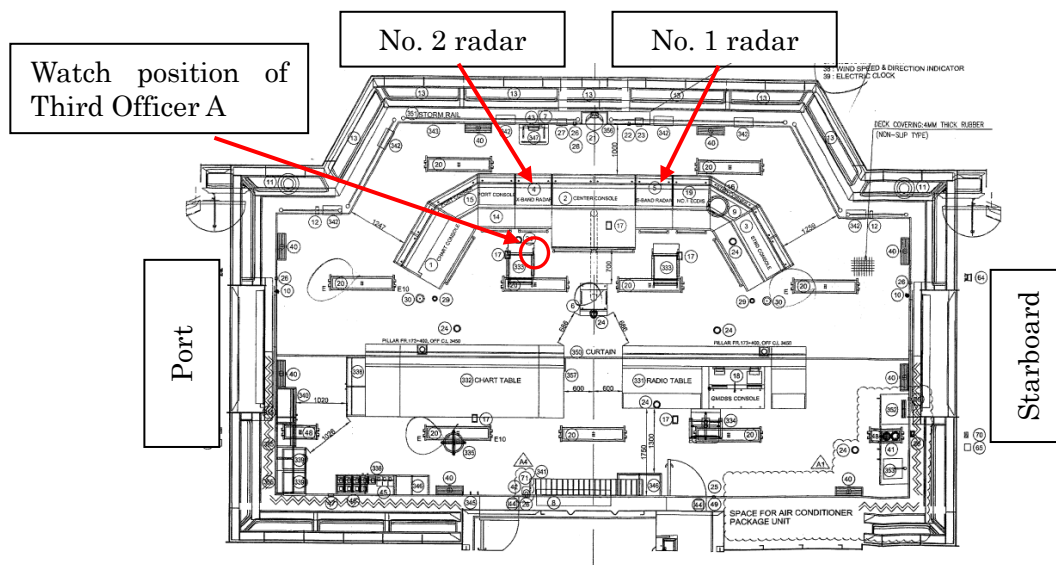
According to the statements of Third Officer A and the general arrangement, when the rain fell heavily while Third Officer A was on duty, he kept watch while standing in front of the No. 2 radar. The distance between the position where Third Officer A was standing and the foremast was approximately 30m, and the height of his line of vision was approximately 1.54m from the bridge floor. (See Figure 2.6-1 and Photo 2.6-1)

Figure 2.6-1 Bridge of Vessel A and Watch Position of Third Officer A

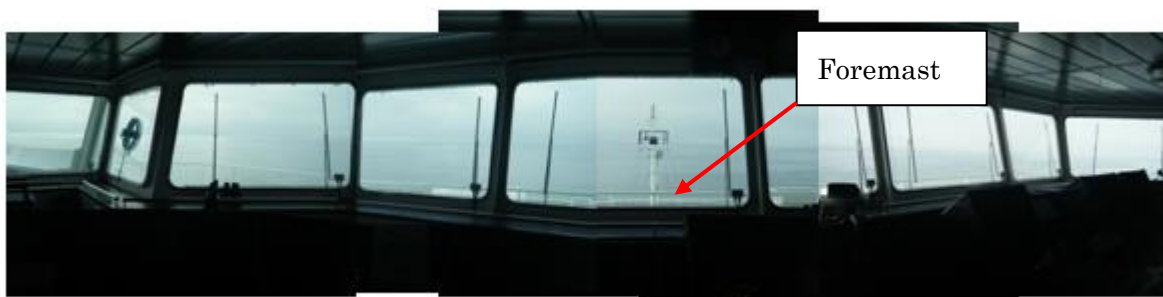
Photo 2.6-1 View in Front of the Bridge from the Watch Position of Third Officer A

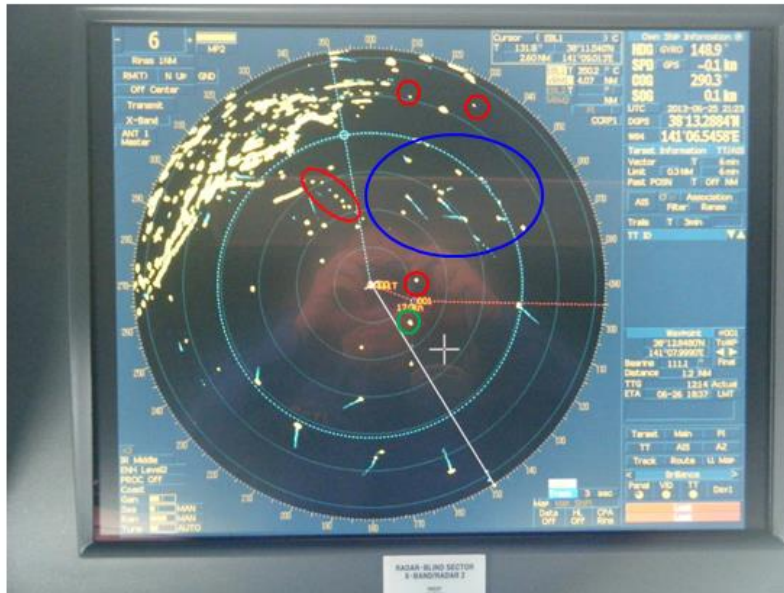
When a marine accident investigator set the No. 2 radar at range of 6M for north-up in the quarantine anchorage of Shiogama Port on June 26 and observed the fishing vessel detection distance, it was possible to detect a fishing vessel operating within 4M. At this time the weather was slightly overcast and there was no rainfall. (See Photo 2.6-2)

Red circles: light beacons  
 Blue circle: fishing boats  
 Green circle: cargo ship

Photo 2.6-1 No. 2 Radar Target Detection Status

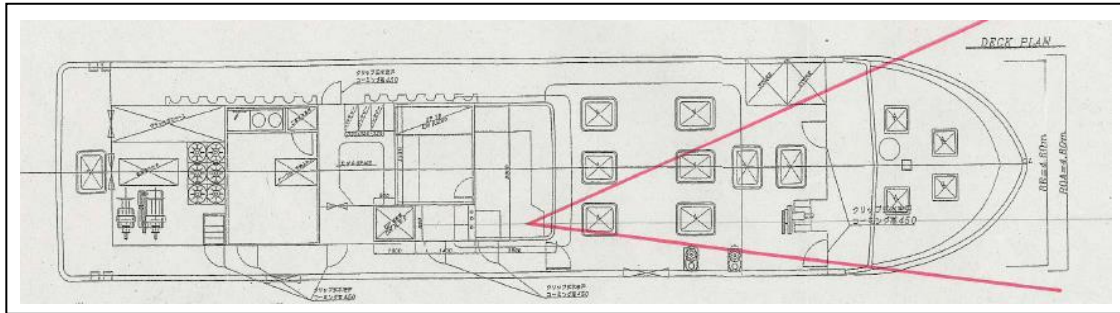
In terms of visibility from the steering room there was a blind area within the range of approximately 23° to the left and 8° to the right of the bow when the sea is calm (peaceful) and if one looks forward in a seat position in the helm chair on the port side of the steering room. When the boat is pitching due to waves, one could see forward when the bow lowers, and when the boat was not pitching the blind area caused by

the bow could be avoided by standing up from the helm chair and looking forward through the window of the watch room above the steering room. (See Figure 2.6-5, Photo 2.6-3, and Photo 2.6-4)

Figure 2.6-5 Blind Area from the Helm Chair Caused by the Bow

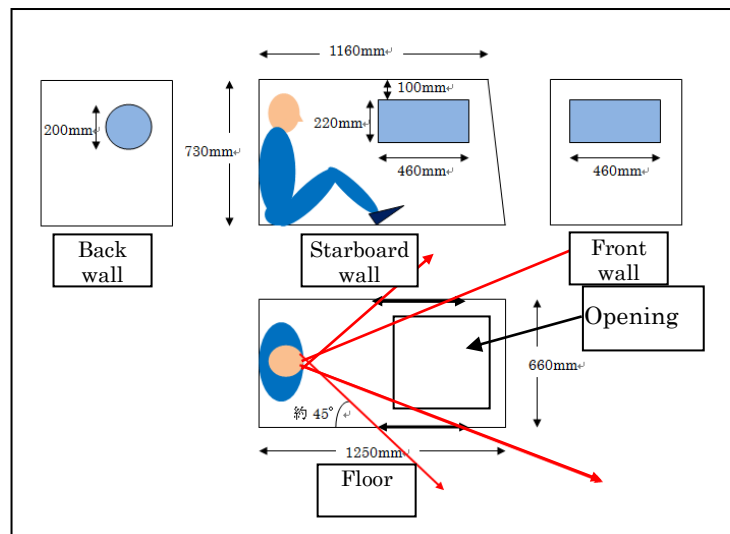
diameter of 200mm on the back wall. The windows on the left and right walls were located toward the bow, and if one kept watch with ones back against the back wall, the structure resulted in a blind area in the back from approximately 45° port and starboard of the bow. (See Figure 2.6-6)

Figure 2.6-6 Watch Room Dimensions Diagram

- (9) As stated in (6) above, because Deckhand B kept watch by eyesight while there was a blind area caused by a wall in the watch room, it is somewhat likely that Deckhand B did not notice Vessel A as Vessel A approached from 83° starboard from the bow that is the blind area caused by the wall.

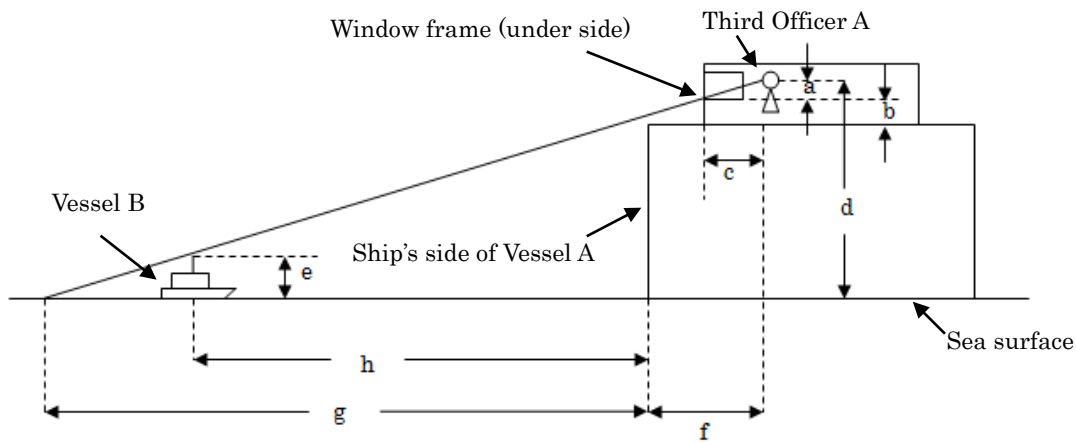
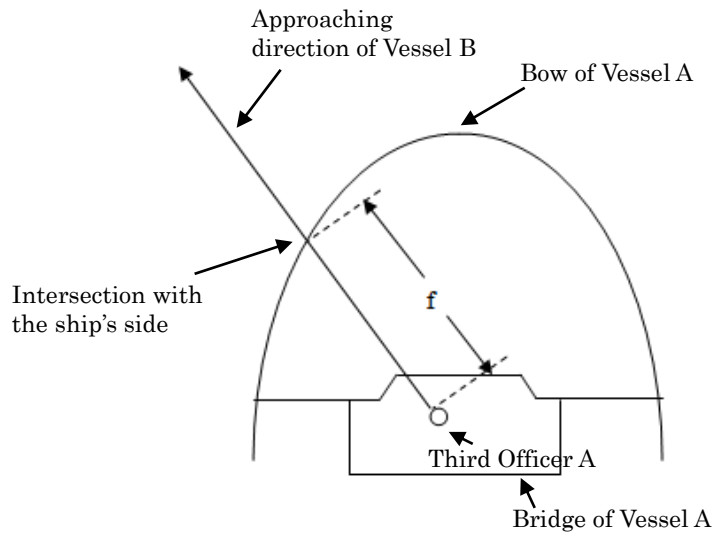
- (3) When one in the position where Third Officer A was standing looked in the direction in which Vessel B was approaching, the horizontal distance from the ship's side when the mast top became hidden under the window frame at the front of the bridge and it became impossible to see was approximately 130m.

- (4) Visibility at the time of the accident was 30m due to heavy showers of rain, and Vessel B had entered the blind area caused by the window frame at the front of the bridge before it could be sighted by Third Officer A. (See Figure 3.2)

a= approximately 0.54m: Vertical distance from viewpoint of Third Officer A to window frame (under side)

b= approximately 1.00m: Vertical distance from window frame (under side) to bridge floor

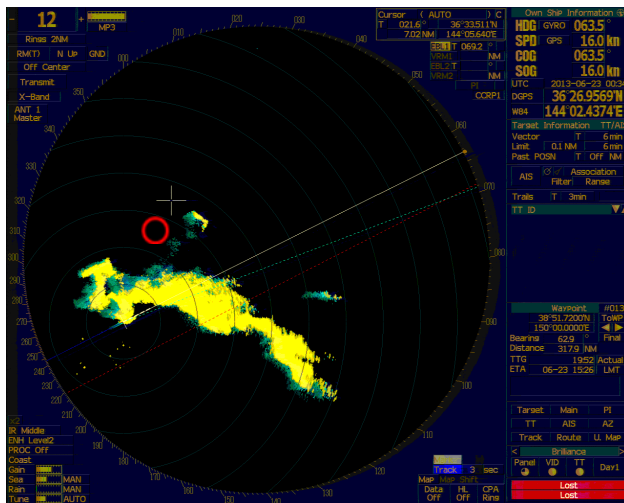
(8) Radar Image for 09:34 on June 23

The VDR microphone outside the bridge started to record the sound of rain falling on the deck of Vessel A at around 09:34. While Third Officer A began to keep watch using the No. 2 radar at that time, no other ships were visible on the radar display.

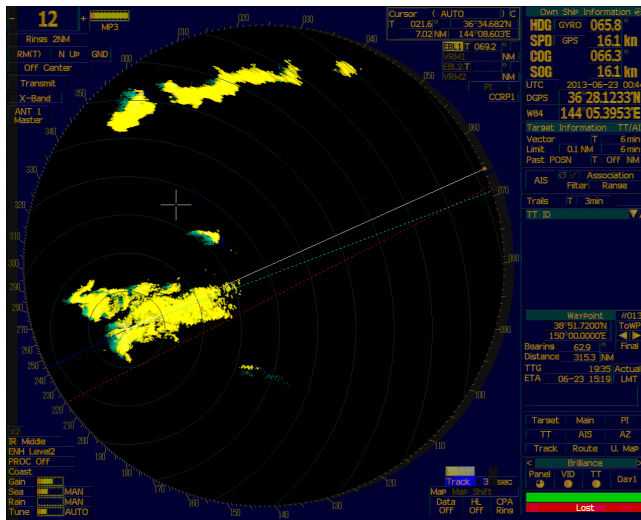
(9) Radar Image for 09:44 on June 23

While the VDR microphone outside the bridge recorded a loud sound at around 09:44, no loud sound was recorded by the microphone inside the bridge.
