**MARINE ACCIDENT  
INVESTIGATION REPORT**

Vessel type and name: Cargo ship, FUKUKAWA

Vessel type and name: Fishing vessel, TSUNOMINE MARU

Accident type: Collision

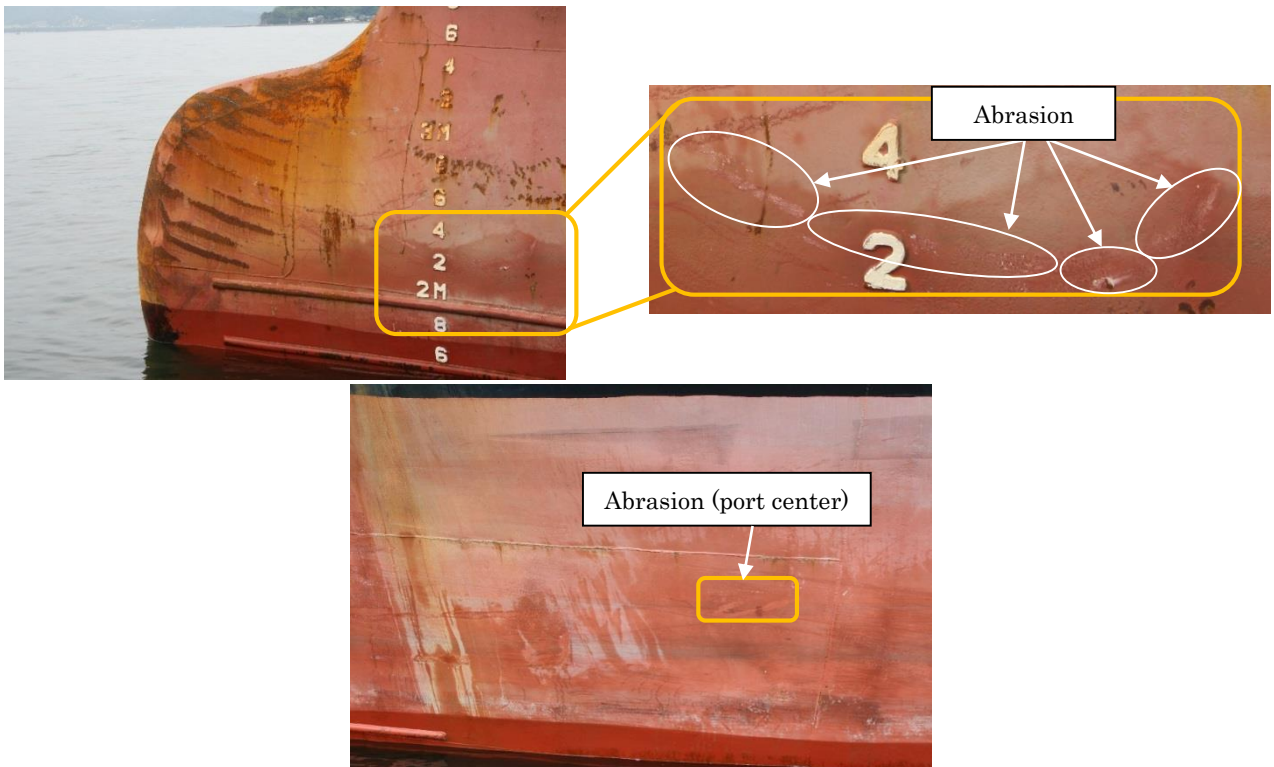
Photo 2.3 - 1 Damage situation to Ship A

Abrasions on the port bow and port center were caused and white paint had adhered to the port bow.

According to 2.3 and 2.10, it is probable that the port bow of Ship A and the bow section of Ship B collided, Ship A caused scratches on the port bow and port center, Ship B resulted in damage to the bow section.

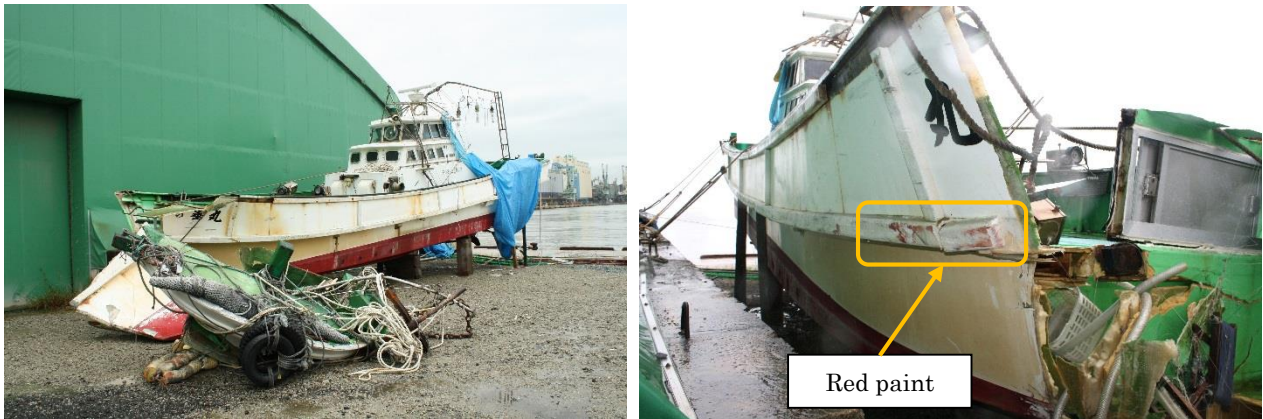
Photo 2.3 - 2 Damage situation of Ship B

Damage was caused to the bow, and it parted from the hull during the lifting. Red paint had adhered to the starboard fender.

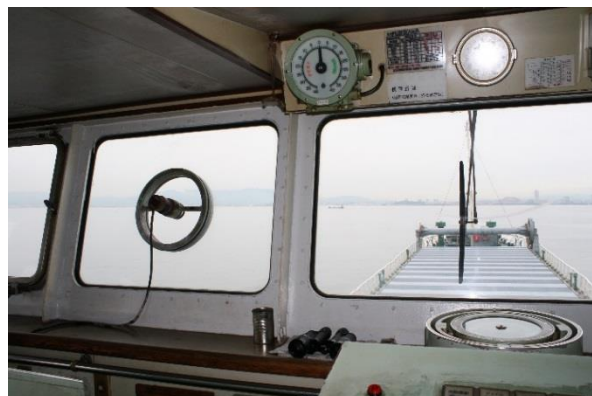
Photo 2.5 -3 View from the ship bridge

View from the bridge to the port bow direction was good. (See Photo 2.5-3)

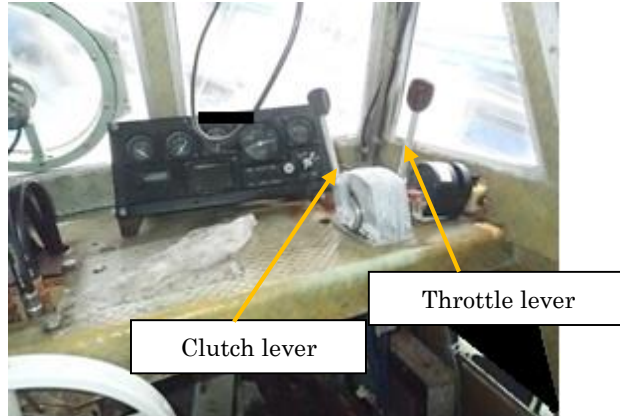
Photo 2.5 -4 State of the remote control apparatus of the main engine

On the remote control device of the main engine, the clutch lever was set to the forward side, the throttle lever was at a position near the slow ahead.
