**MARINE ACCIDENT  
INVESTIGATION REPORT**

Vessel type and name: Cargo Ship "CITY"

Accident type: Grounding

Date and time: Around 05:09 on January 10, 2016 (local time, UTC + 9 hours)

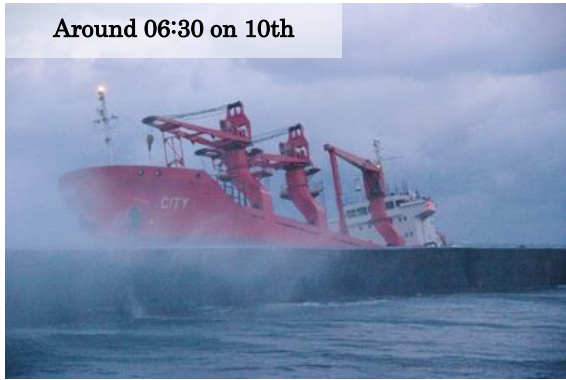
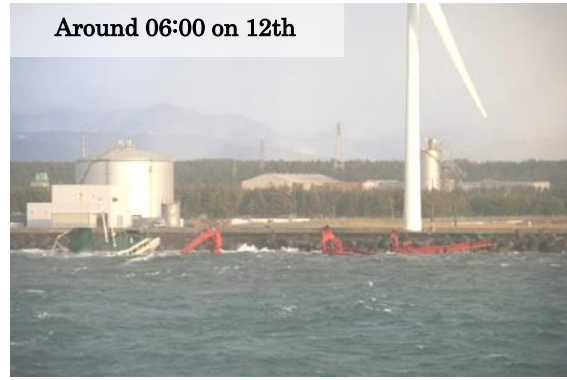
Photos 2 and 3

According to the statements of the master and the reply to the questionnaire by a salvage company, after the ship submerged in water into the floor surface of the bridge, facilities, interior decorating, etc. in the bridge were flown out by about January 18 and the bridge was destroyed and divided into two and the like by about 26<sup>th</sup>. Afterward, she was demolished and removed by the salvage company (See Photos 2 and 3.)

The ship after running-on

- (1) The ship was brought to a state of having swamped to the bridge floor by around 08:28 on January 10 and facilities in the bridge and interior trim flew out by about 18<sup>th</sup> and the bridge was damaged and the body of the ship was separated into half and was completely destroyed.
- (2) The ship was demolished and removed by the salvage company afterward.
