MA2017-8

**MARINE ACCIDENT
INVESTIGATION REPORT**

Accident type	Missing crew member
Date and time	Unknown (Between around 21:15 and 21:42 on May 21, 2016 (local time, UTC+9 hours))
Location	Unknown (Off the south of Cape Ashizuri, Tosashimizu City, Kochi Prefecture (approximately 32°40.5'N, 132°58.5'E to 32°41.9'N, 133°04.3'E))
Summary of the Accident	While chemical tanker FINE CHEMI was proceeding east toward Chiba Port, Chiba Prefecture, off the south of Cape Ashizuri, with a master and other 11 crew members onboard, the chief engineer went missing.
Process and Progress of the Investigation	The Japan Transport Safety Board appointed an investigator-in-charge and one other investigator to investigate this accident on May 22, 2016. May 25 and July 15, 2016: on-site investigation and interview Comments on the draft report were not invited from the party relevant to the cause of accident because the party is missing. Comments on the draft report were invited from the flag State of FINE CHEMI.

Factual Information	
Vessel type and name	Chemical tanker FINE CHEMI (registered in the Republic of Korea)
Gross tonnage	1,307 tons
IMO number	8909977
Owner	DONGNAM SHIPPING CO., LTD. (Compan

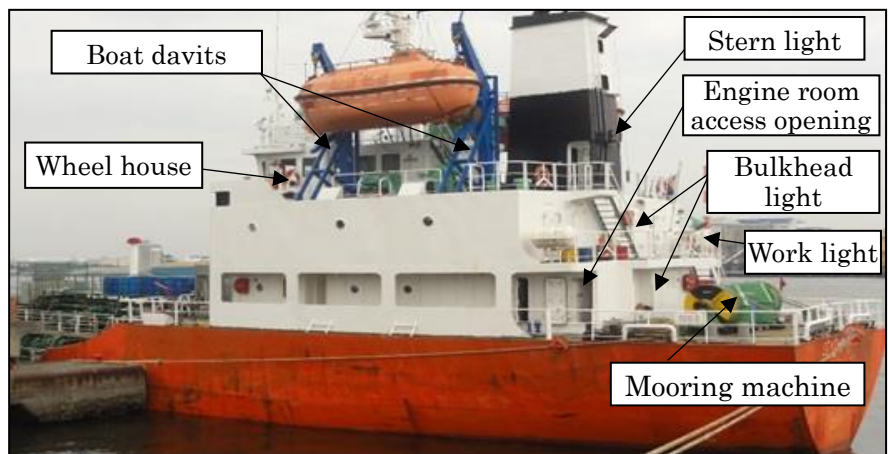
Photo 2 Port aft side of the Vessel

The poop was comprised of three levels: a navigation bridge deck, bridge deck, and poop deck. On the bridge deck and poop deck were crew rooms and other rooms (hereinafter referred to as “the accommodation space”). Around the accommodation space of the poop deck was a part that was exposed to rain and wind. The exposed part had a one-meter-high handrail and other fixtures.

There was an access opening to the engine room on the port aft side of the accommodation space on the poop deck. Stairs leading to the bridge deck and wheel house were installed on the starboard aft side.

A bulkhead light and work light on the handrail of the bridge deck were installed on the poop as lighting equipment; however, these lights were not on at the time of the accident, as the Vessel was underway.

<p>It is somewhat likely that, when the chief engineer went out onto the exposed part, upon which are installed a handrail and other fixtures, at night, in an intoxicated condition, and wearing slippers, he lost his balance when the Vessel pitched and rolled in the swells and fell into the sea. However, because there were no witnesses and because the chief engineer is missing, it was not possible to determine the circumstances of the chief engineer's falling into the sea.</p> <p>(2) The influence of consumed alcohol</p> <p>Given that the chief engineer was consuming alcohol at around 16:00 and that he smelled of alcohol at around 20:30, it is probable that he was intoxicated, even though nothing about him appeared unusual when he entered the engine room around 20:30. However, it was not possible to determine the influence of consumed alcohol.</p>
<p>Probable Causes</p>	<p>It is probable that the accident occurred when, as the Vessel was proceeding east toward Chiba Port at night off the south of Ashizuri, the chief engineer fell into the sea after leaving the access opening that leads from the engine room to the exposed part of the Vessel.</p>

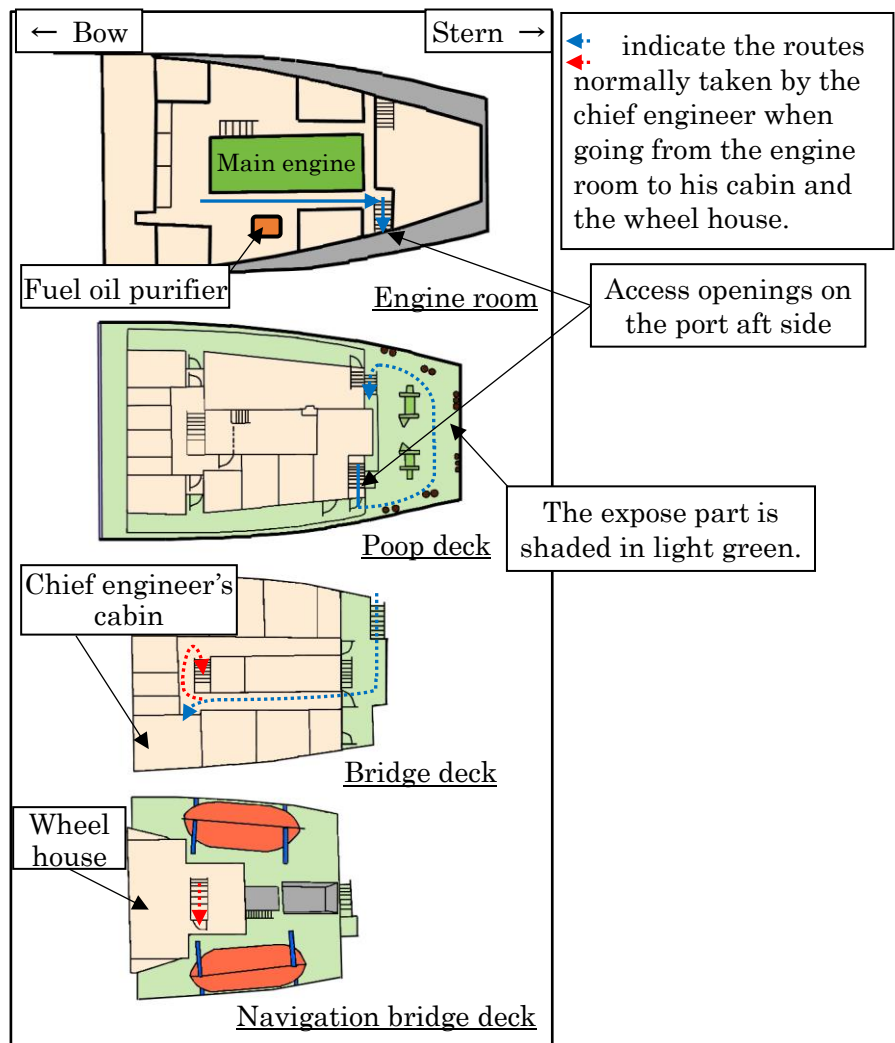
Figure 1 Route from the Engine Room to the Accommodation Space, etc.

When returning from the engine room to his cabin in the accommodation space, the chief engineer left from the access opening leading to the exposed part on port aft side of the engine room, passed along the aft side of the poop deck, and used the stairway installed on the starboard aft side. When further proceeding from the bridge deck to the wheel house, the chief engineer used the stairway of the accommodation space.

As the Vessel was proceeding east toward Chiba Port off the south of Cape Ashizuri, the chief engineer was seen leaving the engine room through the access opening to the Vessel's exposed part at around 21:15 on May 21, 2016. Given that it became clear that the chief engineer could not be found on the Vessel at around 21:42, it is probable that the chief engineer fell into the sea between these two times.

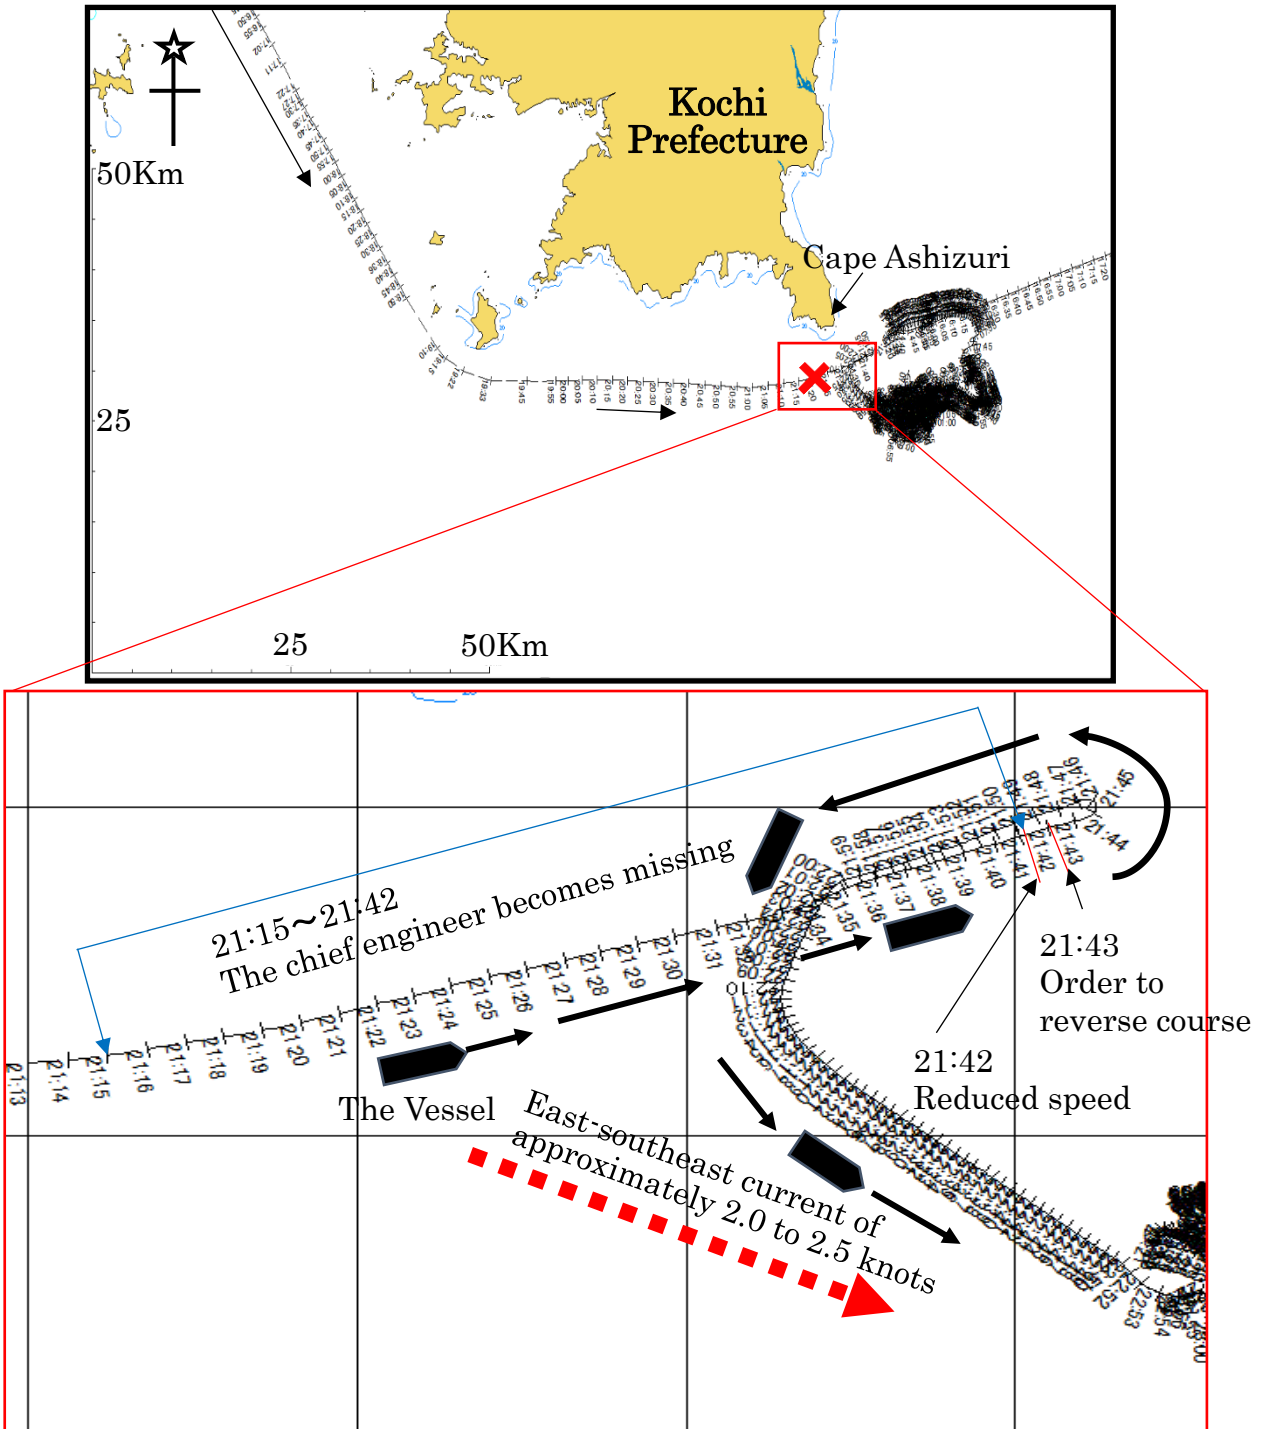
Attached Figure 1 Outline Map of the Course of the Accident Events

<p>third officer informed the master of this request, the master told him that the main engine's RPMs were within the usable range. The third officer was instructed by the master to tell the chief engineer that there was no need to lower the RPMs, and the third officer communicated the master's instruction to the chief engineer.</p> <p>The No. 1 oiler saw the chief engineer making a telephone call in the engine room.</p> <p>The first engineer was asked by the chief engineer in the engine room if the work to repair the fuel oil purifier was proceeding well, after which the first engineer saw the chief engineer leave through the access opening to the exposed part on the port aft side.</p> <p>The No. 1 oiler went to the bridge, the chief officer's cabin, and other areas looking for the chief engineer to report the results of the main engine exhaust temperature measurements that he had been instructed to take by the chief engineer. However, the No. 1 oiler was unable to confirm whereabouts of the chief engineer.</p> <p>At around 21:23, the chief officer, who was in his cabin, began a search of the Vessel with all hands except those on watch on the bridge and engine room. However, because the search did not locate the chief engineer, the chief officer reported to the master the possibility that the chief engineer had fallen into the sea.</p> <p>At around 21:42, the master received the report and reduced speed, and at around 21:43, the master began a search of the area by reversing the Vessel's course and retracing her track.</p> <p>At around 21:54, the master reported that the chief engineer was missing to Japan Coast Guard (JCG), and subsequently contacted Company A and Company B.</p> <p>The master and the chief officer judged that the chief engineer was drifting to the east-southeast due to the effect of the current, and decided to search more in a direction off to the east-southeast than the location where the chief engineer was thought to have fallen into the sea.</p> <p>The Vessel continued searching until around 16:00 on May 23 but did not find the chief engineer, and subsequently headed to Chiba Port with the consent of JCG.</p> <p>The chief engineer was searched for by the Vessel as well as vessels and aircraft of JCG but was not found and became missing. (See Figure 1 Outline Map of the Course of the Accident Events)</p>
