MA2017-10

**MARINE ACCIDENT
INVESTIGATION REPORT**

MARINE ACCIDENT INVESTIGATION REPORT

Vessel type and name: Oil/Chemical Tanker EIWA MARU 3
IMO number: 9073323
Gross tonnage: 740 tons

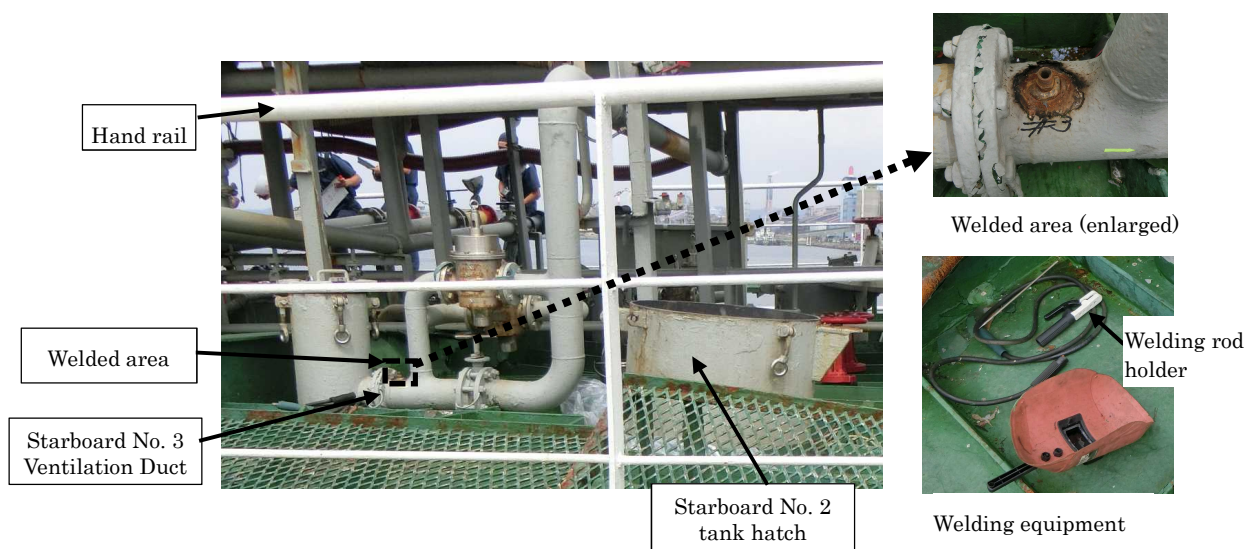
Photo 2.1 Area near the Place of the Welding of the Starboard No. 3 Ventilation Duct

The First Engineer saw a column of flame come from the starboard No. 2 Tank hatch at the time of the second explosion, and the Chief Officer saw a column of flame and black smoke from the direction of the starboard No. 2 Tank hatch. Additionally, the Second Engineer felt a blast moving starboard aft.

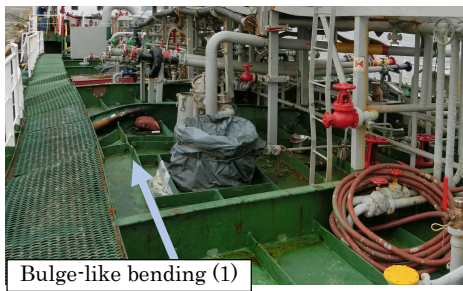
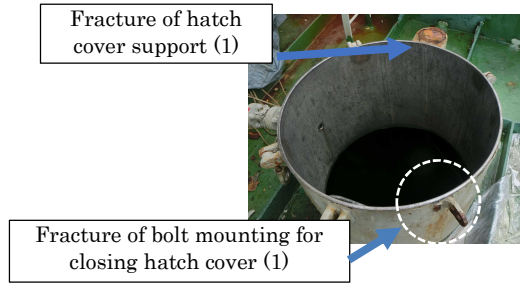
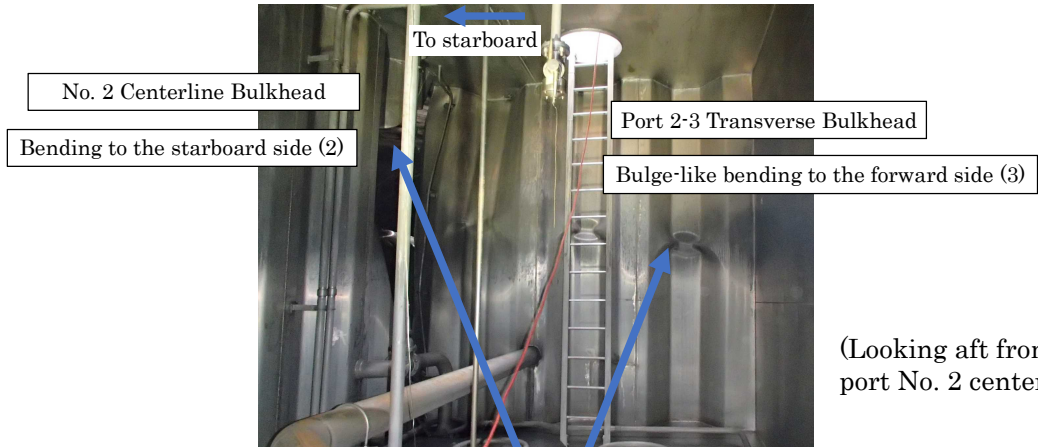
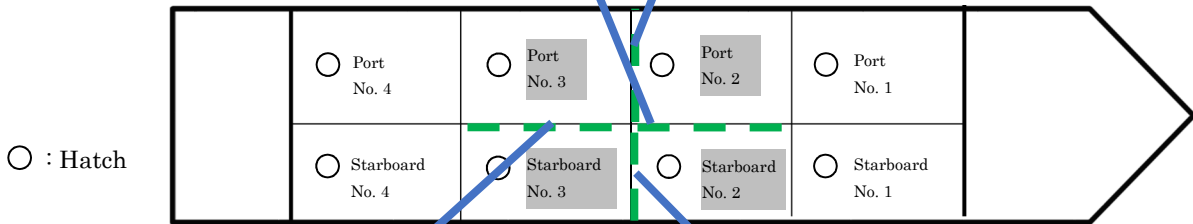
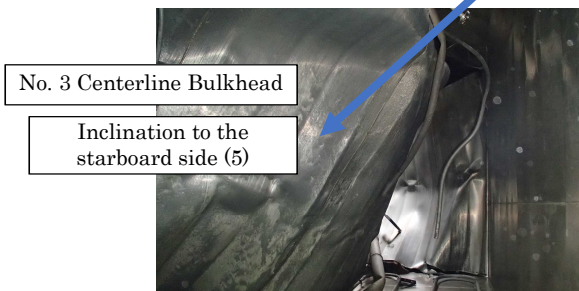
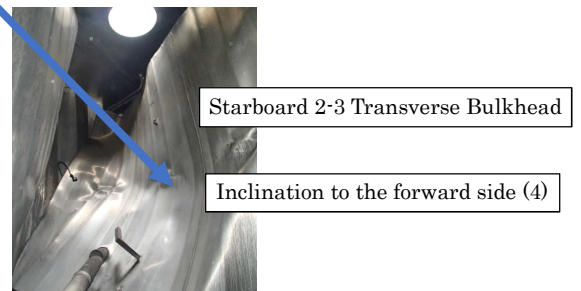
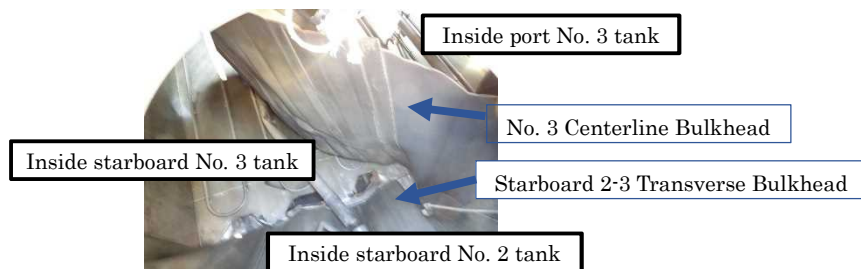
Photo 2.3 Damage to the Hull

- (1) The aft side of starboard No. 2 Tank and tops of starboard No. 3 Tank and port No. 3 Tank had bulge-like bending. Additionally, the hatch cover support and bolt mounting for closing the hatch cover of starboard No. 2 Tank and the hatch cover support for starboard No. 3 Tank were fractured.

- (3) The transverse bulkhead between the port No. 2 Tank and port No. 3 Tank (hereinafter referred to as the "Port 2-3 Transverse Bulkhead") bulge-like bending toward the forward side and fractured at the weld line (starboard side of the bottom edge).

- (4) The transverse bulkhead between the starboard No. 2 Tank and starboard No. 3 Tank (hereinafter referred to as the "Starboard 2-3 Transverse Bulkhead") inclined toward the forward side, bulge-like bending toward the forward side, and fractured at the weld line (upper and lower edges and port edge).

- (5) The longitudinal bulkhead between the starboard No. 3 Tank and port No. 3 Tank (hereinafter referred to as the "No. 3 Centerline Bulkhead") inclined toward the starboard side, bulge-like bending toward the starboard side, and fractured at the weld line (upper and lower edges and forward edge).

(Damage to the starboard-side cargo tank top)

(Damage to the starboard No. 2 tank hatch)

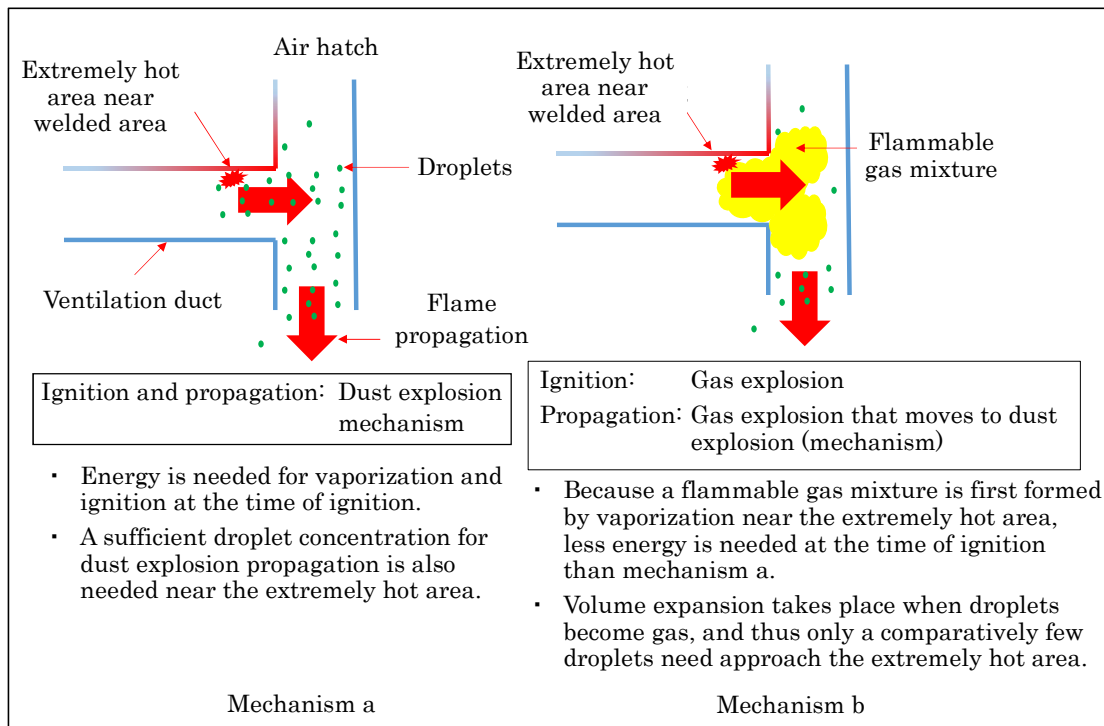
Figure 2.12 Explosion Mechanisms

- 1) In the event that the explosion occurred when, under conditions in which oil with a flash point of 164°C formed tiny liquid drops (hereinafter referred to as "droplets") that became airborne with a roughly even distribution within the tank (length of approximately 8.4 m x width of approximately 4.2 m x height of approximately 4.3 m), and in which some of the droplets became dispersed even within the ventilation duct that was connected to the air hatch above the tank shown in Photo 2.5, welding was conducted on the ventilation pipe (temperature at the welded area: 1,400°C or higher), the two cases, a and b, presented below can be considered as mechanisms of the explosion.

- a The airborne droplets contacted with an extremely hot area near the welded area and burned after vaporizing and igniting and then exploded as a result of (a) and (b) below.

- (a) Nearby droplets burned after vaporizing and igniting from heat released by the burning.
 - (b) The burning of (a) above sequentially propagated.
 - b The airborne droplets vaporized after being heated in the ventilation duct and the accumulated flammable gas mixture contacted with an extremely hot area near the

welded area, ignited and burned, and then exploded as a result of (a) and (b) above.
(See Figure 2.12)

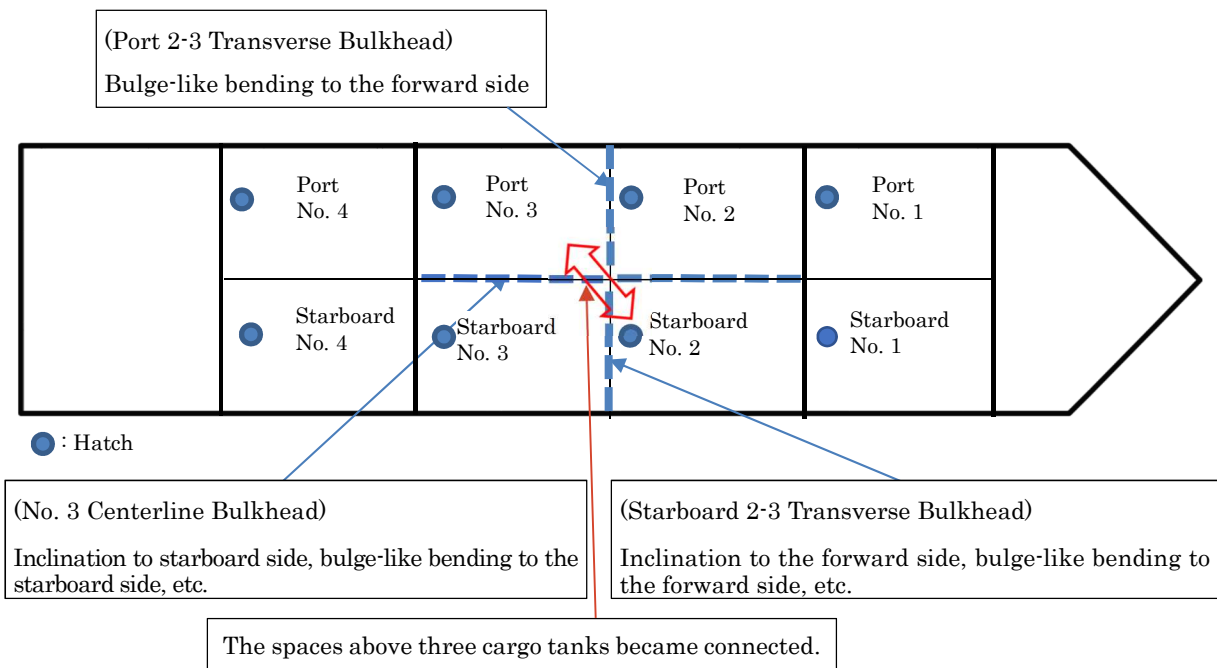
Figure 3.1 Damage to the Cargo Tank Bulkheads

- (1) No explosions occurred in the No. 1 and No. 4 Tanks.
- (2) The Port and Starboard 2-3 Transverse Bulkheads on both sides and No. 3 Centerline Bulkhead suffered bending and other damage as shown in Figure. 3.1.
- (3) As a result of the damage mentioned in (2) above, the spaces above the starboard No. 2 Tank, starboard No. 3 Tank, and port No. 3 Tank became connected.

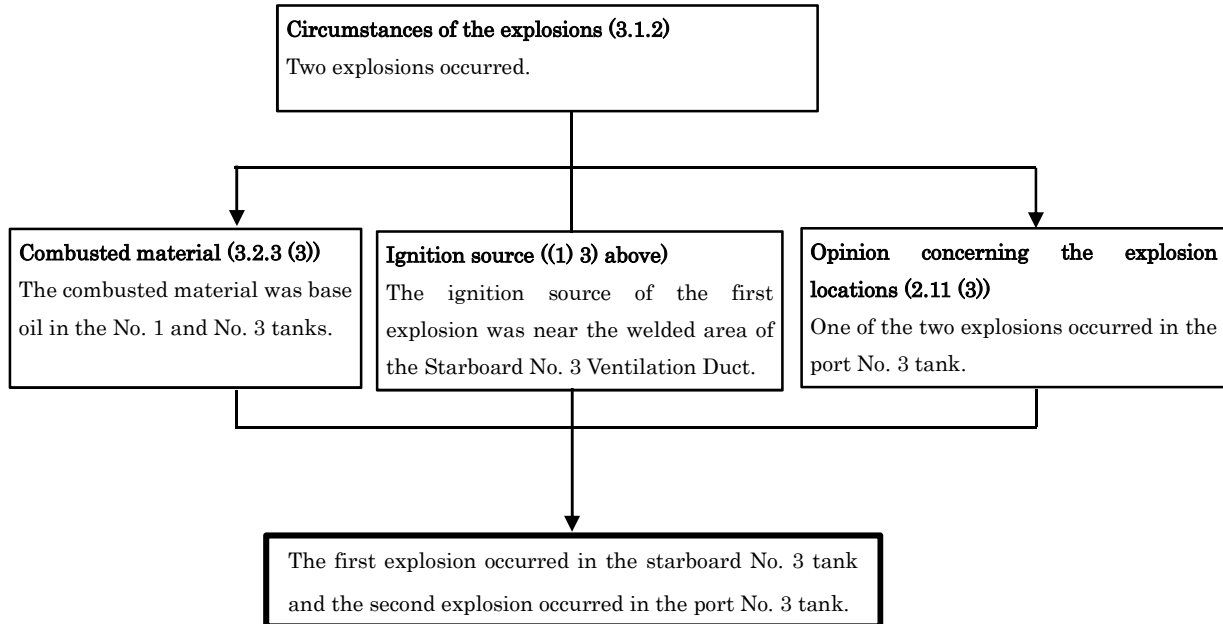
Figure 3.2-1 Explosion Locations

From 2.11 (3), 3.1.2, 3.2.3 (3), and (1) 3) above, it is probable that the first explosion occurred in the starboard No. 3 Tank and the second explosion occurred in the port No. 3 Tank.

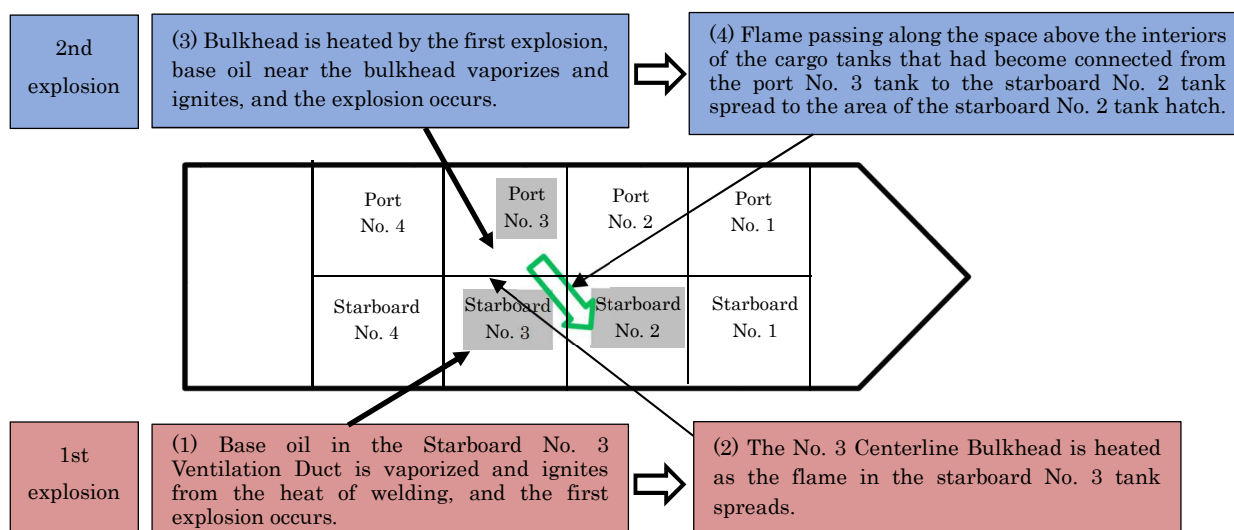
Figure 3.2-2 Explosion Process

- (1) After unloading of the base oil, base oil remaining in the No. 2 Cargo Pump System was sprayed in the No. 3 Tank by the cargo pump and Butterfield cleaning machine, droplets of base oil that became airborne spread to the inside of the Starboard No. 3 Ventilation Duct, the droplets became vaporized by the heat of the welding and ignited, burning in the tank propagated, and the first explosion occurred.

- (4) Flame passing along the space above the interiors of the cargo tanks that had become connected from the port No. 3 Tank to the starboard No. 2 Tank as a result of the explosion of (3) above spread to the area of the starboard No. 2 Tank hatch.

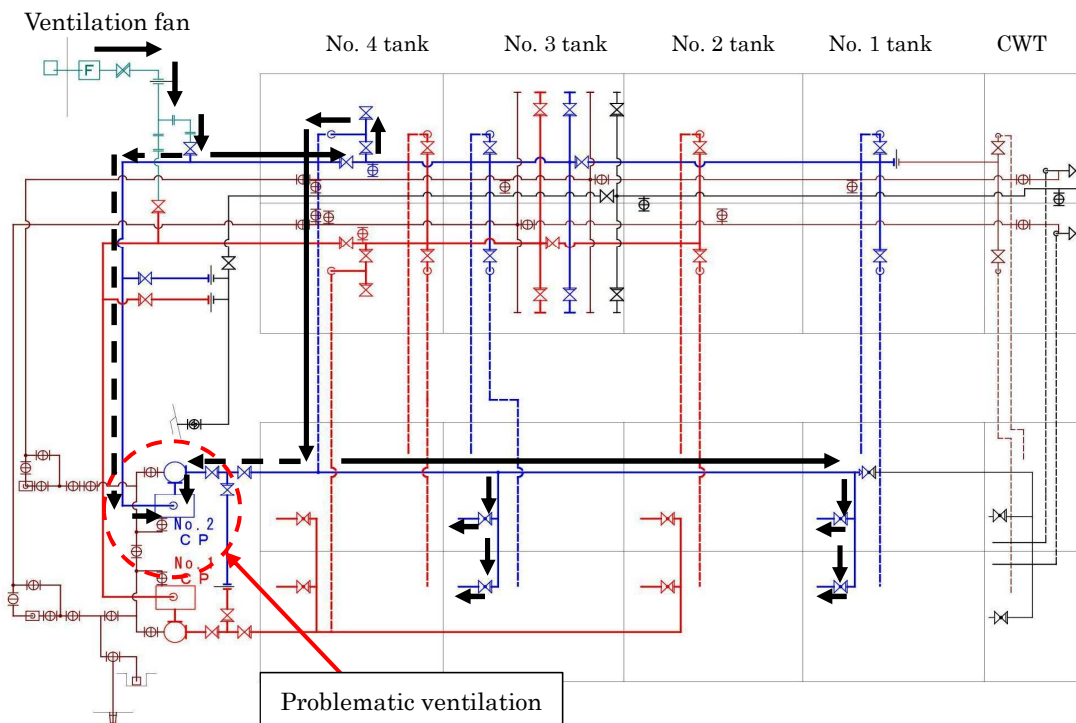
Figure 3.2-3 Vent Lines during Gas-Free Operations

Given that, as shown in Figure 3.2-3, circumstances on the Vessel were such that removing flammable gas by sending air to the cargo pump was problematic when conducting gas-free operations, it is probable that it was necessary to conduct said operations after preparing a vent line through which the cargo pump was ventilated.

- (1) Make the flushing of cargo tanks, etc., prior to tank cleaning part of the work procedure when cleaning tanks after unloading petroleum products.
- (2) Instruct crew members to conduct gas-free operations after preparing ventilation lines through which cargo pumps will be ventilated.
