MA2017-8

**MARINE ACCIDENT
INVESTIGATION REPORT**

Marine Accident Investigation Report

Accident type	Injury of worker
Date and time	09:45 on April 7, 2016 (local time, UTC+9 hours)
Location	Honmoku Pier D5 Wharf, Yokohama City, Kanagawa Prefecture Near 236° true, 520 m from Yokohama Honmoku Breakwater Lighthouse (Approximate position 35°26.4' N, 139°41.1' E)
Summary of the accident	On the container ship MOL DEVOTION, during loading of containers, one worker was injured by falling into the cargo hold.
Process and progress of the investigation	The Japan Transport Safety Board appointed an investigator-in-charge from Yokohama Office and 1 other investigator to investigate this accident on April 8, 2016. Comments on the draft report were invited from parties relevant to the cause of the accident. Comments on the draft report were invited from the flag State of MOL DEVOTION.
Factual information Vessel type and name, gross tonnage Vessel number, owner L×B×D, hull material Engine, output, date of launch	Container ship, MOL DEVOTION (Republic of the Marshall Islands), 39,906 tons 9352420 (IMO number), Clan Navigation Ltd. 260.00 m × 32.25 m × 19.30 m, steel Diesel engine, 36,560kW, Augu

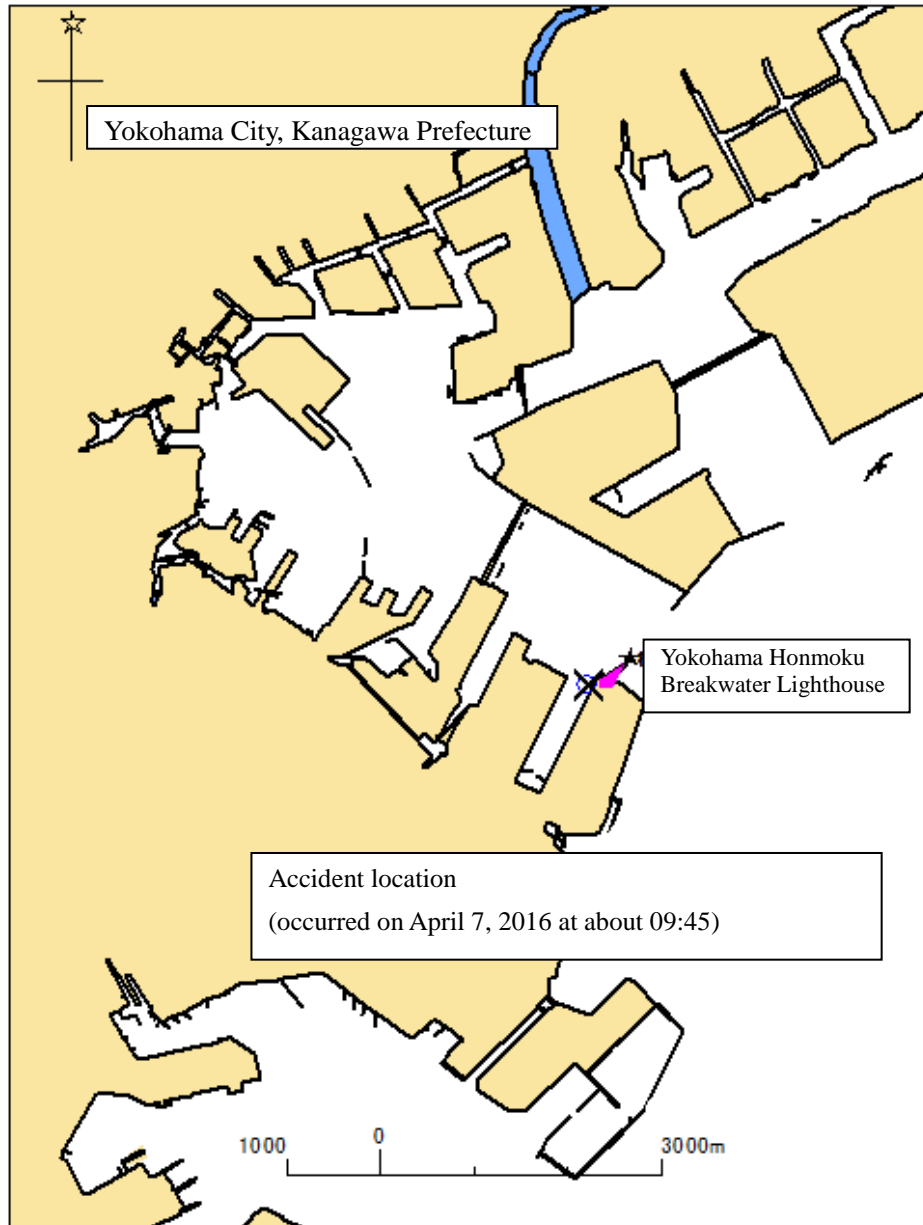
Attachment 1 Rough sketch of the location of the accident

<p>Events leading to the accident</p>	<p>On the ship, with its Master and 24 others (all citizens of the Republic of the Union of Myanmar) aboard, stevedoring containers began at Honmoku Pier D5 Wharf at about 8:30 on April 7, 2016.</p> <p>The stevedoring work was performed by workers employed by a port and harbor transportation company. Worker A was the general supervisor, and Worker B and 6 others were performing the work.</p> <p>On the ship, the stevedoring work in Hold No. 1 ended at about 9:20, then at about 9:40, Worker B and one other worker started to place the portside hatch cover of the No. 2 Hold on the wharf, while the other five workers were lashing Hold No. 1.</p> <p>Worker B unlatched the Chain of the passageway hatch (below, “the Chain”), which is used to prevent falling, installed transversely at a height of about 1m above the upper deck in order to place the hatch cover on the land, and with one other worker, moved to the portside while watching the crane shift the hatch cover to the land.</p> <p>At about 09:45, when the ship started to load containers on the portside of Hold No. 2 and a container had been lowered about 5m from the same hold opening, Worker B, noticing that he had forgotten to attach the Chain, approached the passageway hatch intending to attach it, tripped in the passageway and fell into Hold No. 2 from the passageway hatch.</p> <p>Worker A stopped the stevedoring and directed other workers to take action to rescue Worker B because Worker B did not move.</p> <p>Worker B was transported to a hospital in an ambulance, was diagnosed as having suffered multiple fractures to his face etc. was admitted to the hospital and was treated as an inpatient for about 4 months.</p> <p>(Refer to Attachment 1: Rough sketch of the location of the accident, Photo 1: View of the area around the portside Hold No. 2, Photo 2: View of the passageway, Photo 3: View of the location of the fall.)</p>

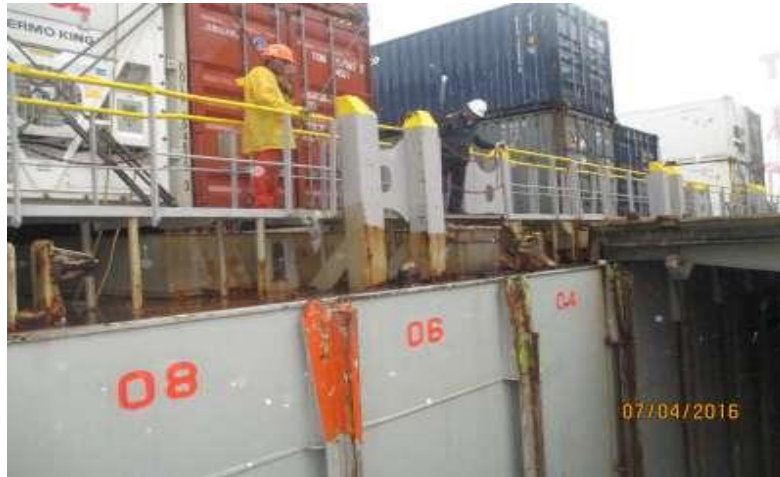
Photo 1 View of the area around the portside Hold No. 2

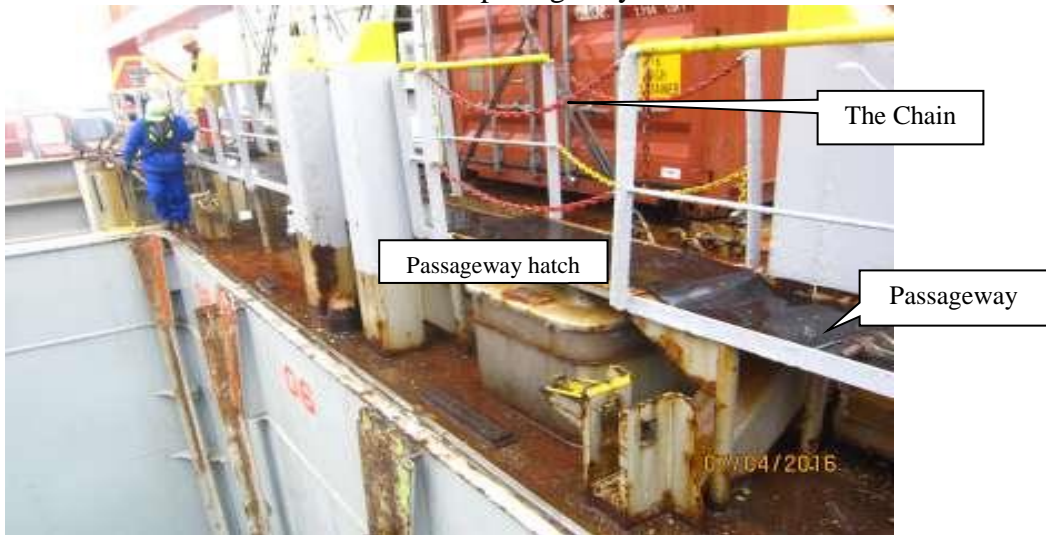
<p>Involvement of weather or sea conditions</p> <p>Analysis of matters that were clarified</p>	<p>No</p> <p>It is probable that during container stevedoring work on the ship at Honmoku Pier D5 Wharf, Worker B approached the passageway hatch intending to attach the Chain, then tripped in the passageway, resulting in him falling into the hold from the open passageway hatch and suffering injuries.</p> <p>It is somewhat likely that worker B tripped in the passageway partly because it was difficult to move wearing the rain wear.</p>
<p>Probable causes</p>	<p>It is probable that this accident occurred because, during container stevedoring work on the ship at Honmoku Pier D5 Wharf, Worker B approached the passageway hatch intending to attach the Chain, then tripped in the passageway, resulting in him falling into the hold from the open passageway hatch.</p>
<p>Actions taken</p>	<p>After this accident, the port and harbor transportation company revised its work standards related to the use of safety belts at places where there is a danger of falling and informed its entire company of the revised standards in order to prevent accidents.</p> <p>The following are considered measures which would help prevent a recurrence of any similar accidents.</p> <ul style="list-style-type: none"> ▪ Being sure to always be wearing a safety belt when approaching a location where a passageway fall prevention use chain has been unlatched. ▪ When wearing rain wear, performing work extremely carefully because it is difficult to move wearing rain wear.

Photo 2 View of the passageway

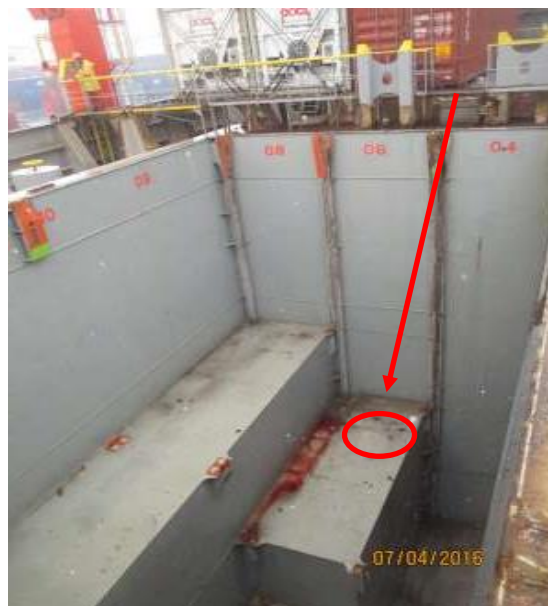
Photo 3 View of the location of the fall
