**MARINE ACCIDENT
INVESTIGATION REPORT**

Vessel type and name: Cargo ship SWIFTNES

Vessel type and name: Work boat Fuji Maru

Accident type: Capsize

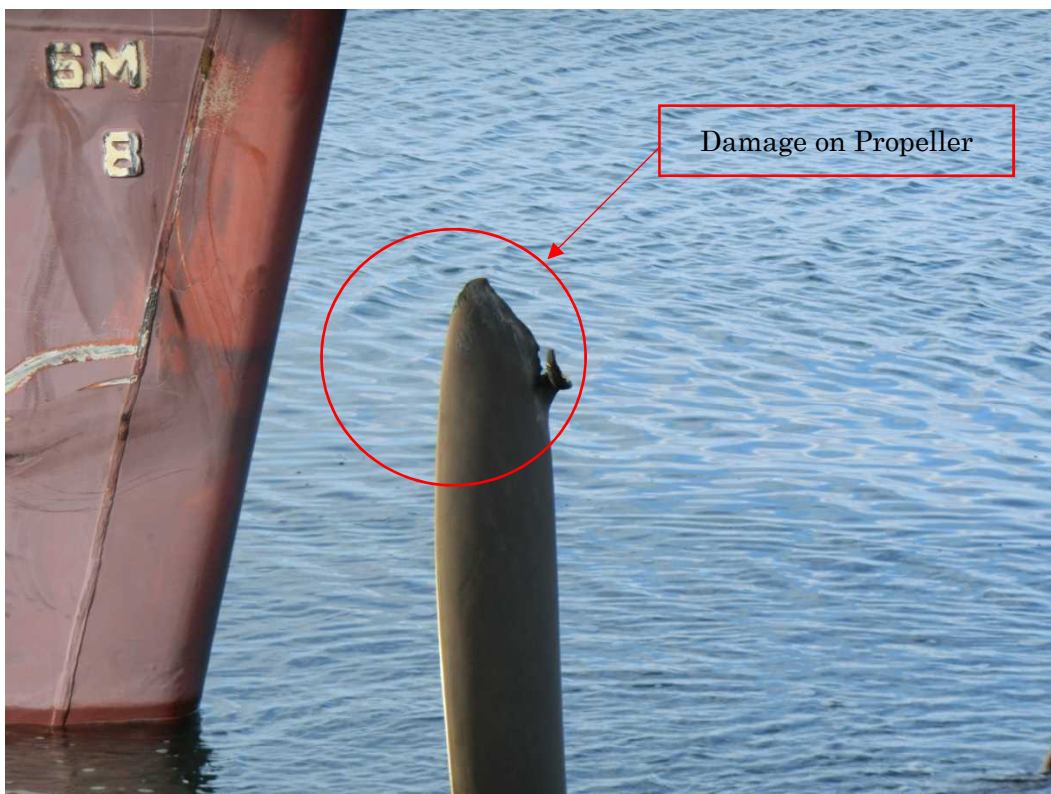
Photo 1 Propeller of Vessel A

According to the statement of Mater A, Vessel A suffered damage on her propeller.

Judging from 2.1.3 and 2.3, it is probable that Vessel A suffered damage on her propeller, Boat B suffered severely damage on her engine and was abandoned.

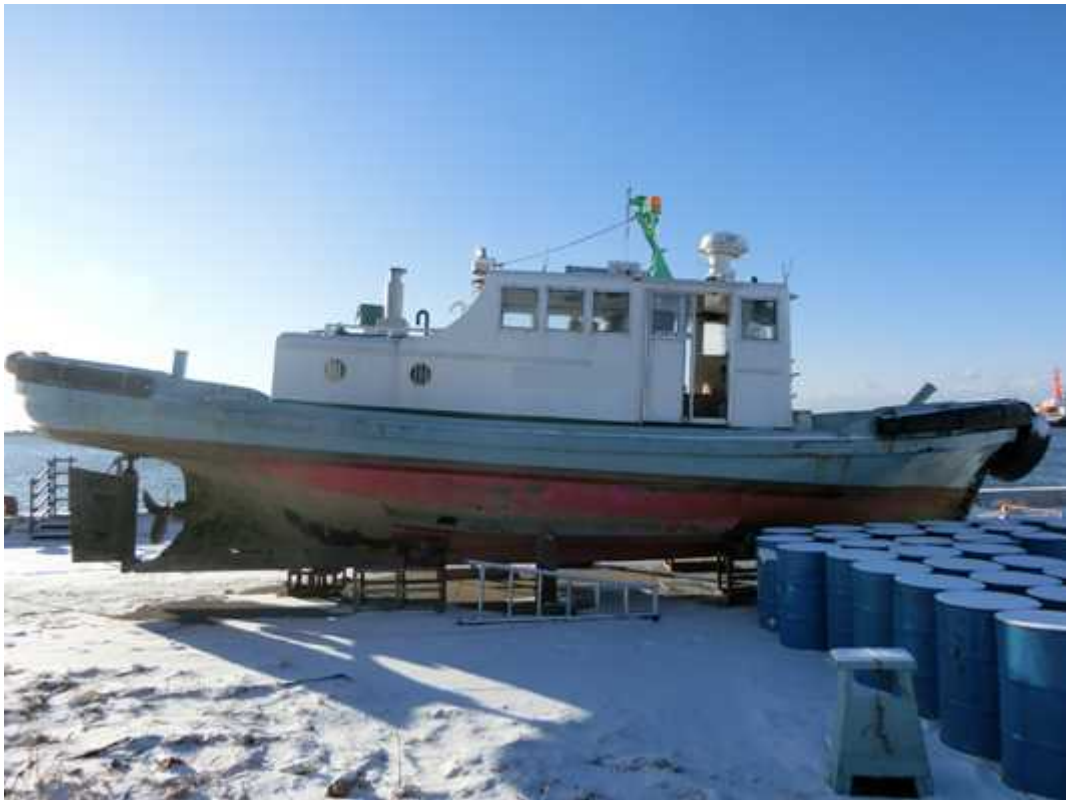
Photo 3 Boat B

According to the statement of a representative of Tomako Service Company (hereinafter referred to as "Company B"), Boat B suffered severely damage on her engine and was abandoned.
